Techos Siglo XXI – Constructing Your Green Home

Home Diary – Playa Grande

Super Home #3 begins with a BIG MOVE!

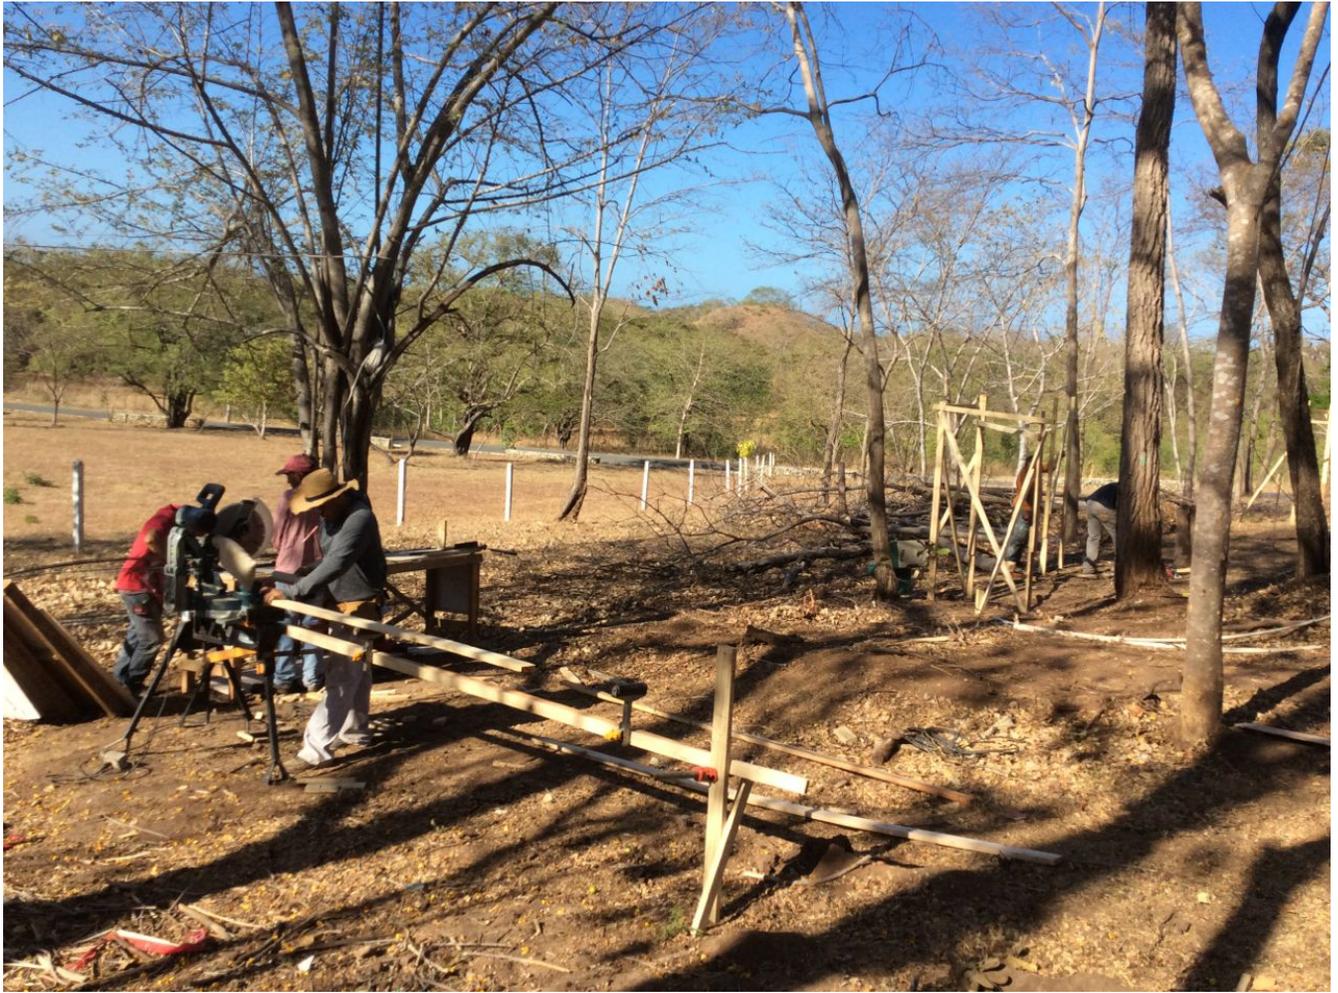
Cutting of batter boards and stakes to set up building and excavation lines.

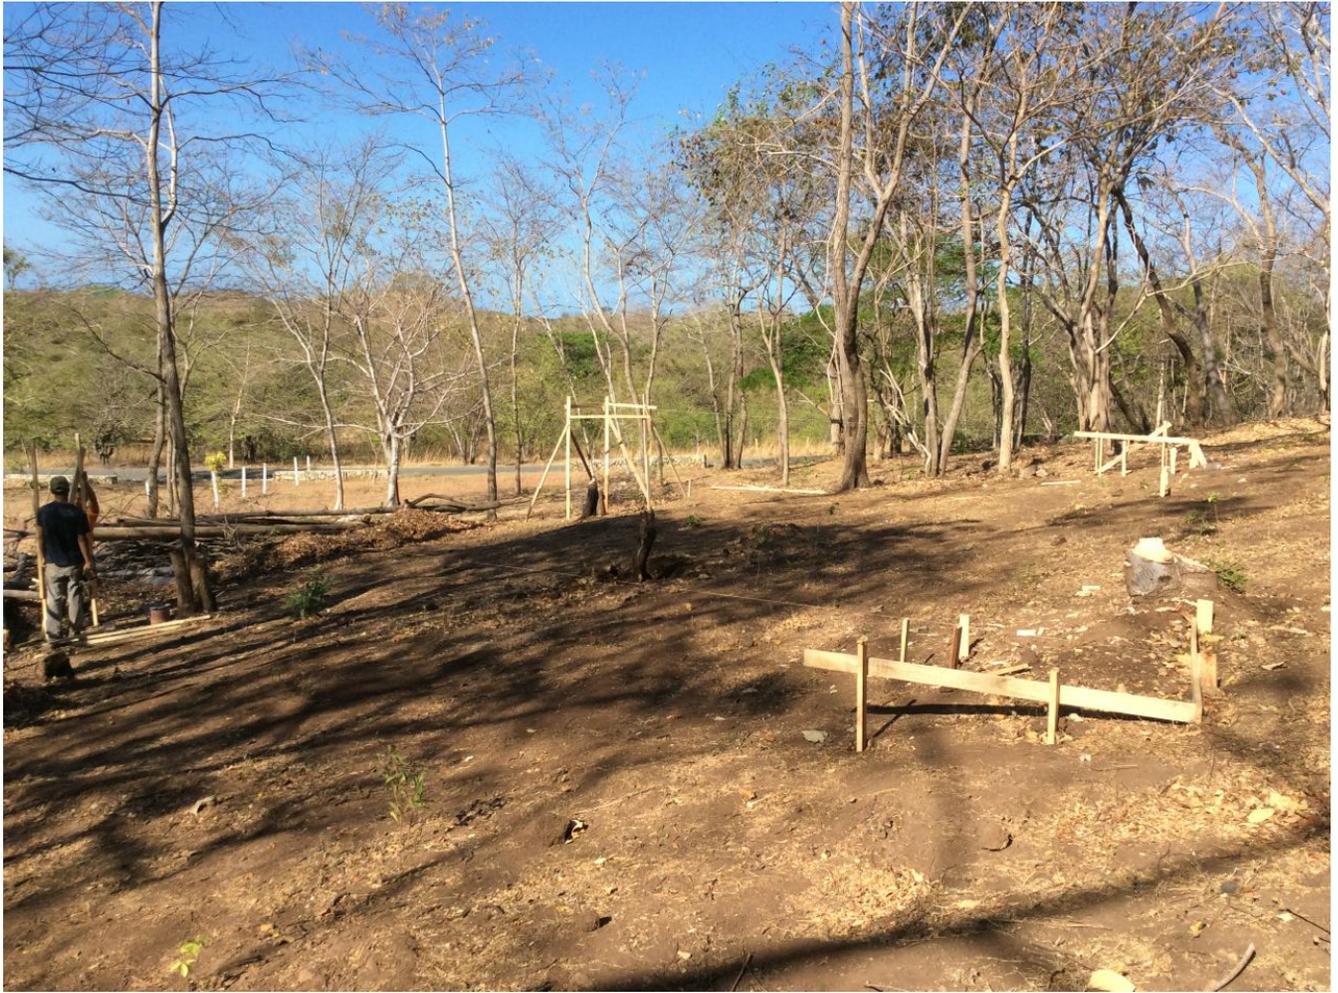
Batter boards are set up to establish the exact location of the new home after debate and option selections with the owners Ian and Corynne.

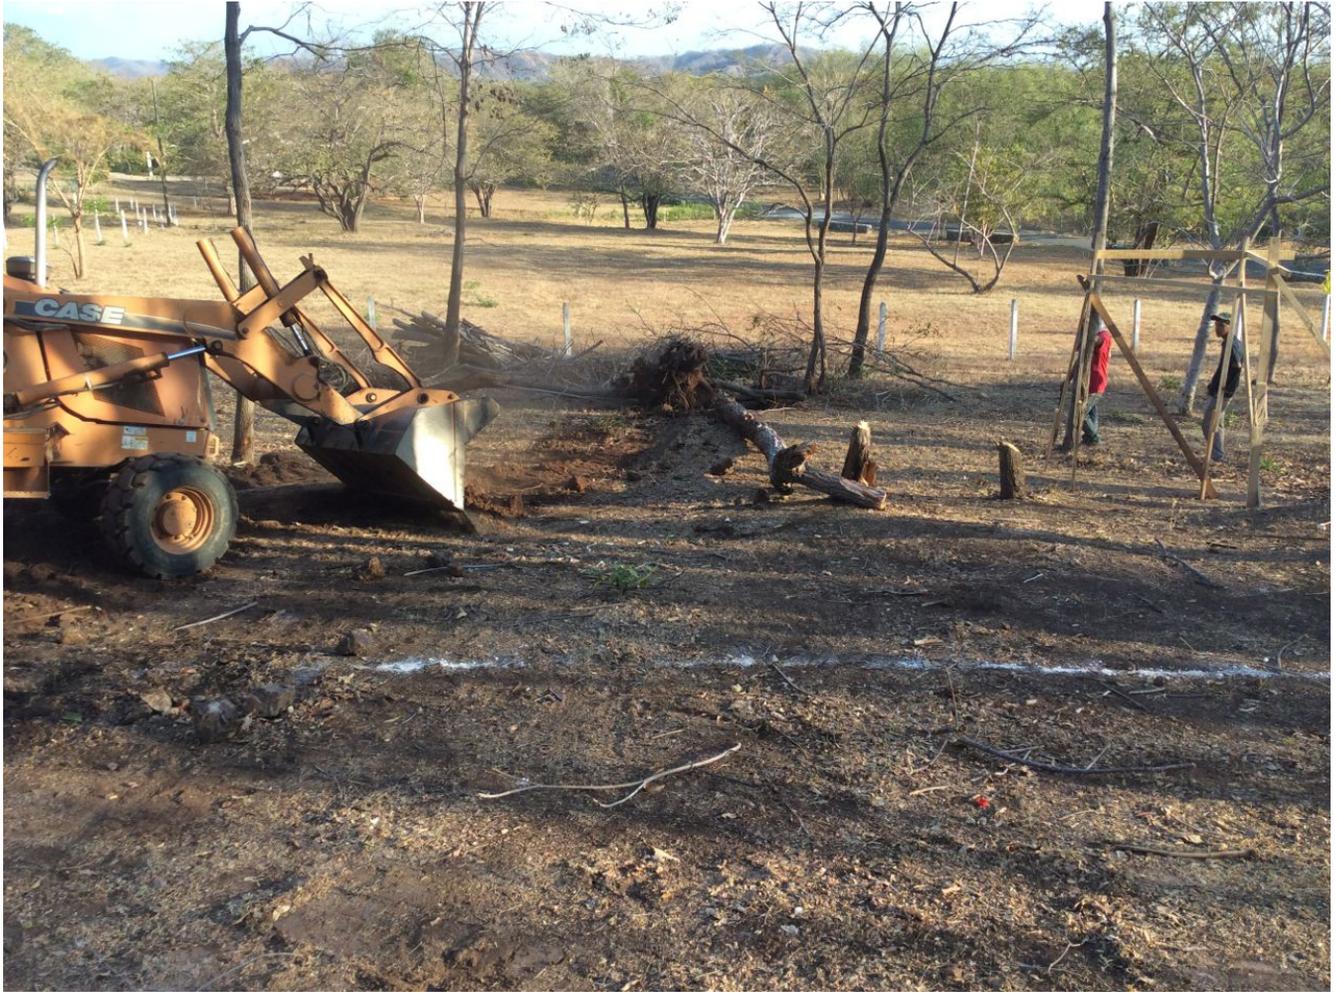
Small trees are downed and pulled out of construction zone with the backhoe. White line in the foreground marks out the carefully selected septic field.

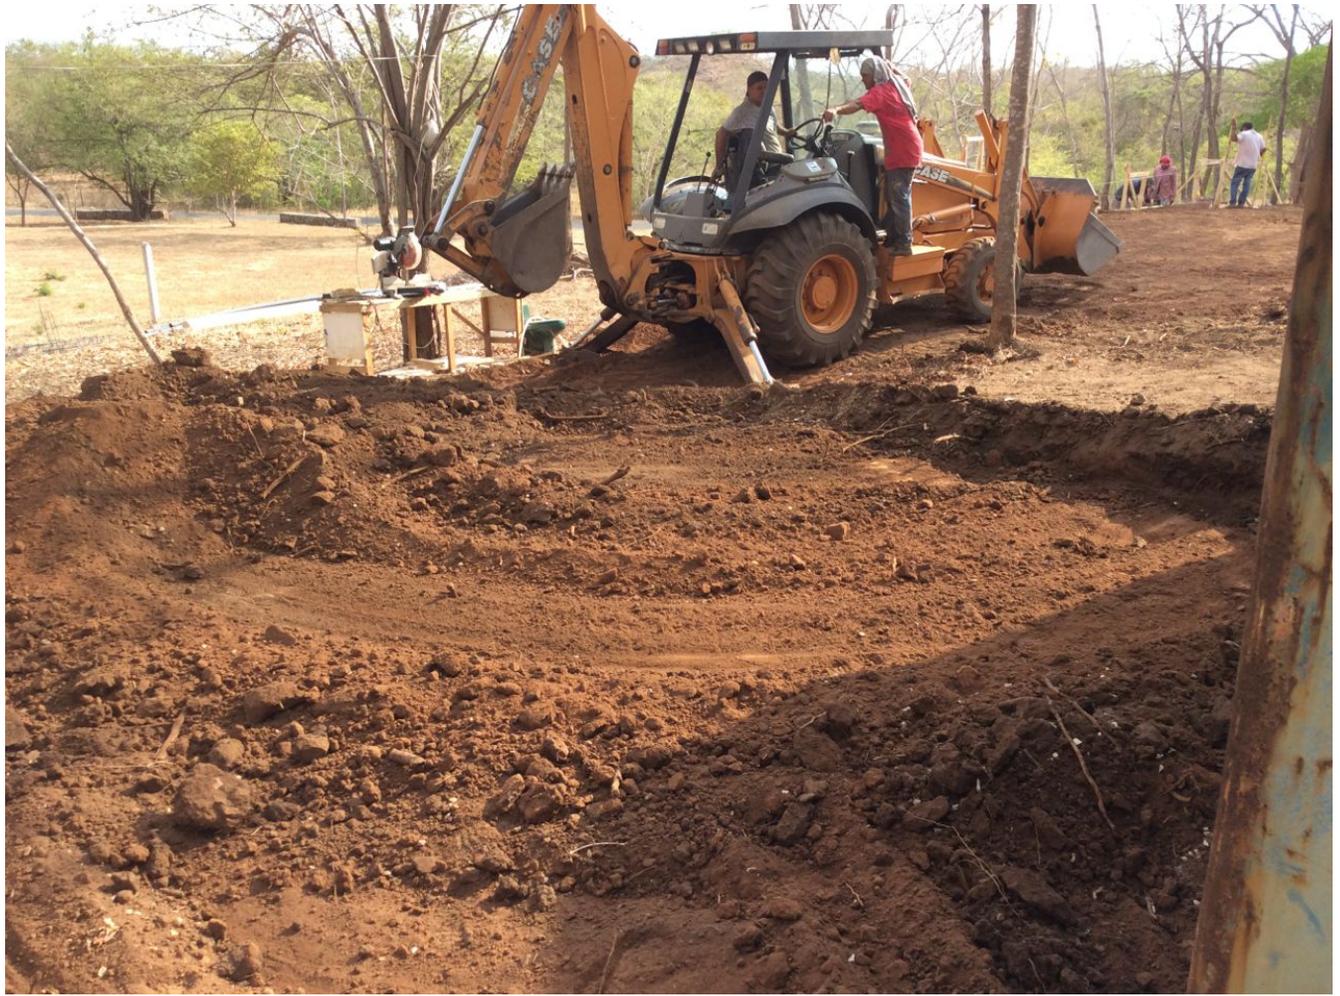
Removing the natural sloping hillside to create a flat spot for a carport pad.

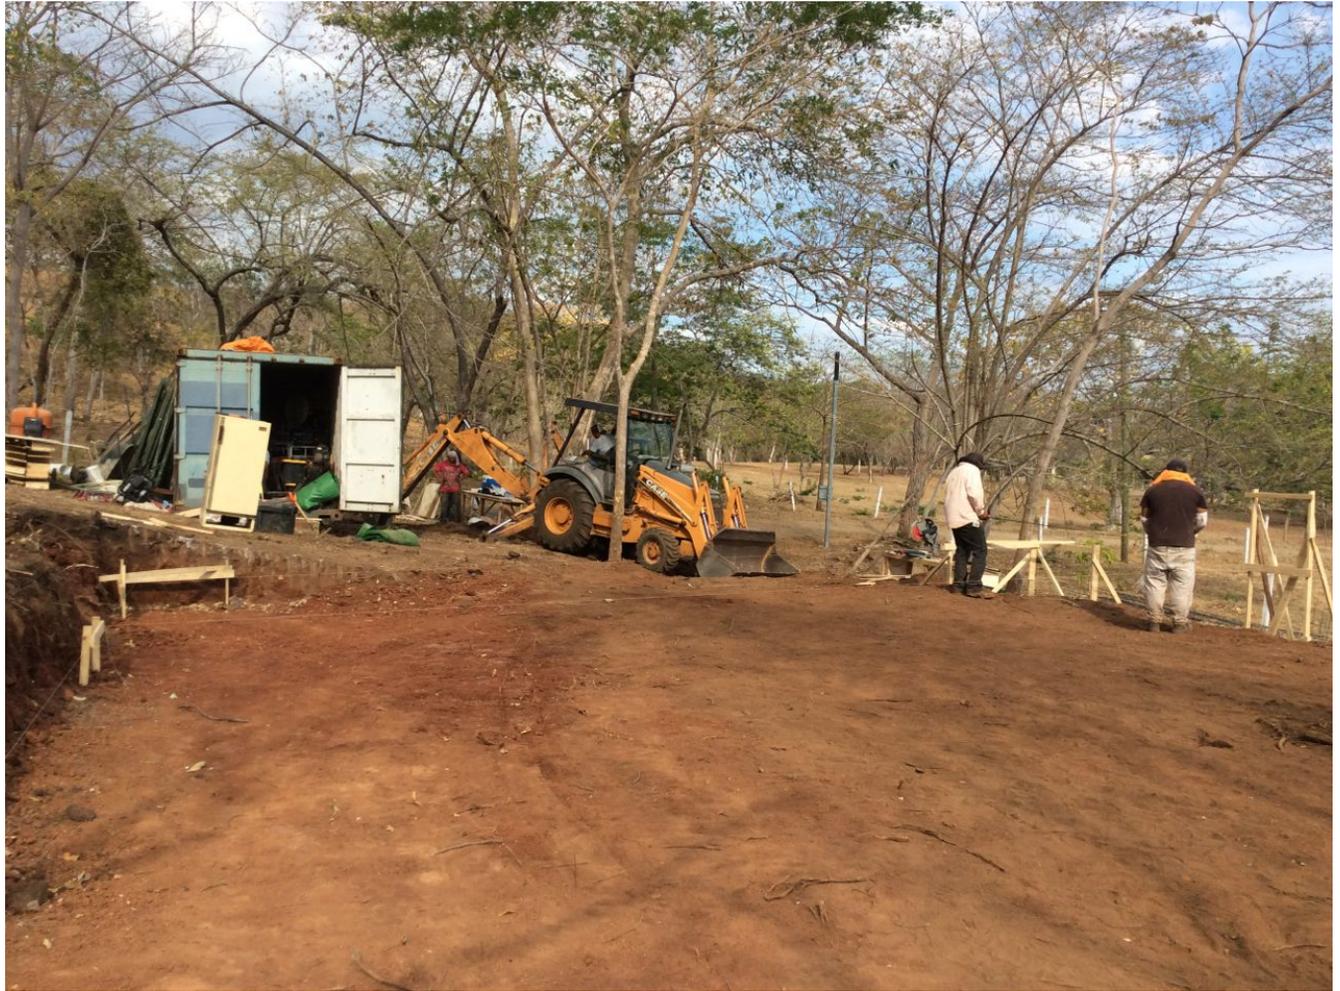
The homes platform is made ready by cutting into the high side and moving the fill down to the low side which was a 6 foot drop prior to our massaging efforts.

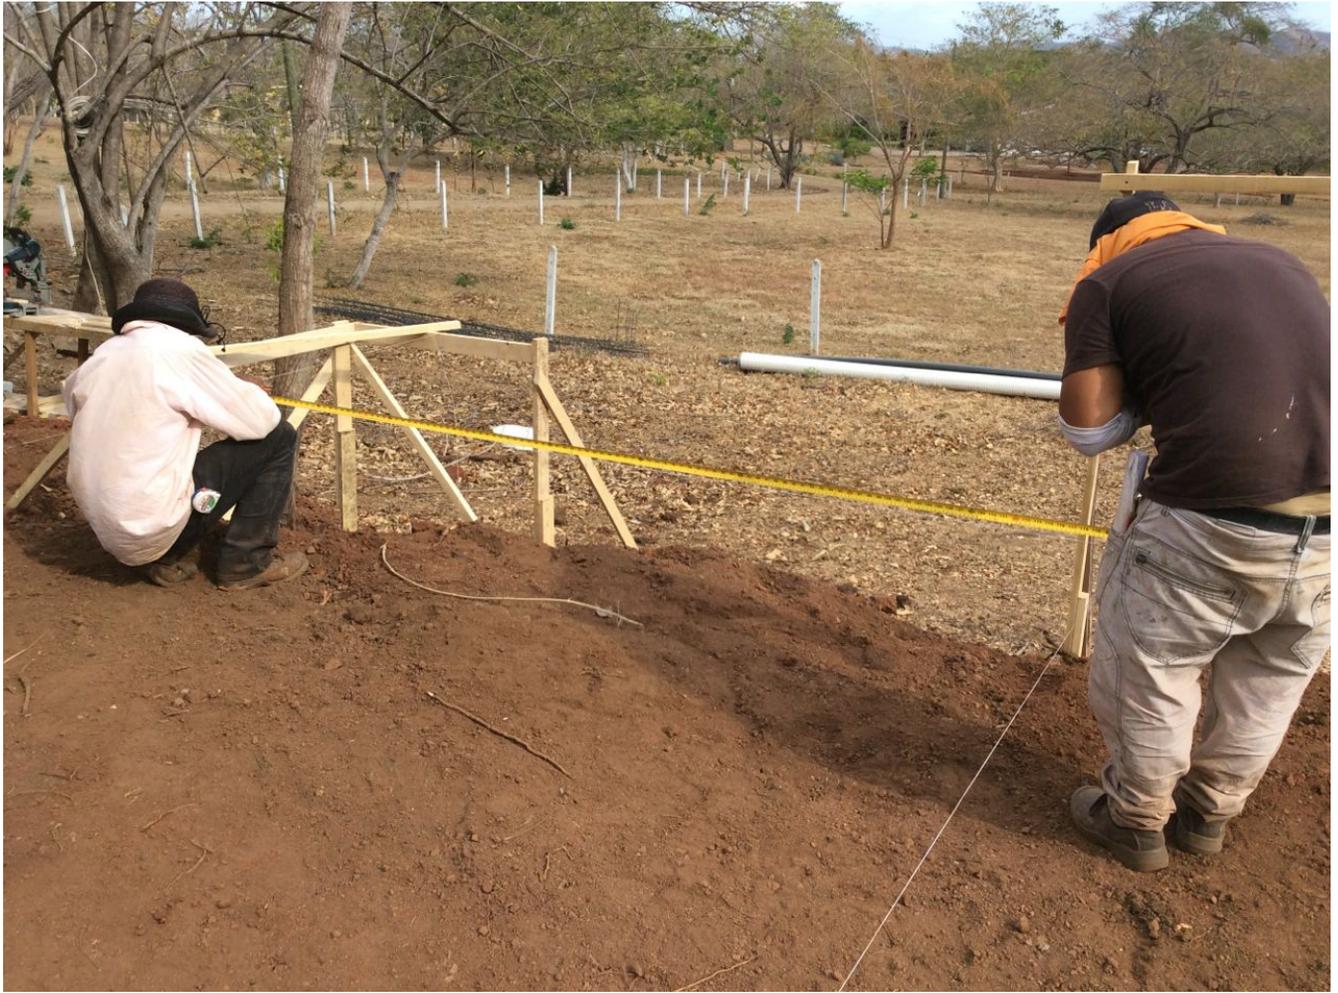
Layout and squaring up the the building lines using age old methods and basic geometry.

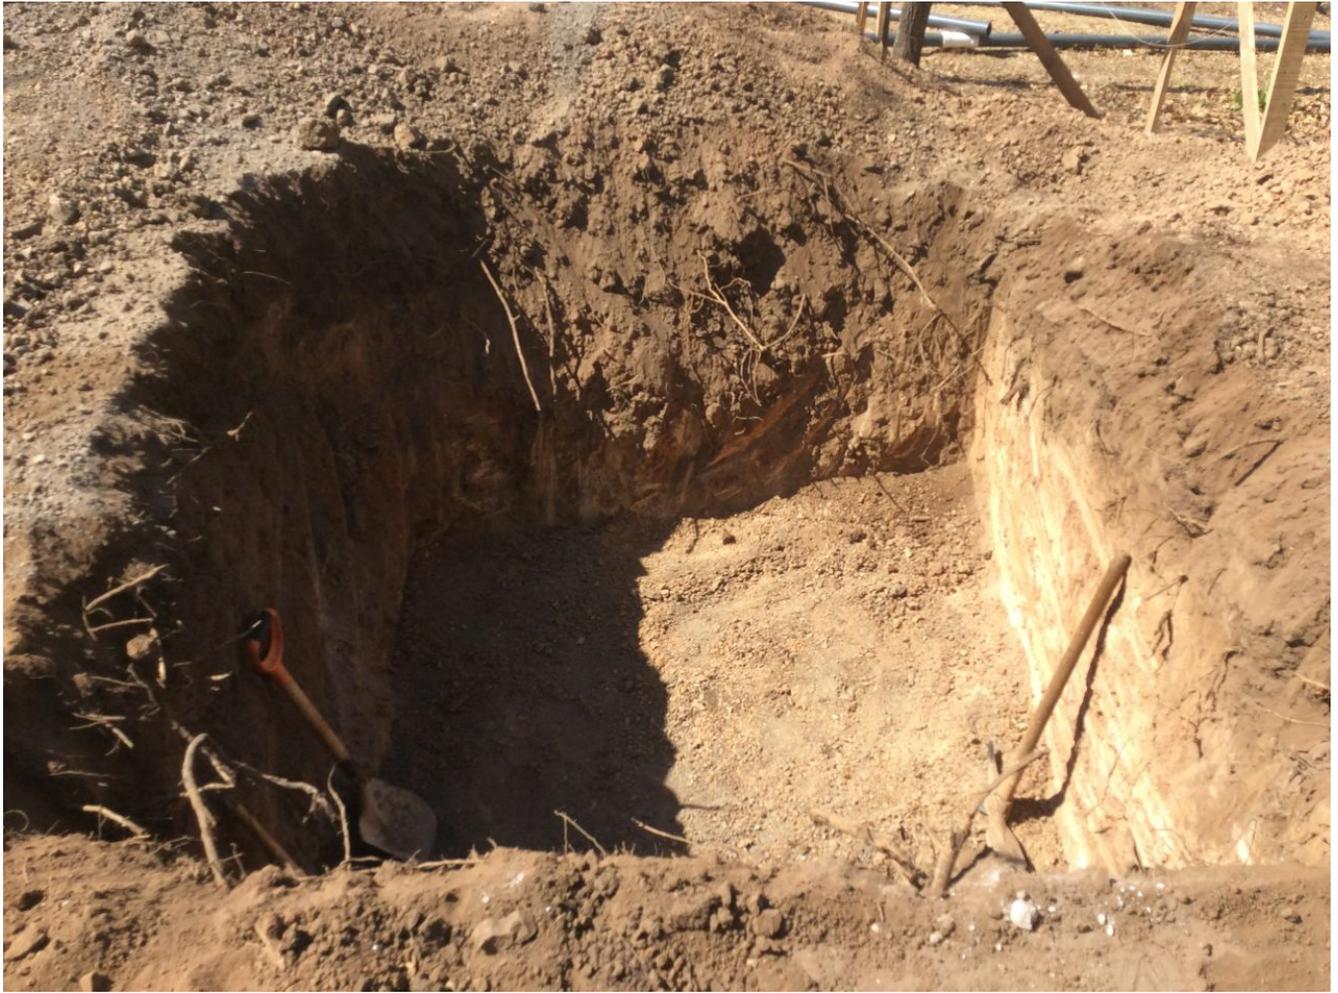
Hole dug into the site to make a space for the required 5,000 liter (1,250 gal) water reserve tank that is a requirement of the project. This was tough digging as this hill side has a layer of rock 1 - 4 feet under it that behaves a bit like shale or highly compressed gravel fines. Auger would not dig through it and no filtration existed as water left in these verrrry dry holes remained there for over a day. A bit of a pain to dig and drill into but provides great support to hold up any house let alone a featherweight such as this one is. Next comes the digging of the hole to house the dual septic tanks.

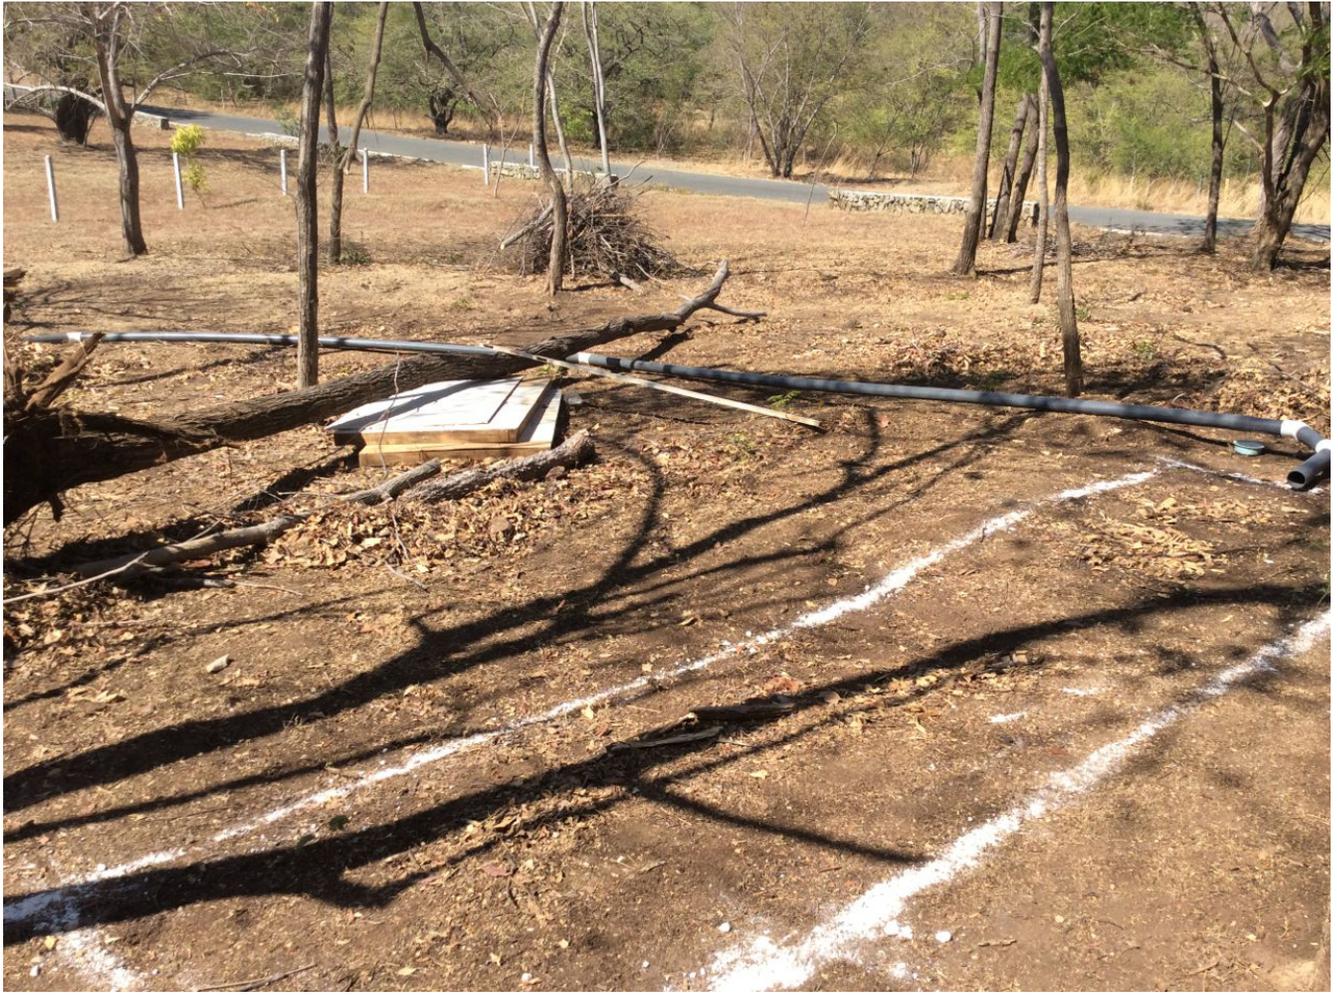
Lines laid out for tank hole as well as feeder tube going down to septic field.

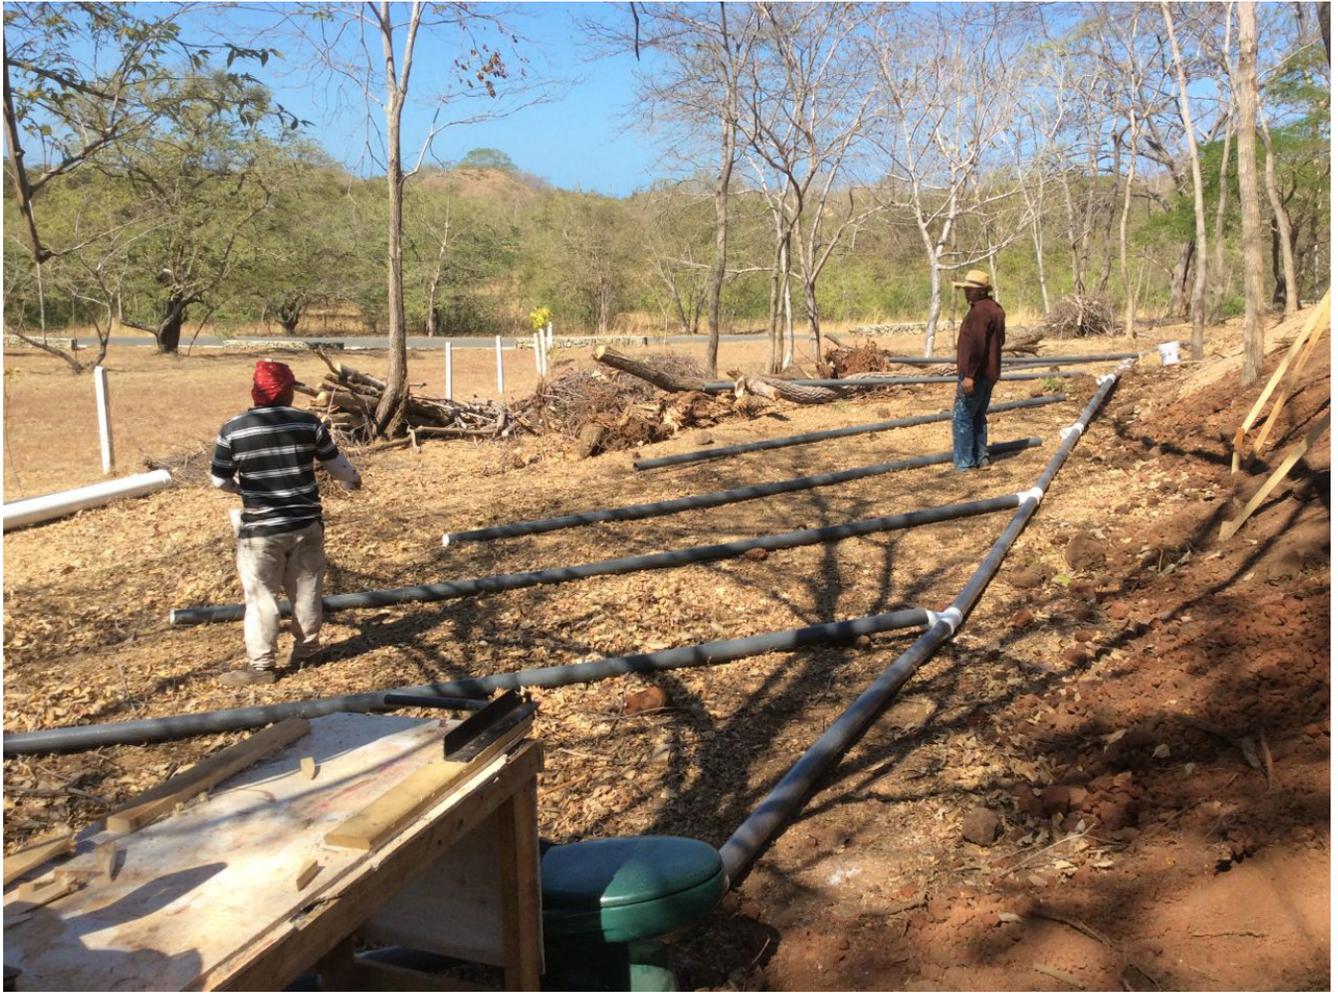
Field lines assembled dry to establish all the trenches required for the system. This is strategically located in front of the house on a relatively flat area to accommodate the perfectly level weeping system used with our custom made pipes. This will also ensure that when we revisit this site next dry season the front area of the house will stay a perpetual green due to the leaching of the field providing a source of water for plantings to flourish even throughout dry season. Needless to say a necessary trick to provide a perpetual green space in the very dry Guanacaste summers.

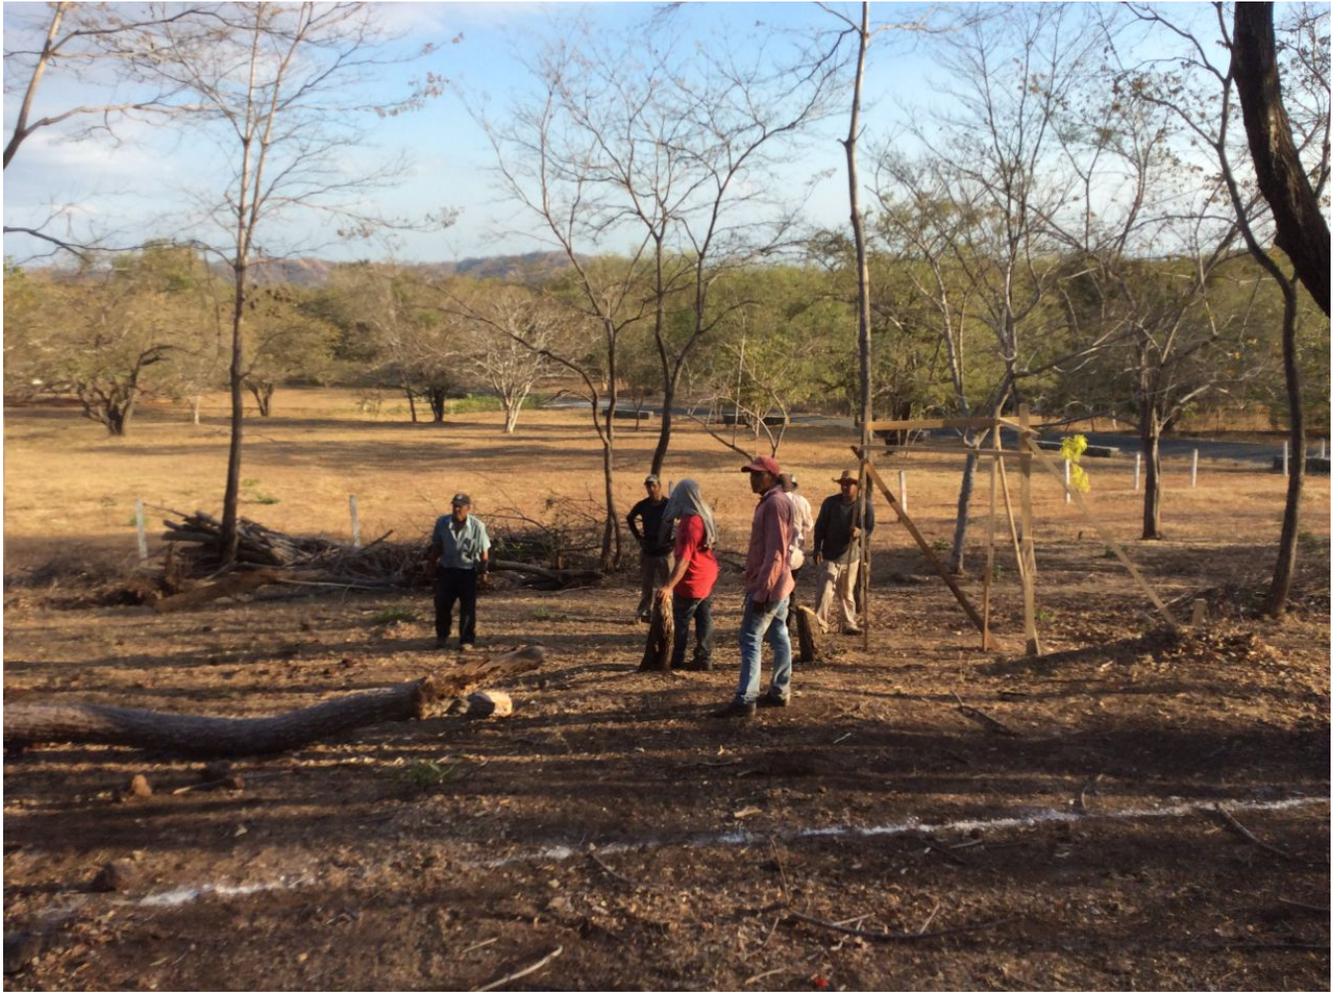
Laying out chalk lines for operator to follow for the septic field drain lines.

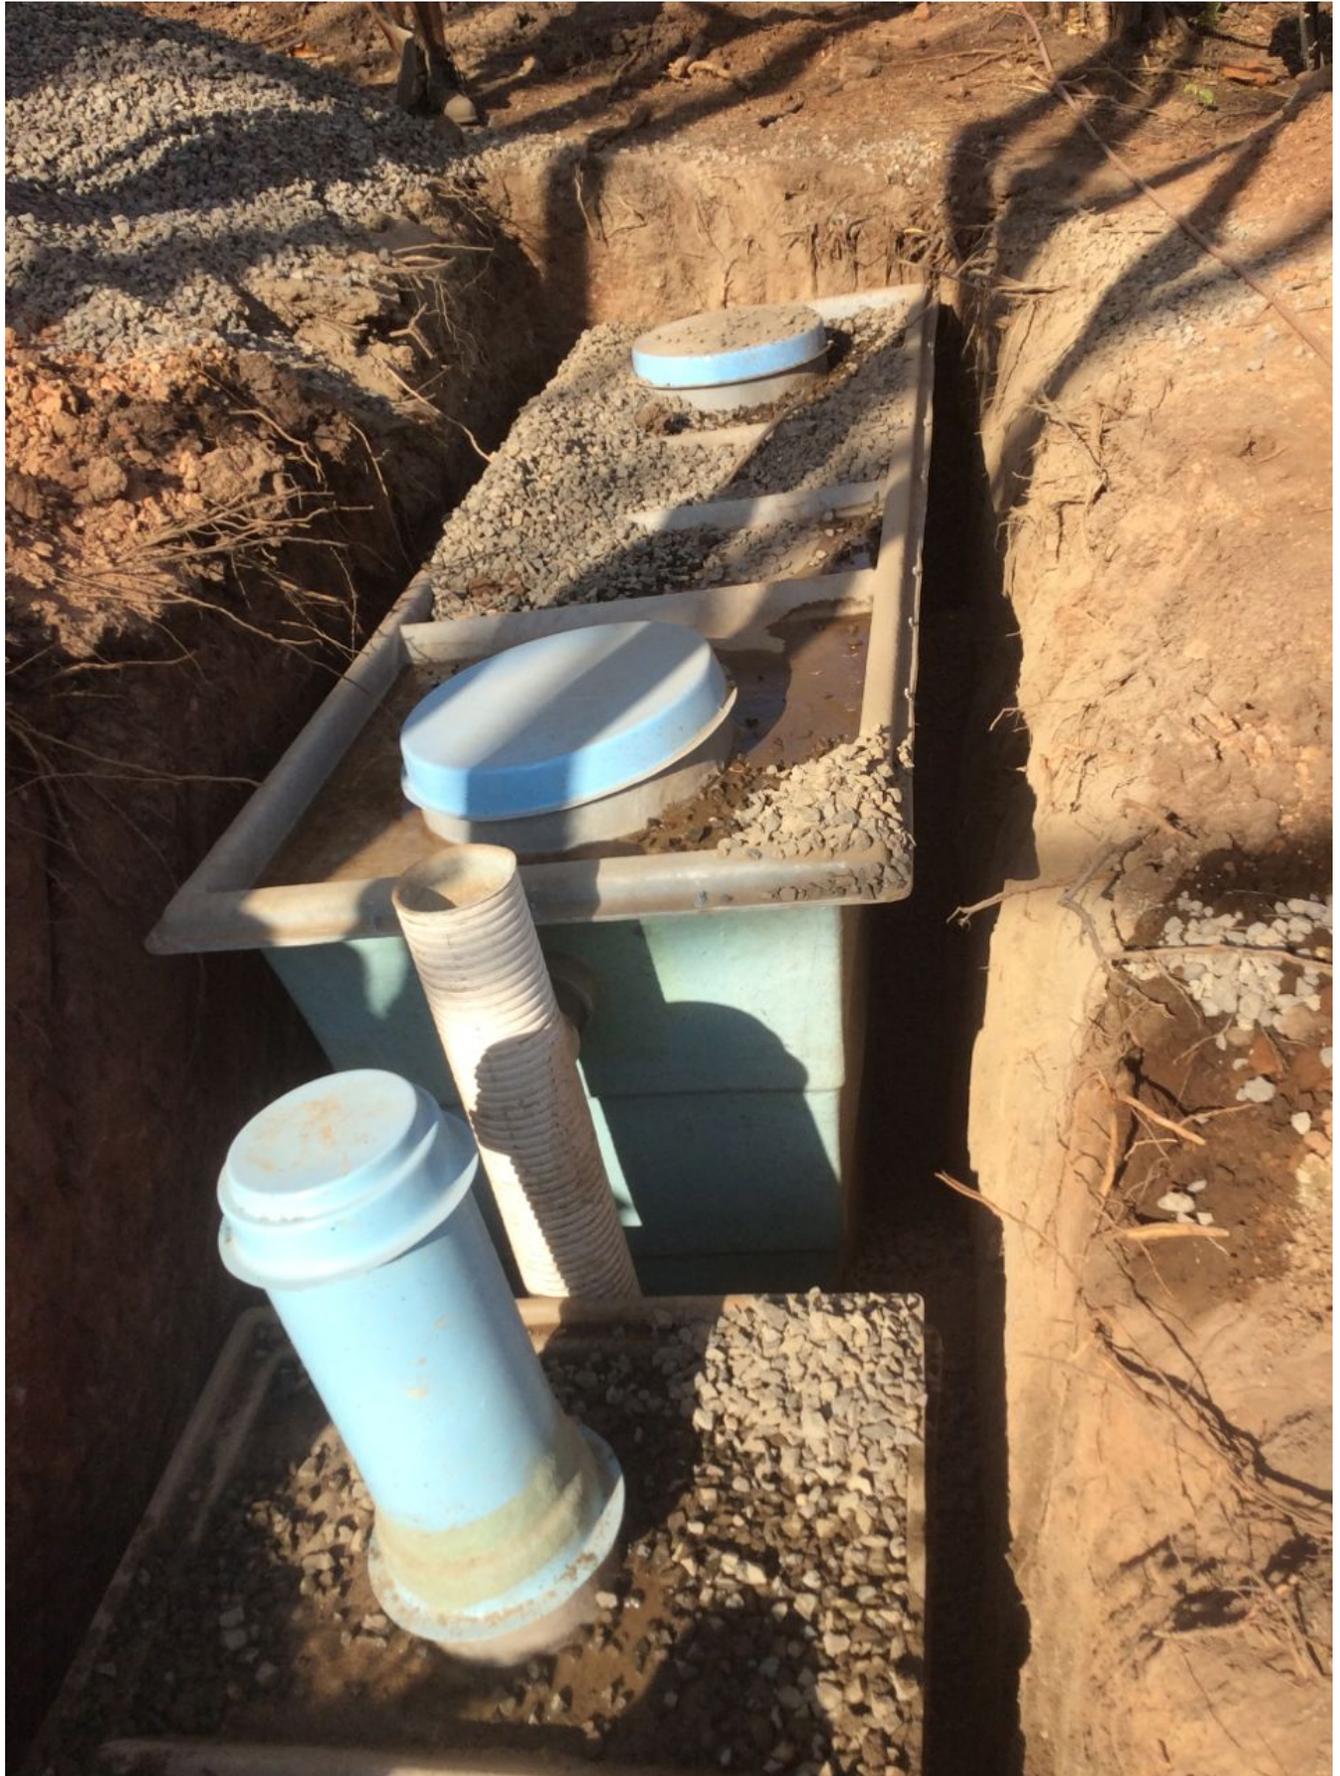
Main septic settling tank (the higher one) is placed along with the biodigester FABA as the working partners to this system.

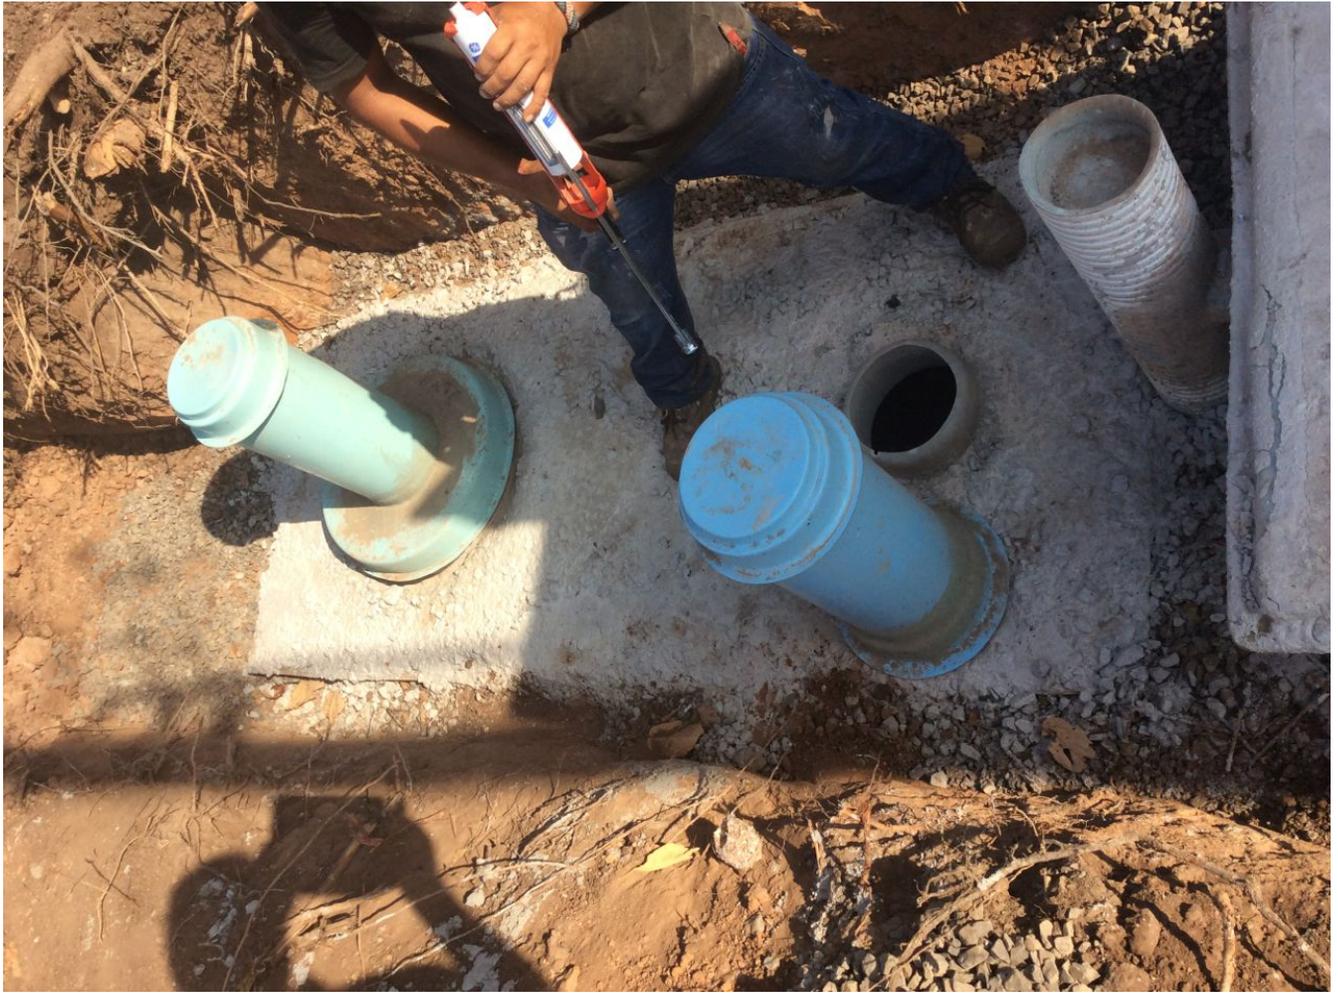
Concrete cap is poured over fiberglass to ensure a durable top.

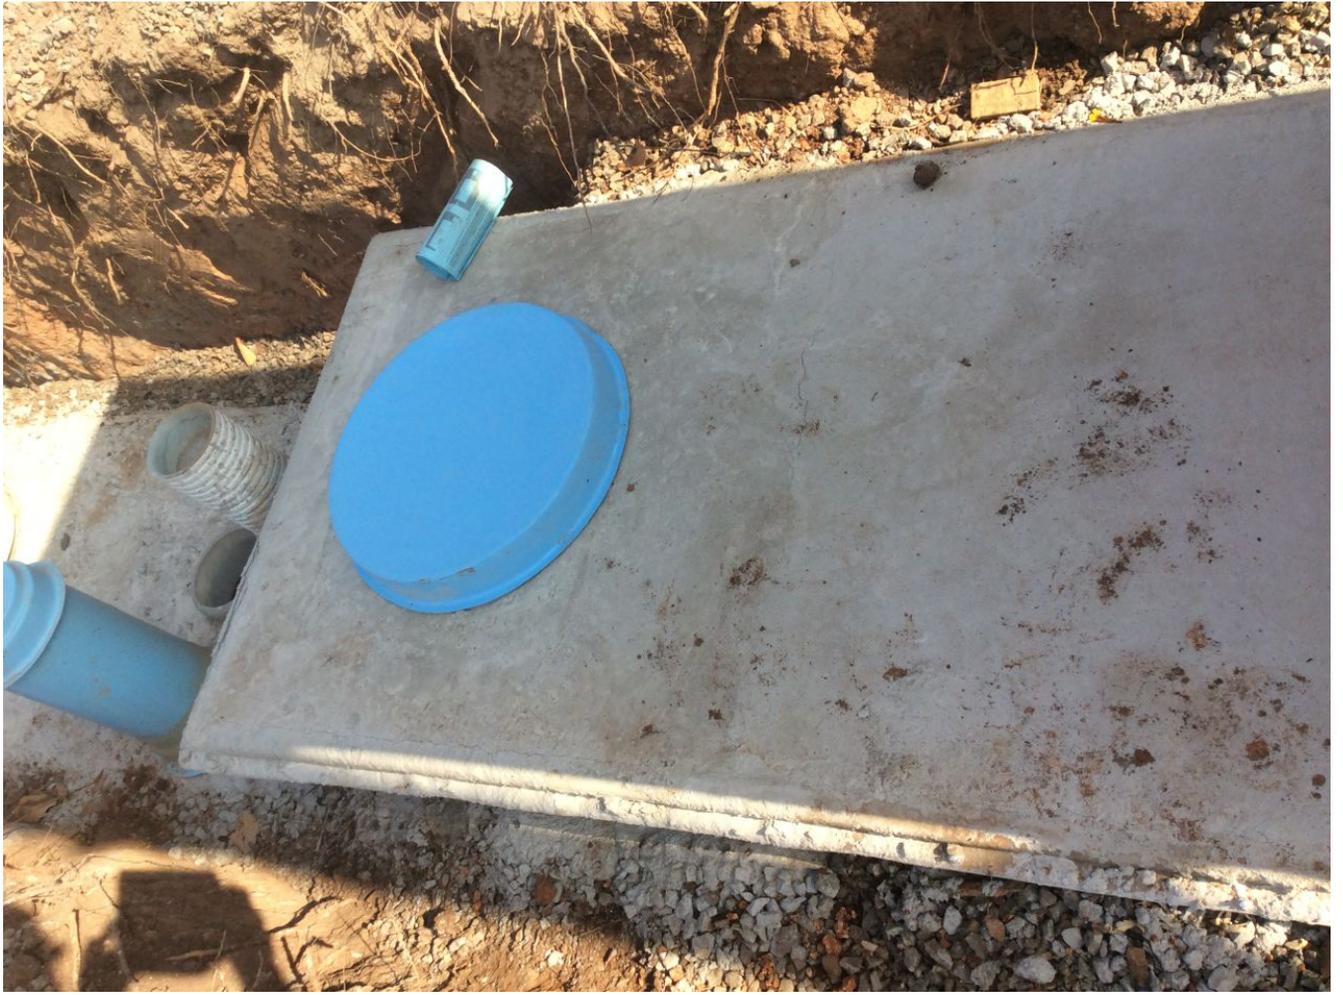
Concrete cap poured over the main settling tank.

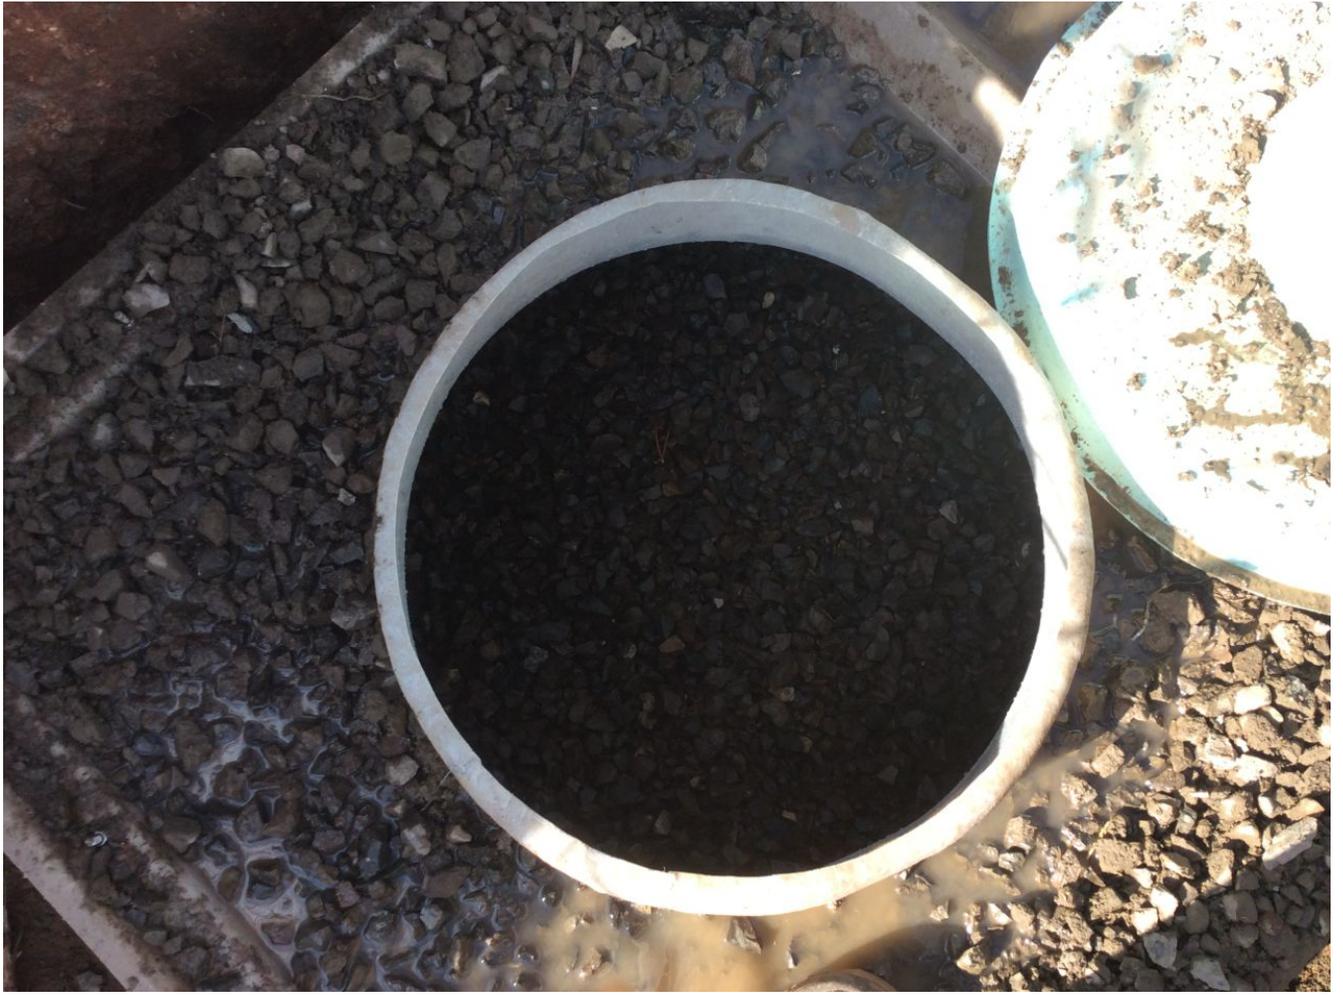
Looking into bio-digester you see that it has been filled with washed crushed rock to create a homey environment for billions of bacteria that will go to work quietly breaking down the human wastes prior to sending the overflow out into the field.

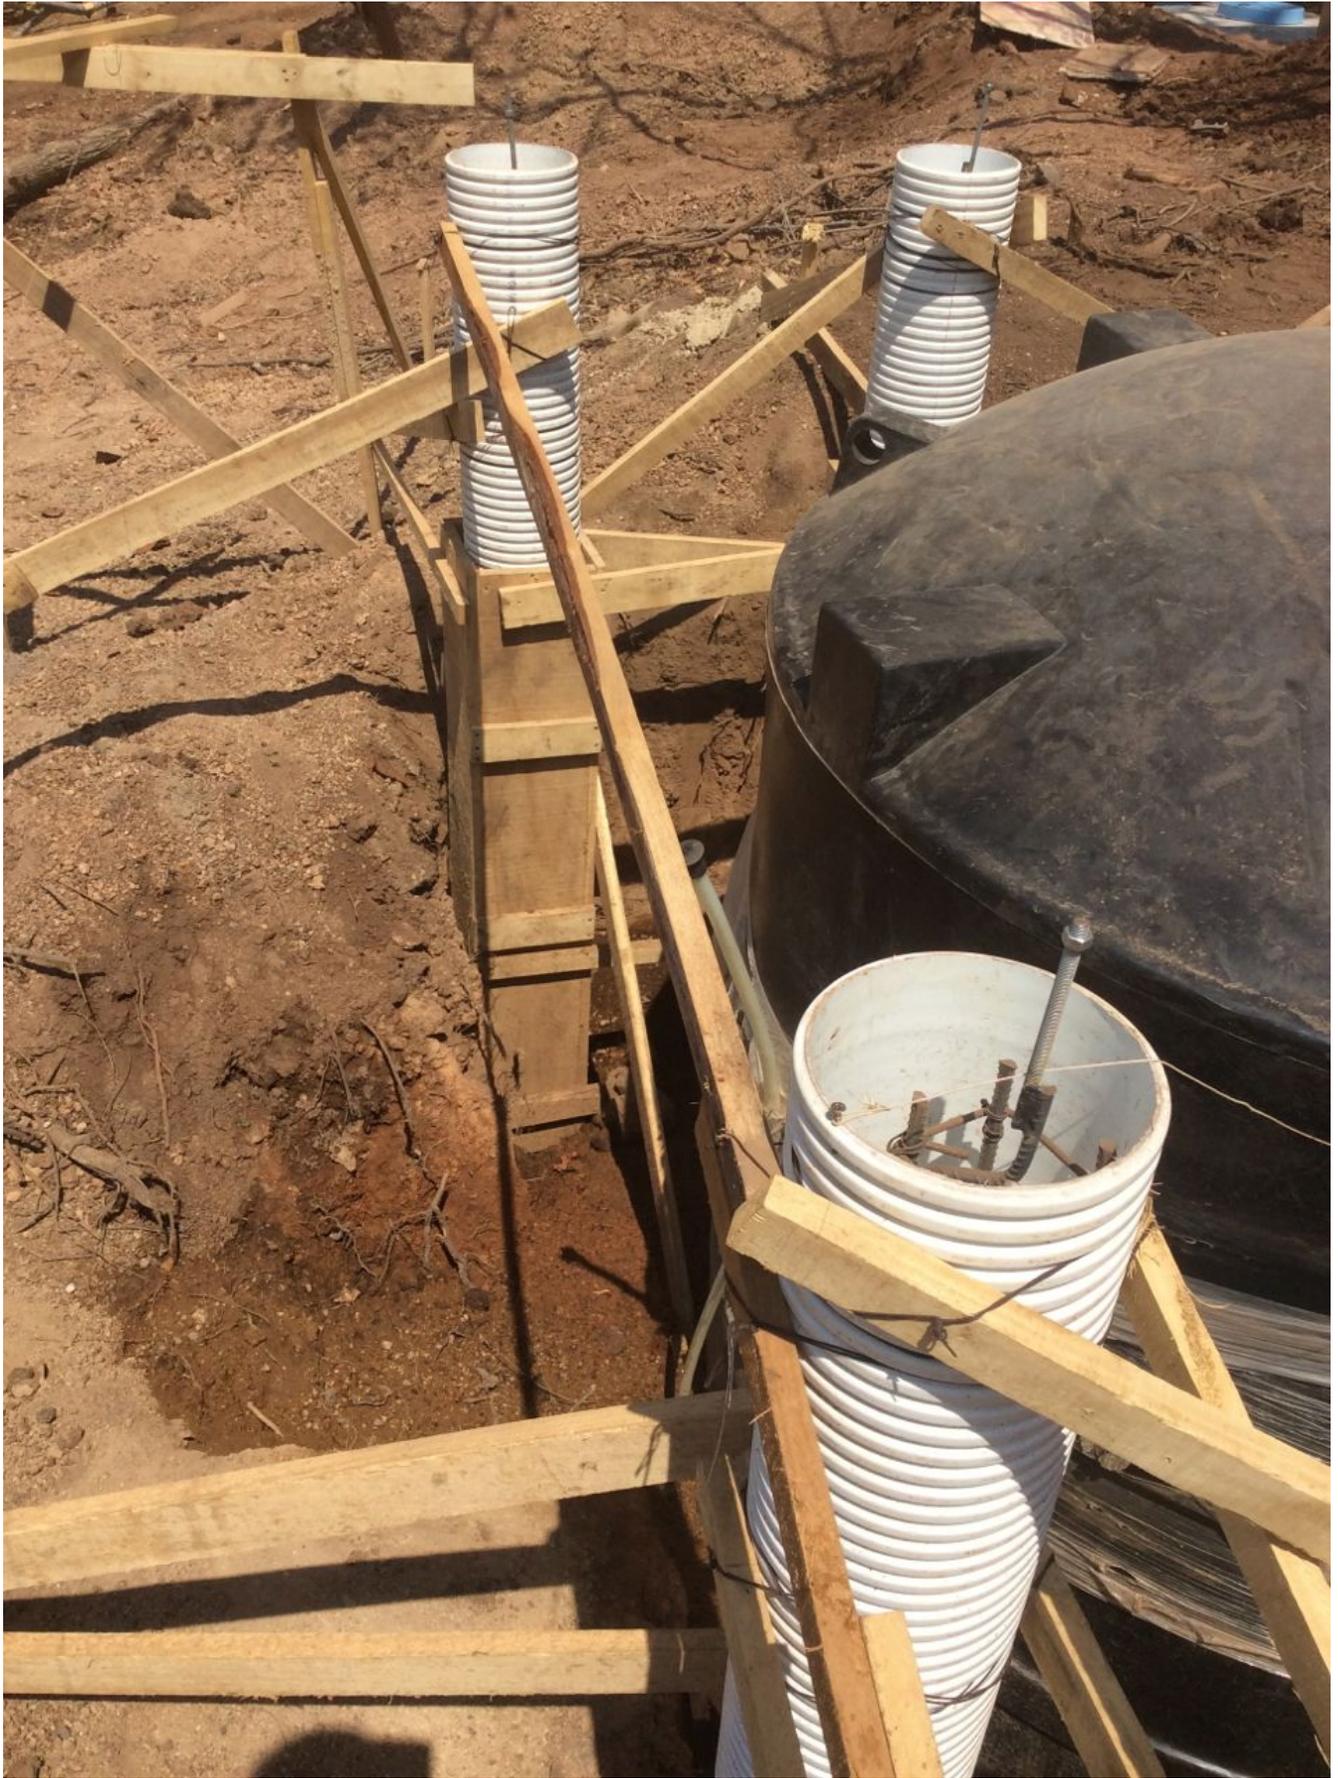
Piling forms are built around the tank to support the floor structure while going down below the base of the tank.
