Techos Siglo XXI – Constructing Your Green Home

Home Diary – Playa Grande

Super Home #3 begins with a BIG MOVE!

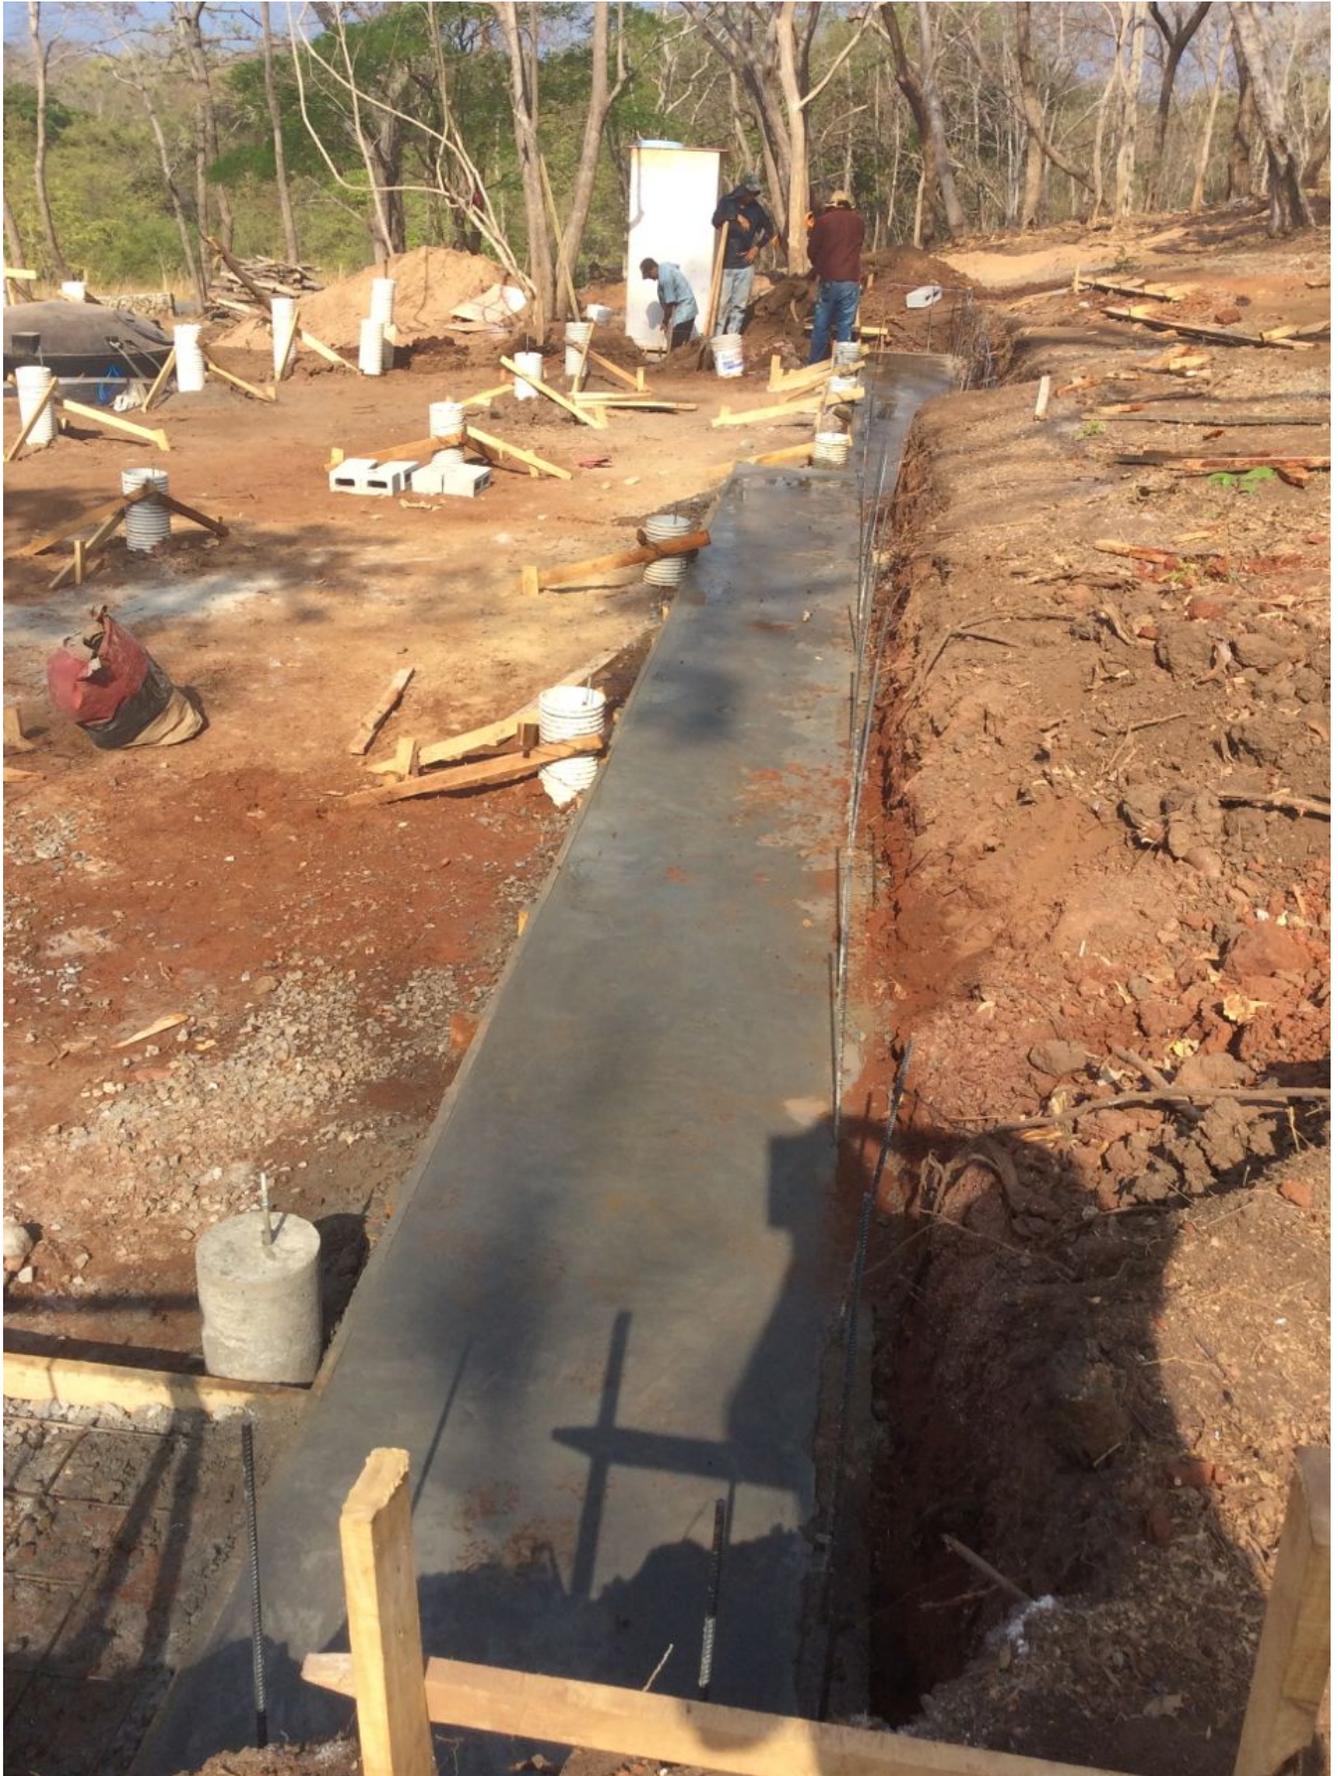
Sidewalk poured at the high side of the house now ready to receive a small retaining wall to keep the hillside in place and direct the water from the hillside away from the house and of course to avoid water entering into the house's footprint. First row of pilings supporting the future deck also poured.

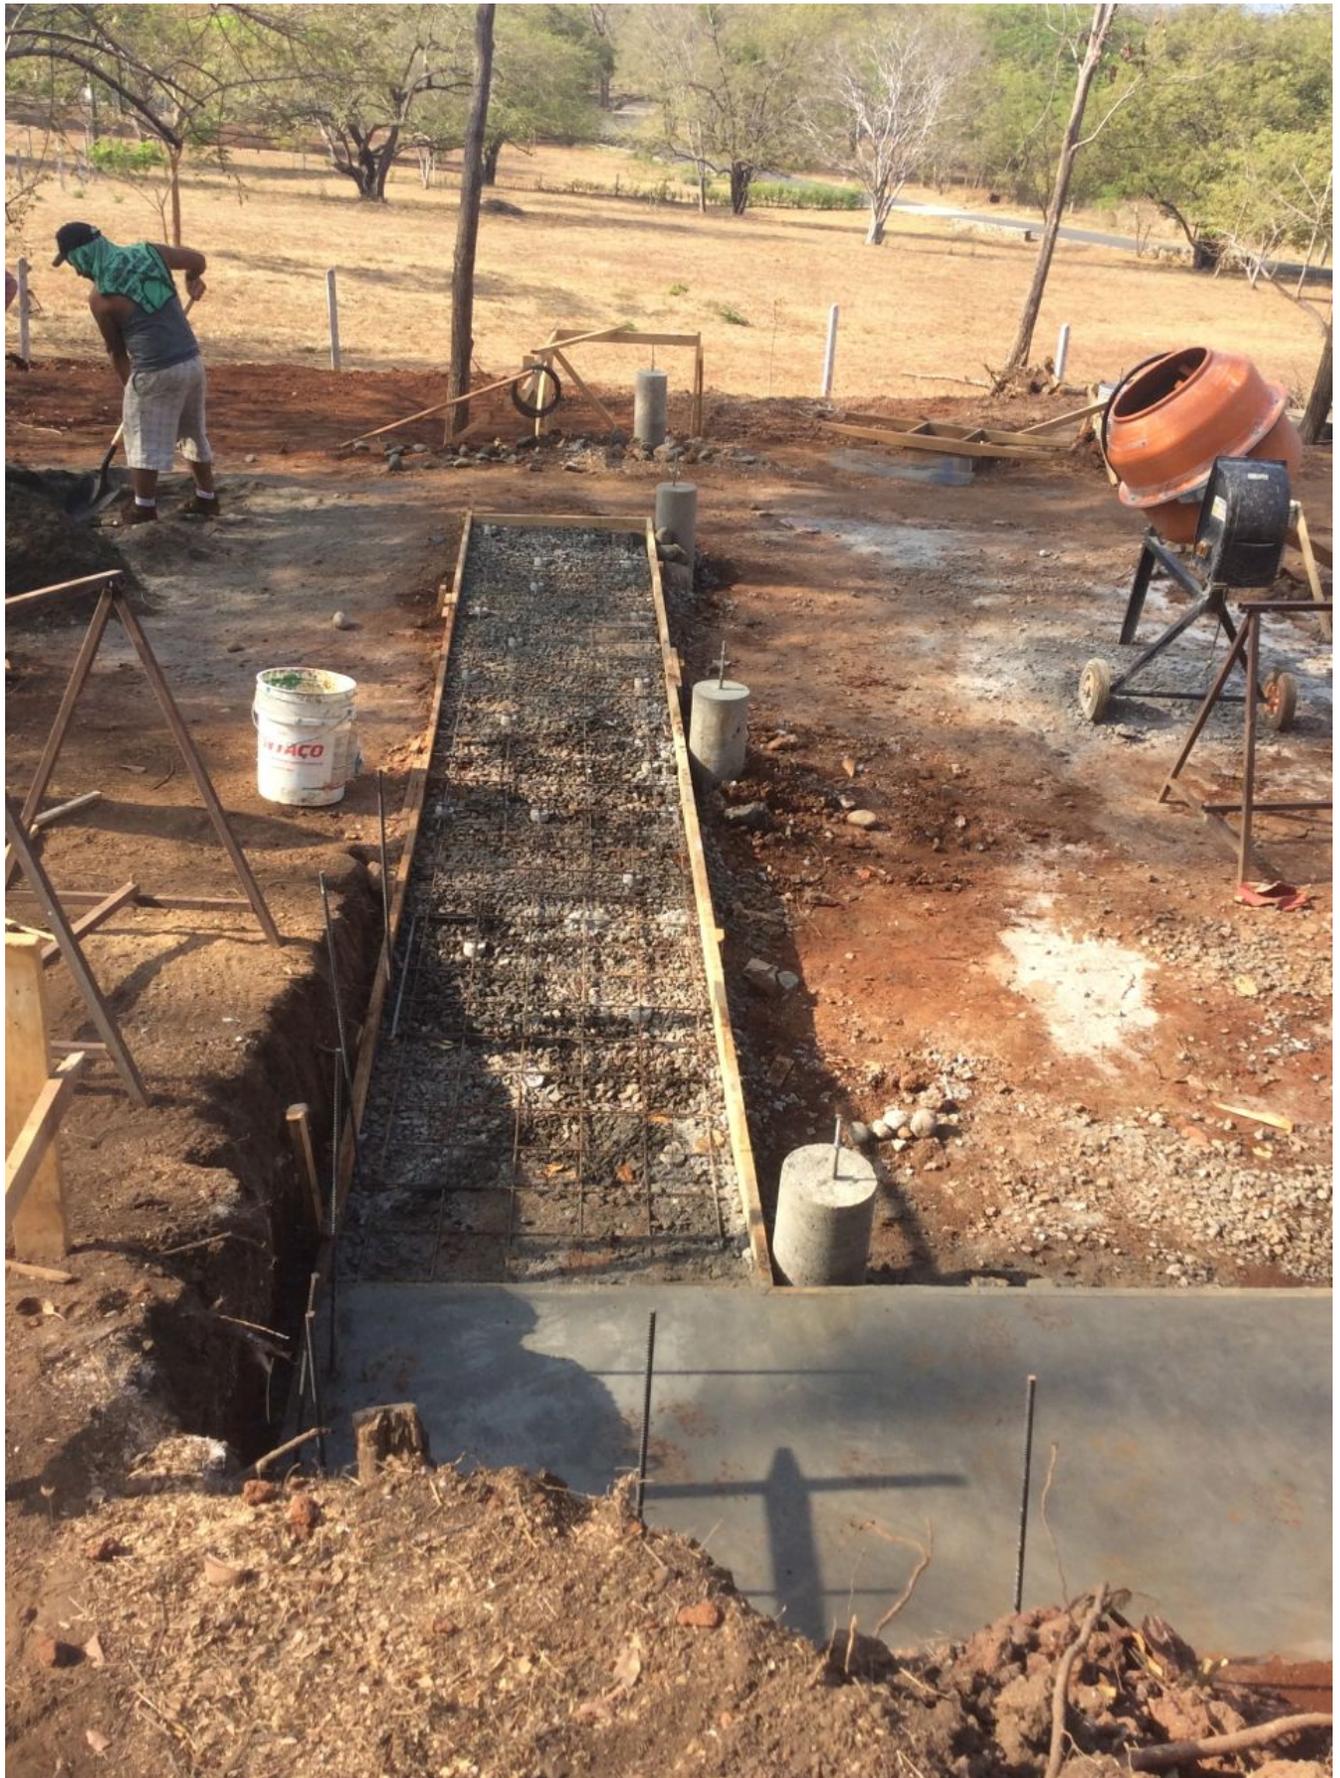
Sidewalk in front of deck formed and ready for another day's pour.

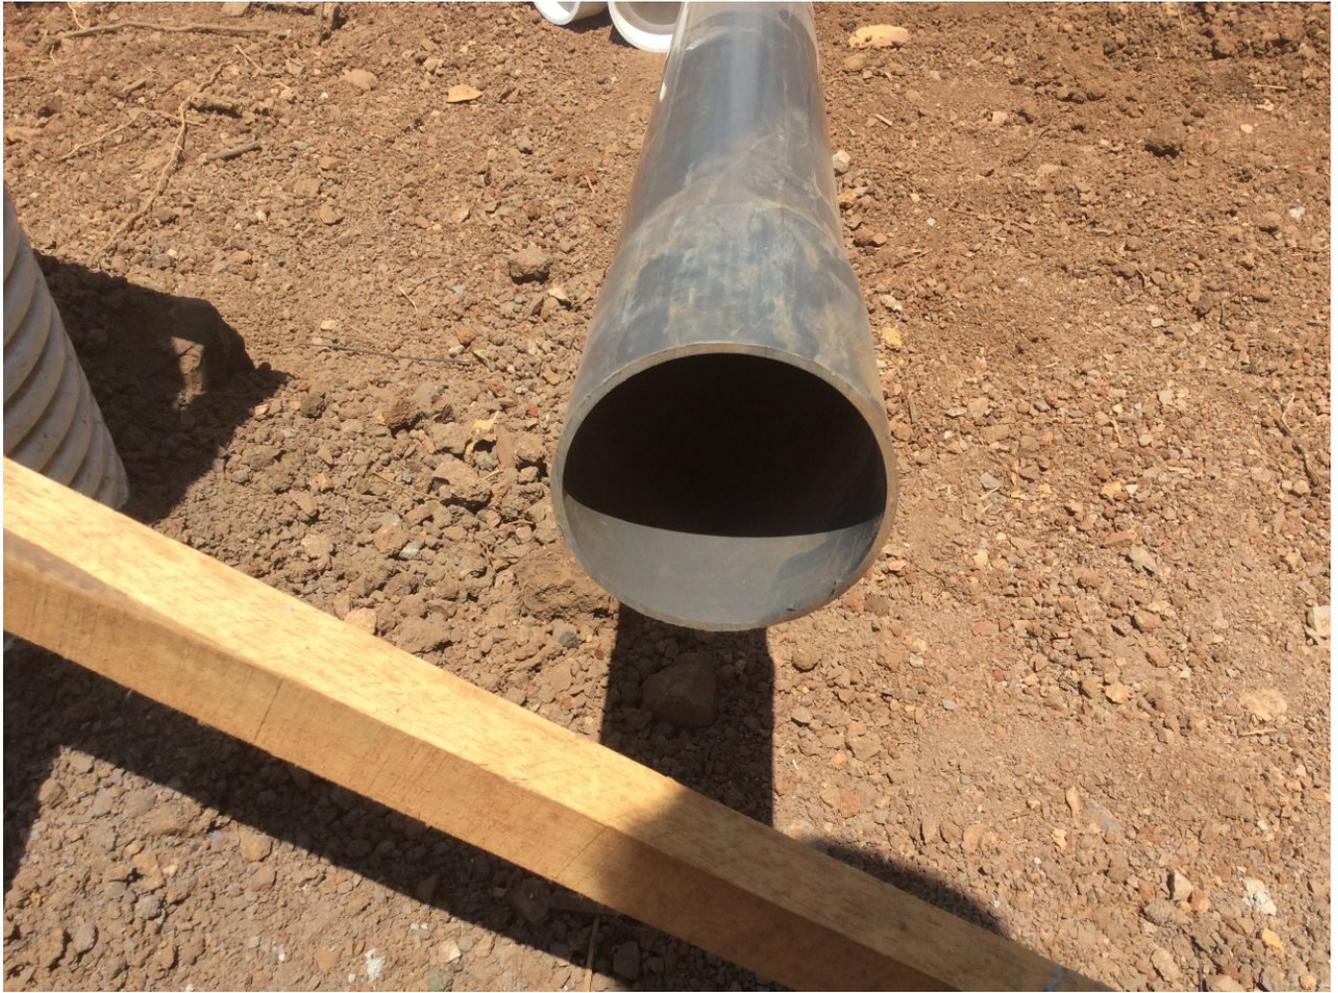
This is the sewer pipe that we use a SDR17 rated pipe that is at least double the thickness of the typical sanitary grade pipe that is typically used which is delicate when new and 5 years later it is like plumbing with crystal when problems arrive on the scene.

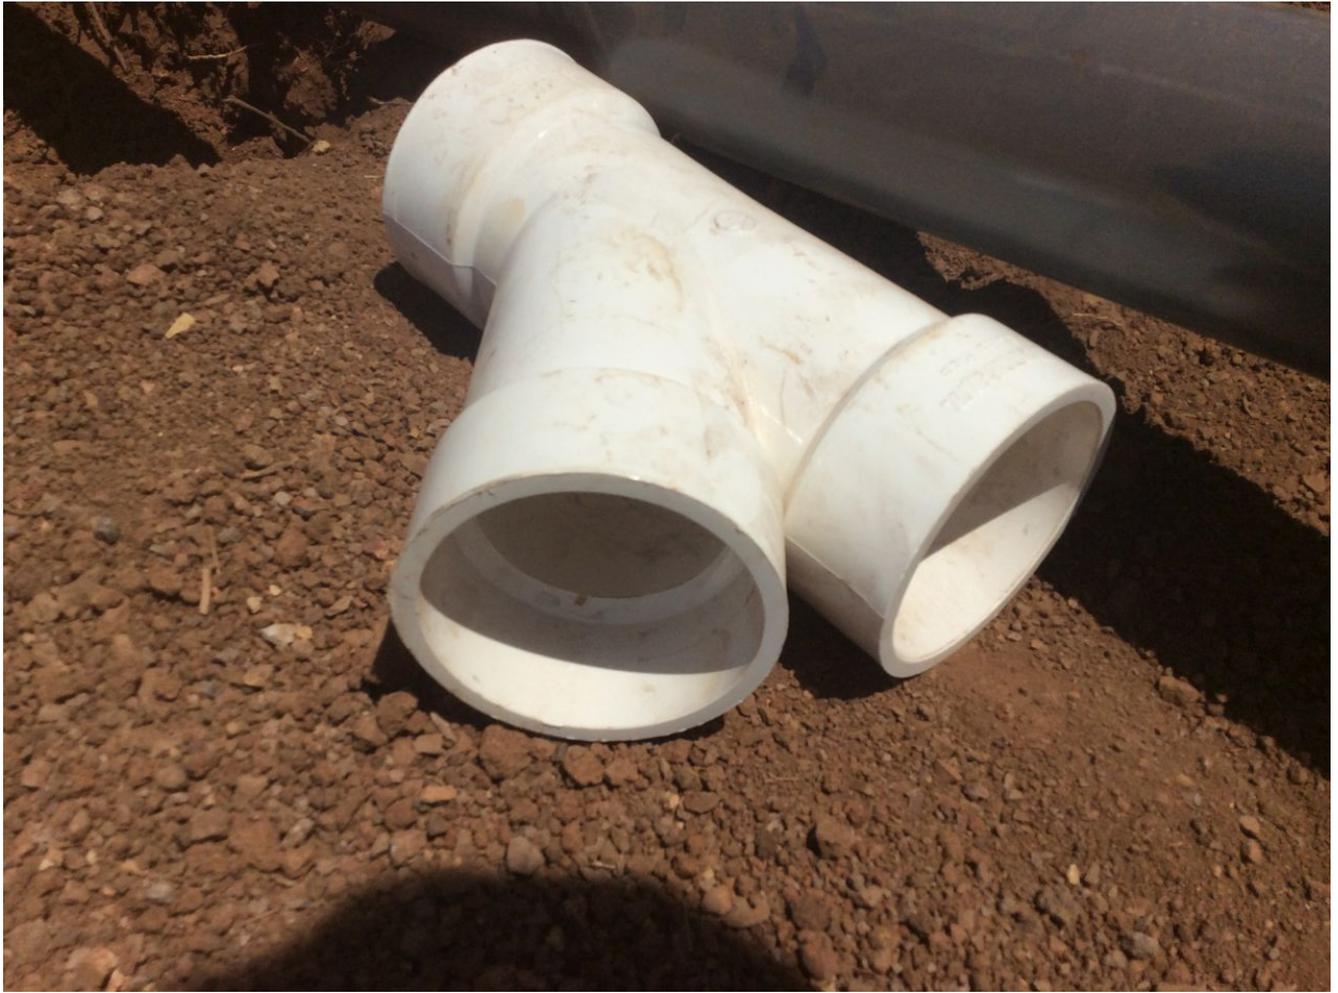
Even more important the fittings used are schedule 40. Do take note it is almost always the fittings that come back to haunt home owner's when the crack up and leak like crazy. Note you never find elbows on our job sites everything is run through 45 deg turns or Y's as you see here so as to maintain the speed of flow of the sewage hence not allowing solids to settle out leaving the owner up to their elbows in crap!!!

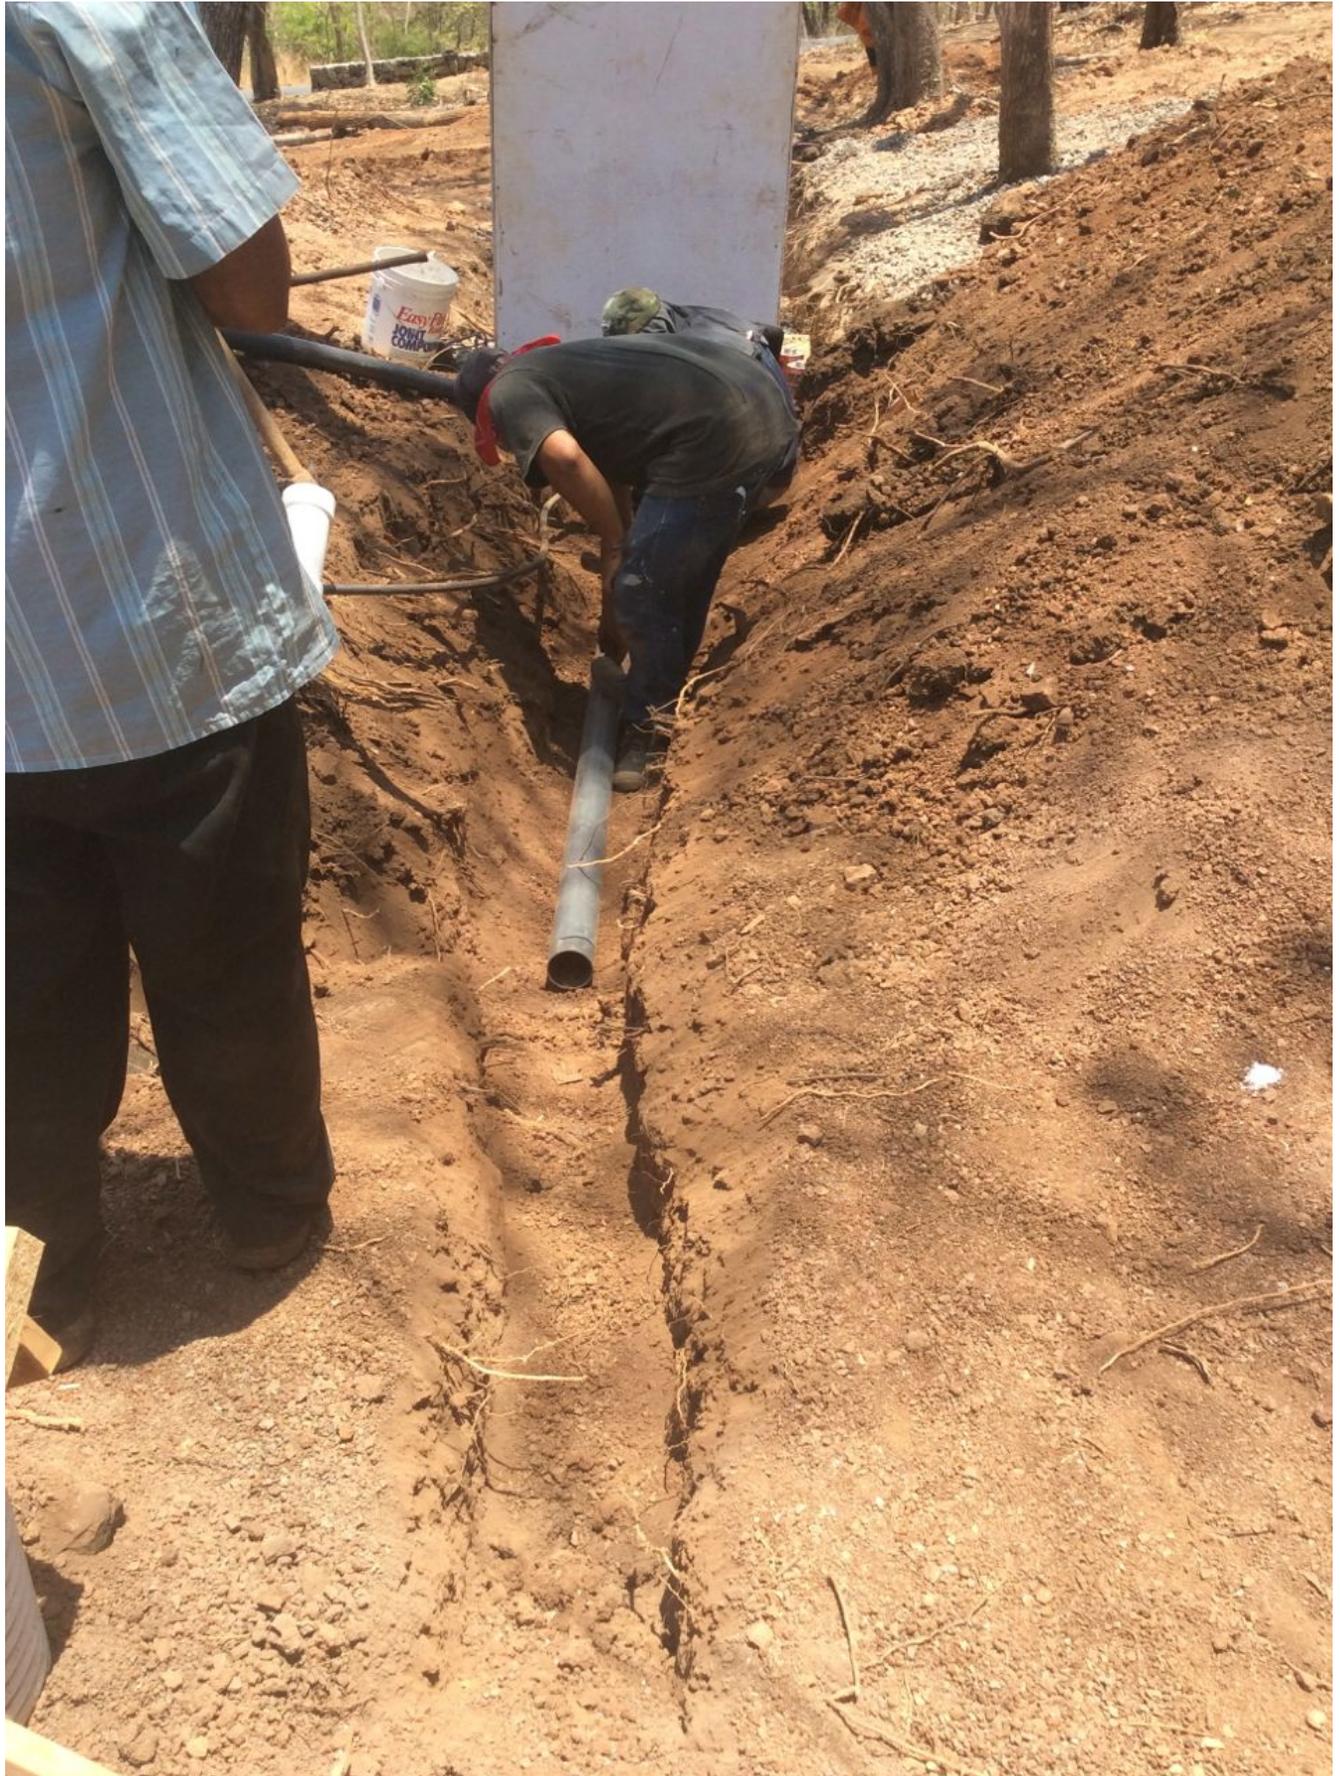
The main line from the house heading into the septic tank being put in at the optimal 2% slope which again ensures ideal speed of sewage flow.

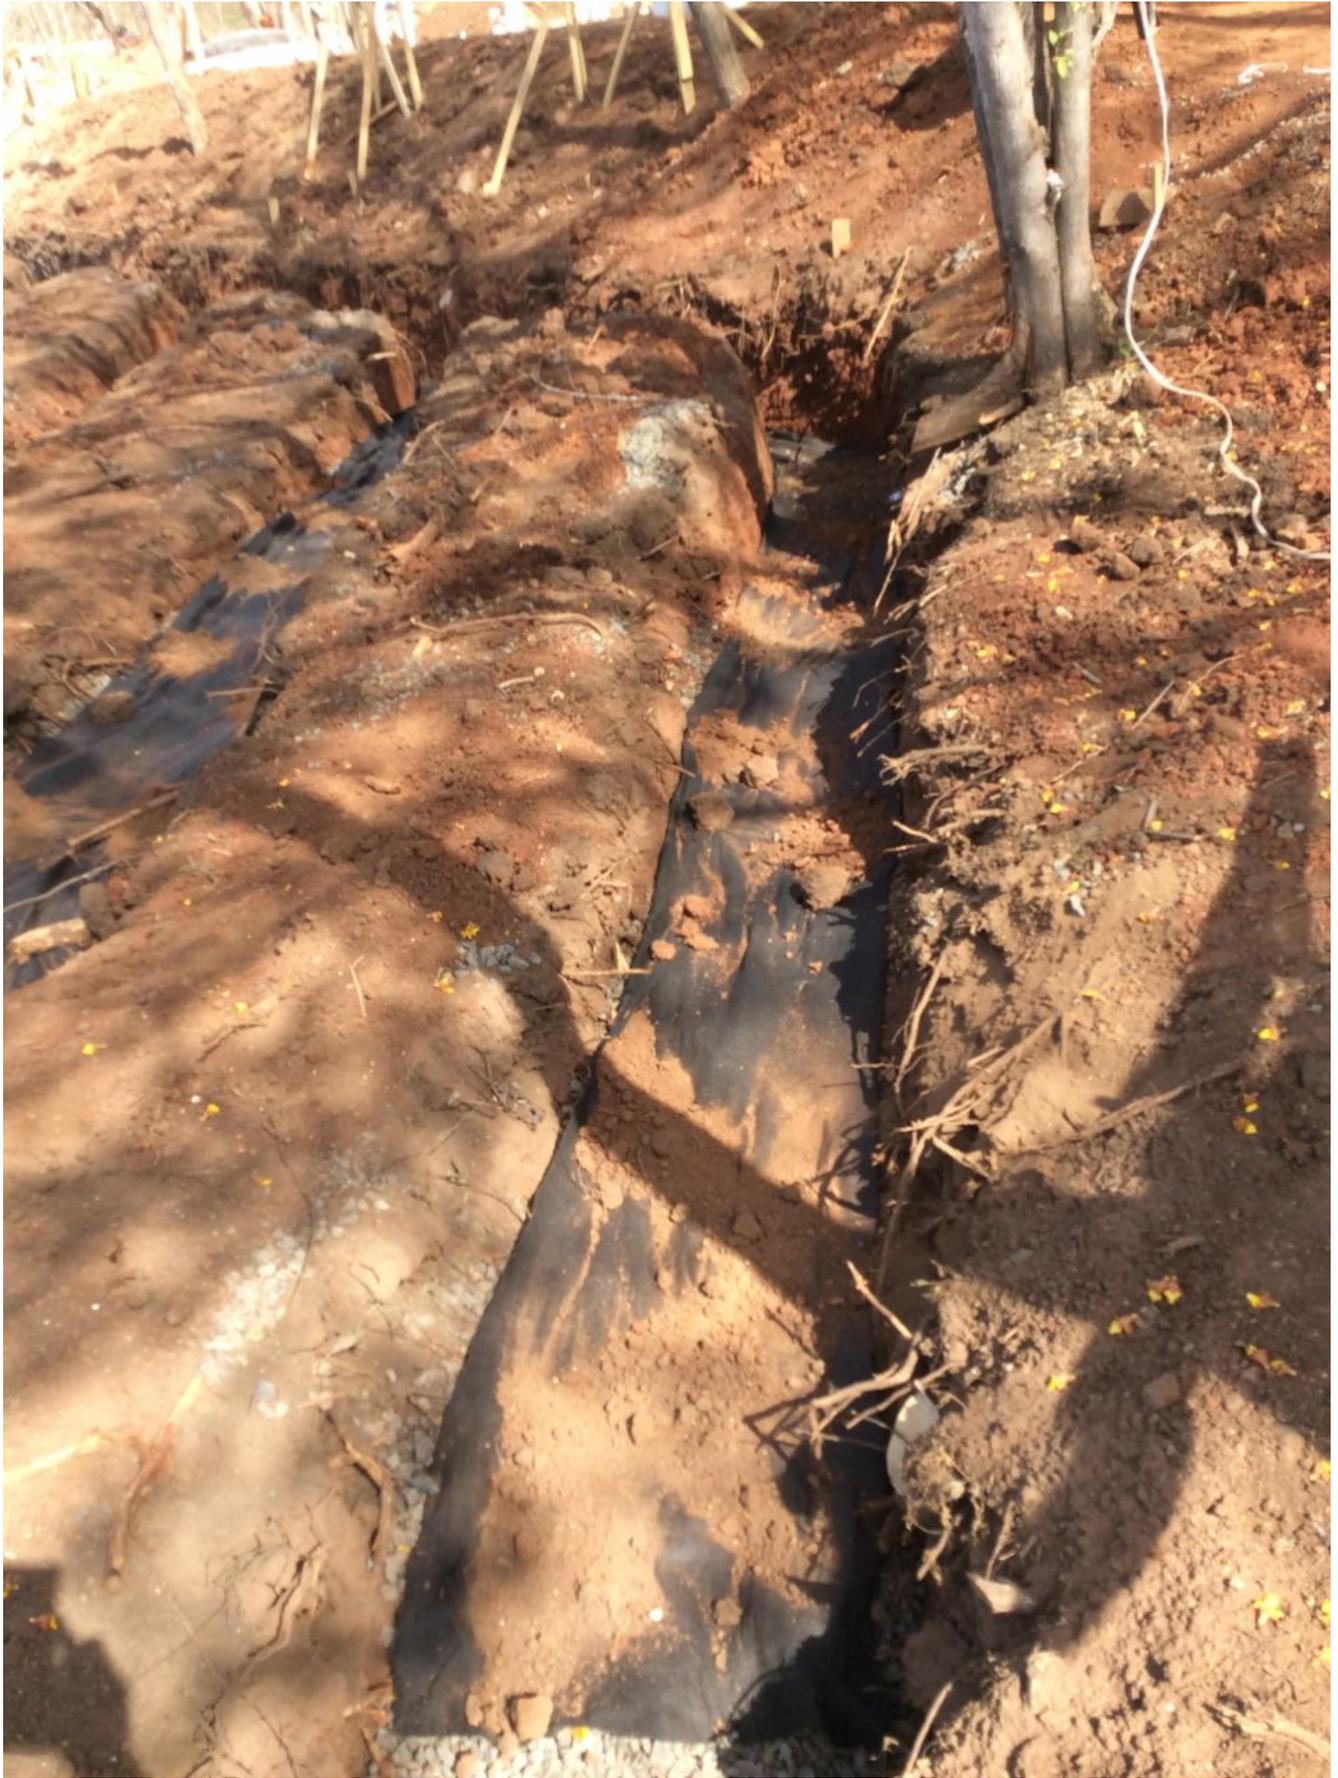
The final arm of the drainage field installed with crushed rock surrounding the tube at roughly a foot deep and then covered by geo textile to prevent fines from filtering down through the rock filter into the critical weeping tubes.

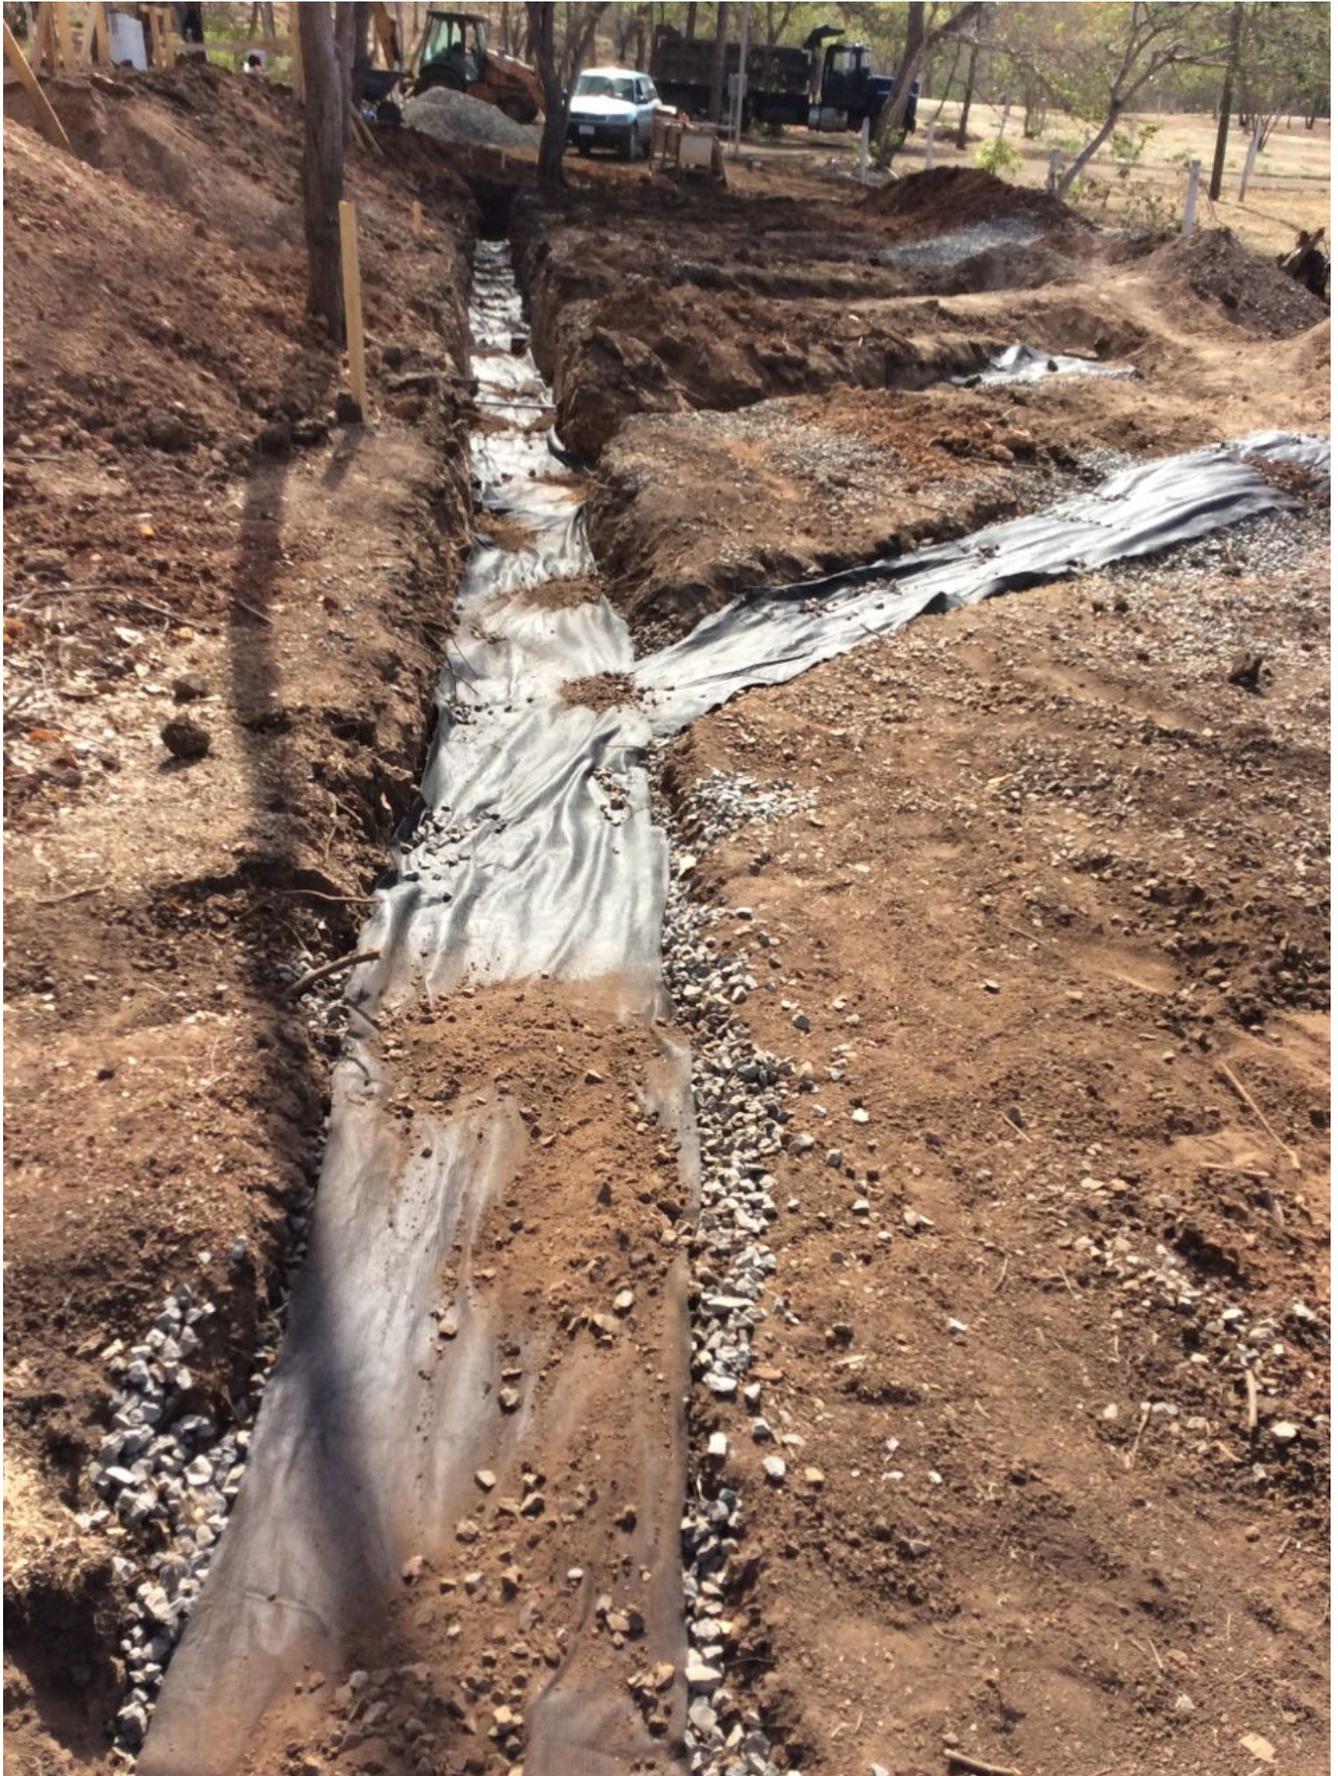
Looking down the main distribution tube prior to filling in with dirt to create the green area. Note how the trench gets deeper and deeper as it heads down to the higher area of the lot.

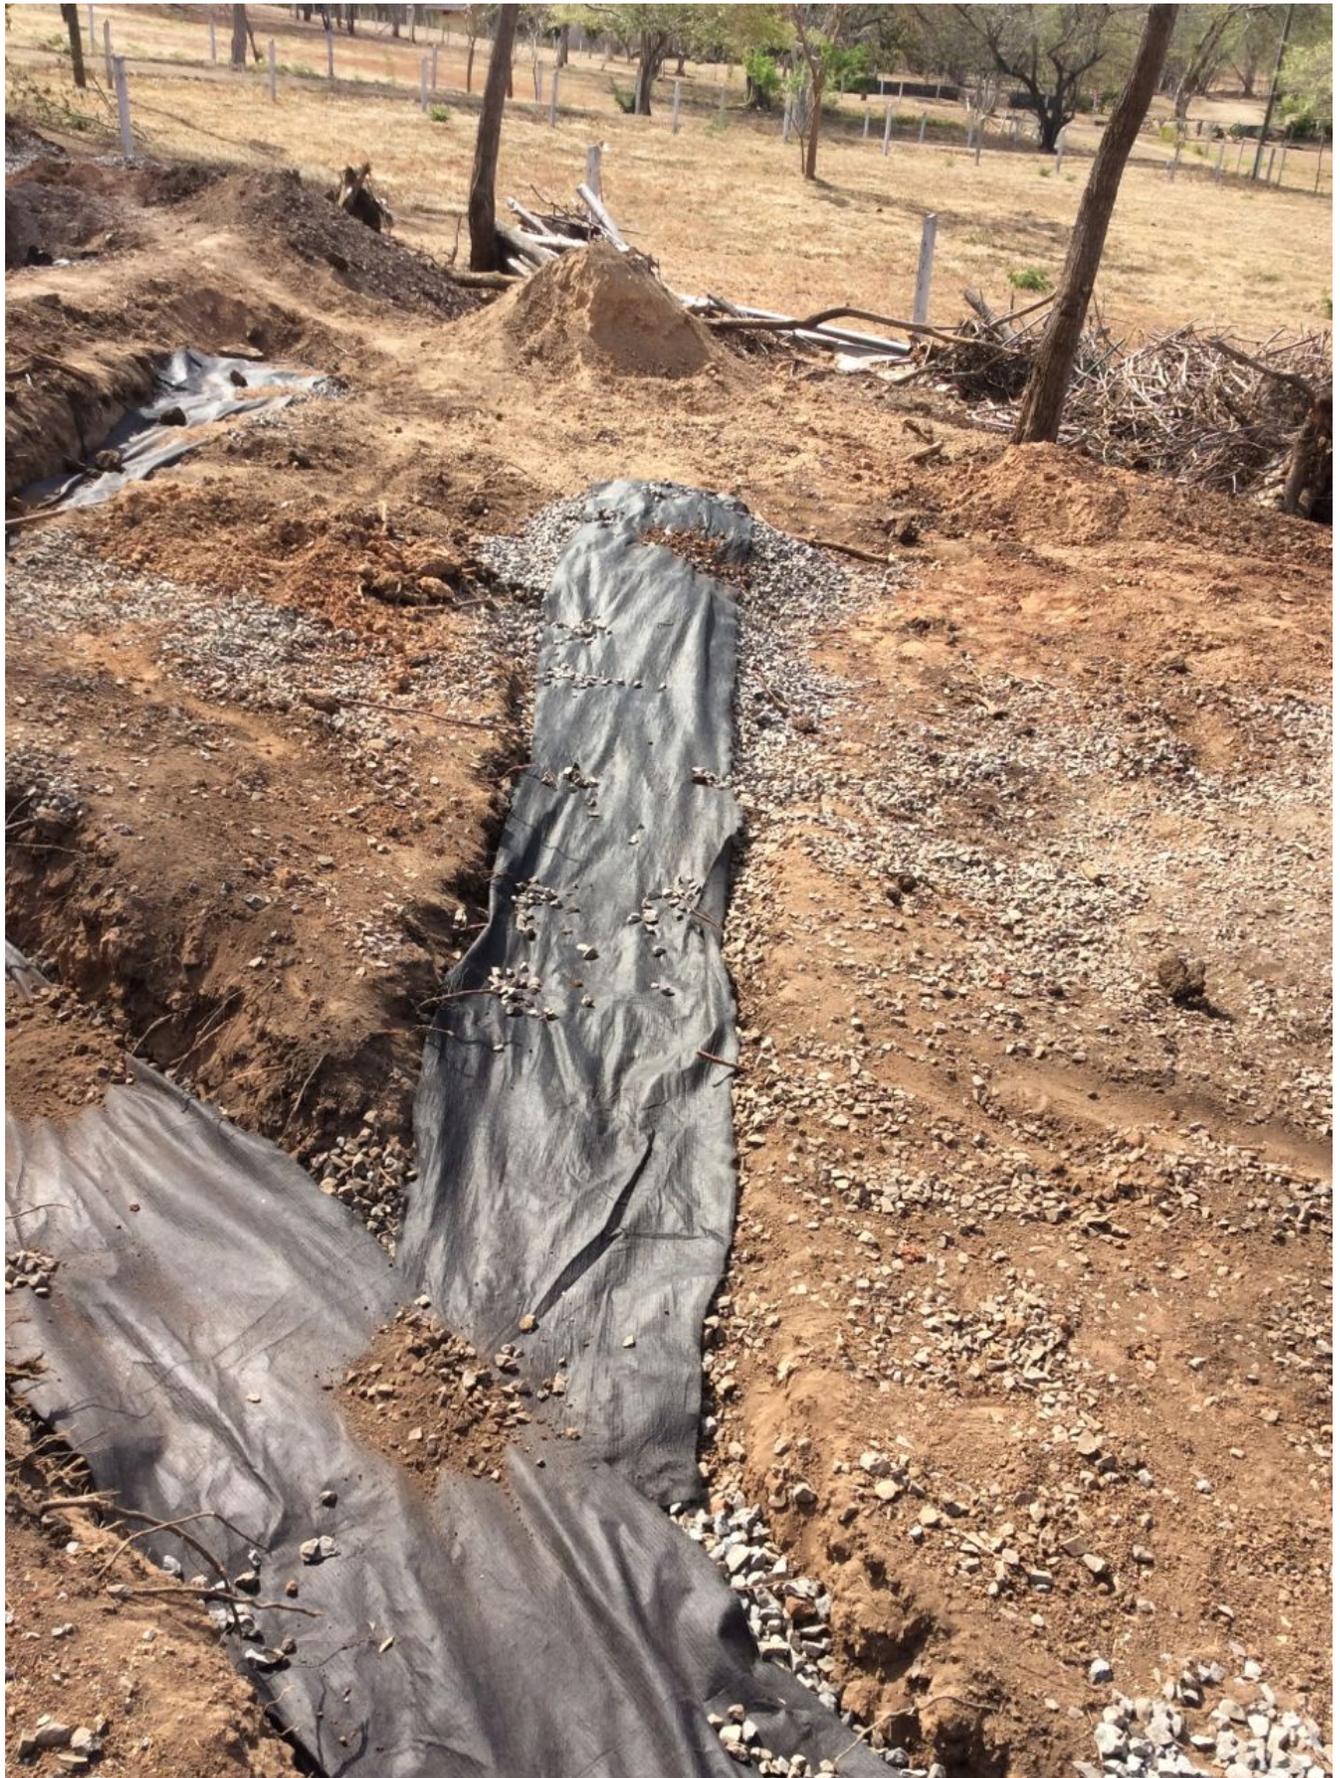
Take note this is the first arm of the field and the very end of it is almost out of the ground due to the slope of this whole drainage area. Now since the field piping must be perfectly level to ensure that the water seeps out uniformly over the entire area hence making certain no area is flooded and being

overworked. Here we moved fill in to actually raise this whole area of the lot while covering up the field and leveling the lot out more in this critical green area along with quiet waste dispersal.

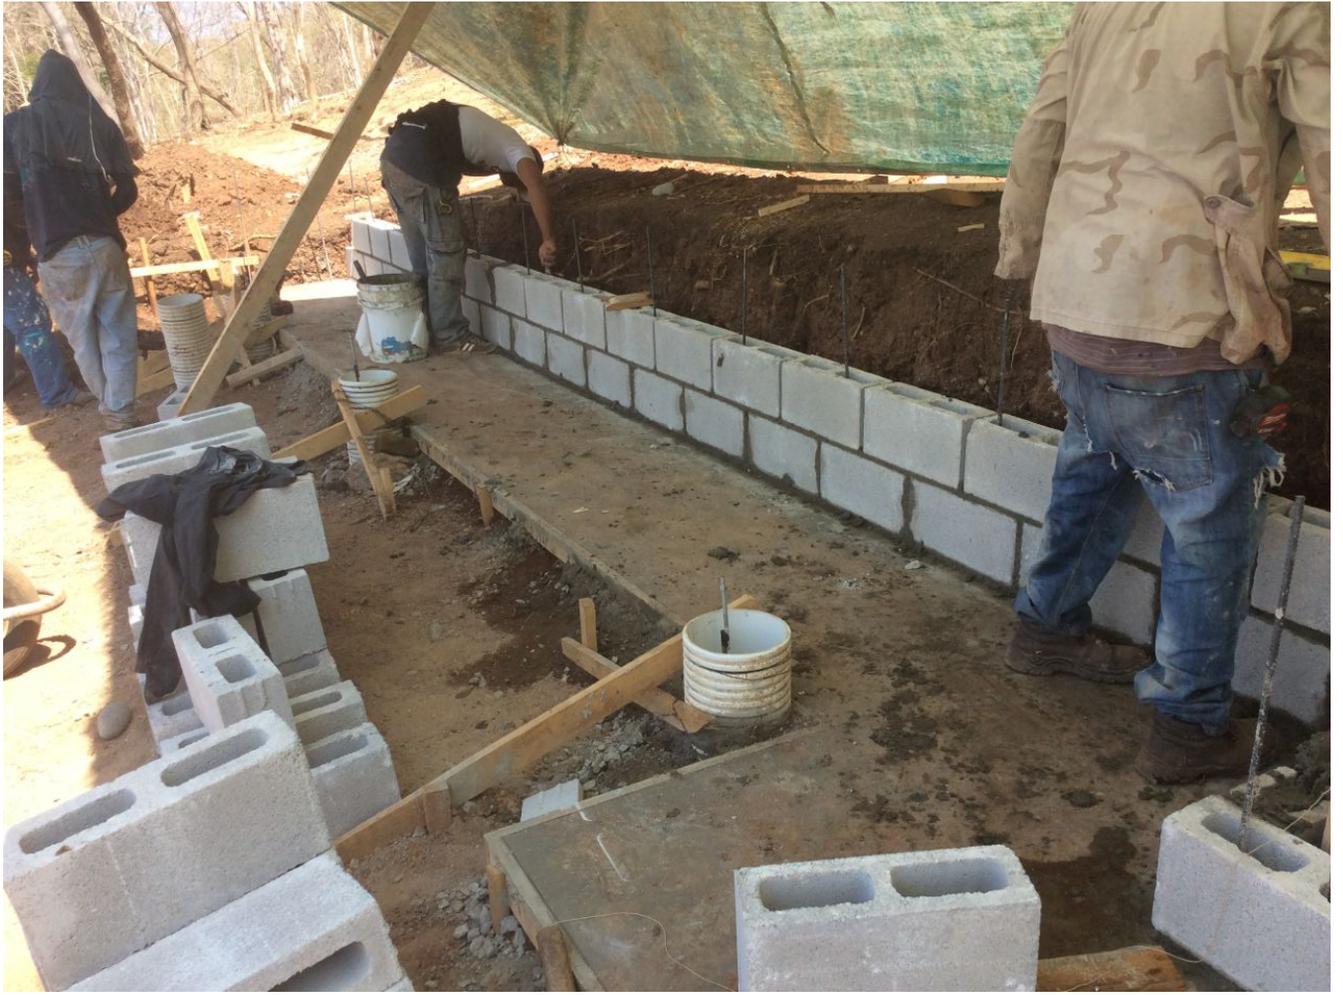
Block retention wall going up on top of the sidewalk.

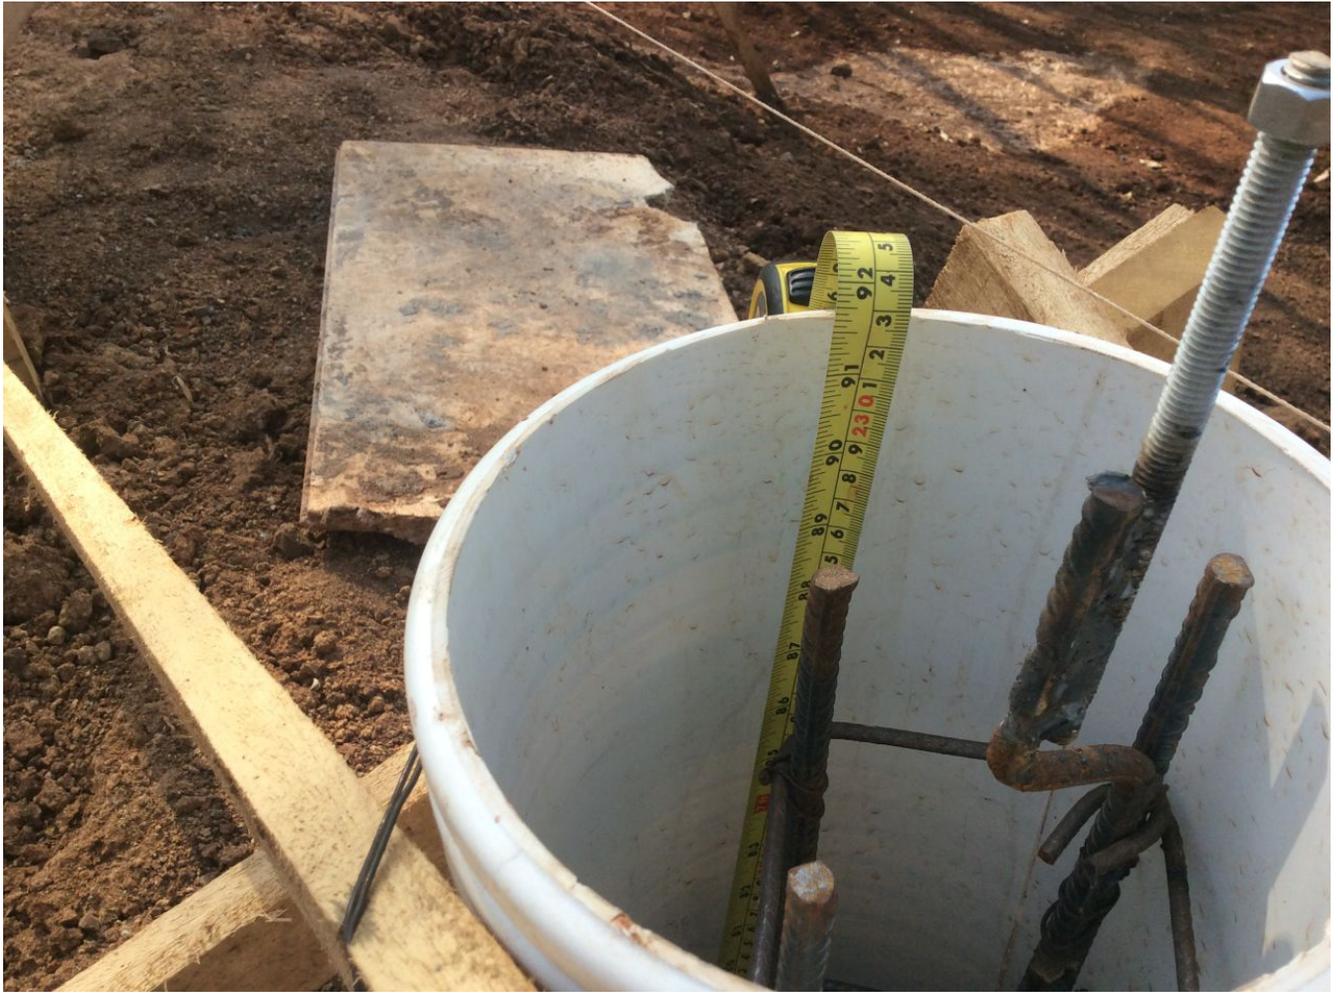
Pilings are all ready to go for pouring with the steel cage installed and 3/8" threaded rod welded to cage to hold down the floor structure and tie all the pilings together. AS you can read this is one of the deeper ones going down 2.3 meters through the fill area and down into the rock field to lend us solid support.

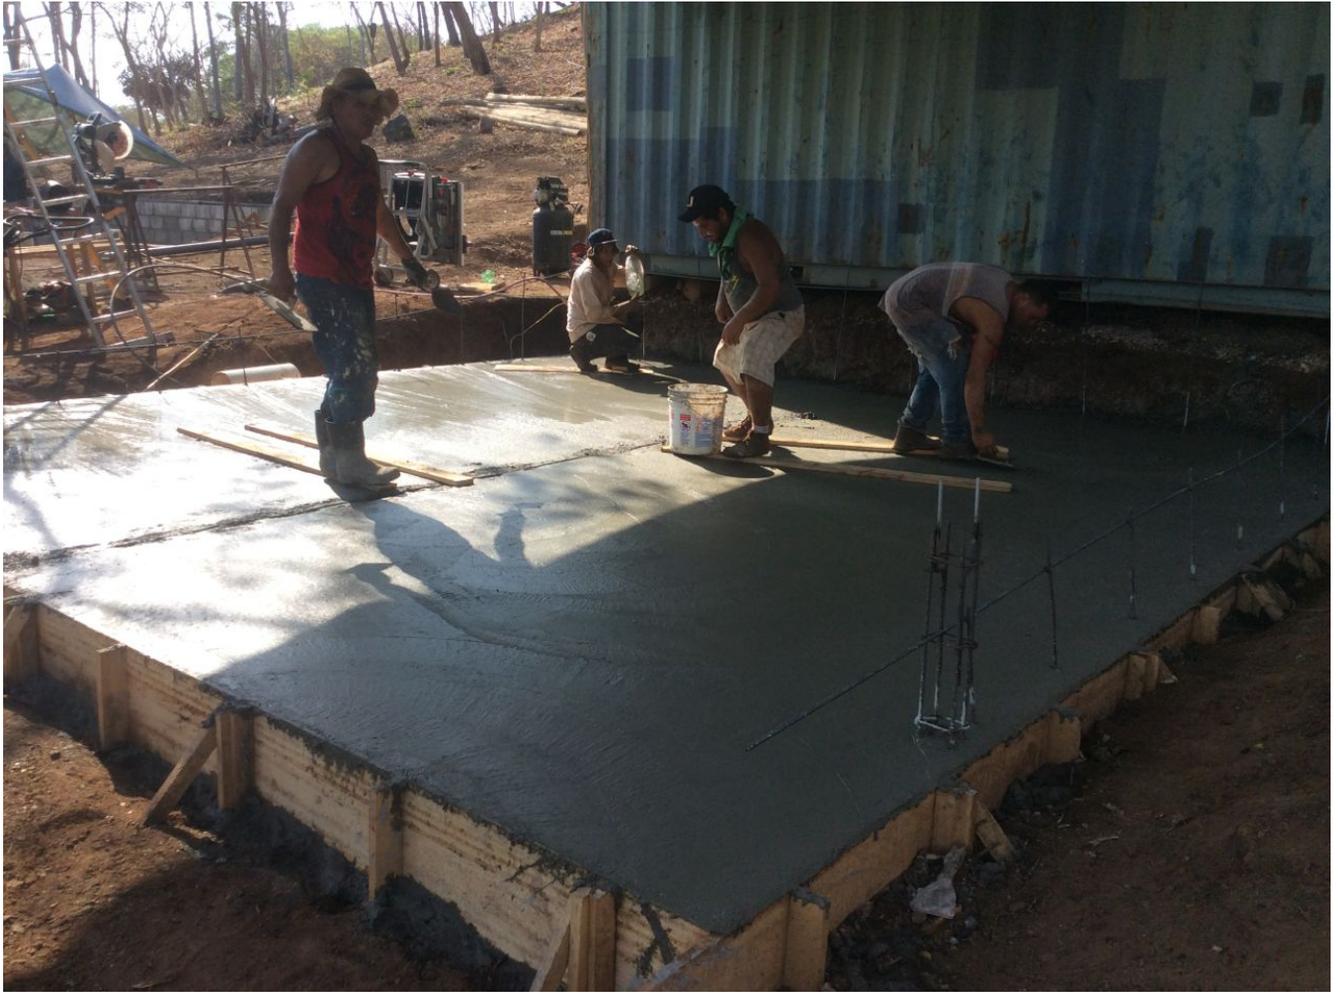
Floating the carport pad after the truck has placed it at 2 pm to avoid the hottest part of the day as well as under tarp as direct sun on concrete is bad news.

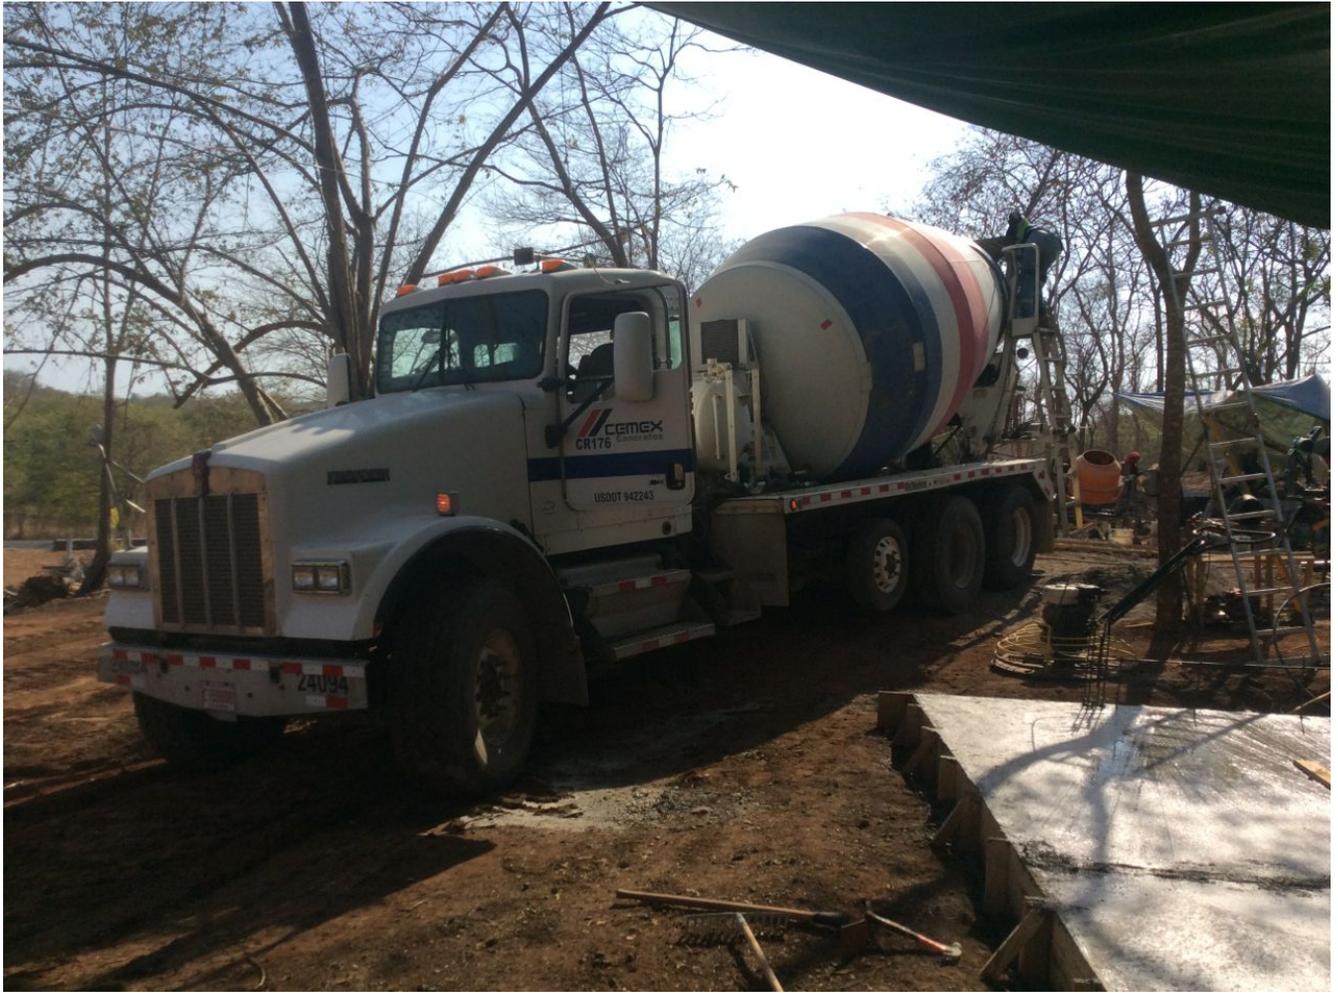
Truck has now moved on to fill up the pilings bores. We never mix our own concrete for larger pours when there is ready-mix available. This truck only had to travel 20 kms to get to us. This batch had both a fluidity additive and an anti filtration one added to it to prevent rainy season weeping as well as zero water was added on site so as to ensure the formula stayed true.
