Techos Siglo XXI – Constructing Your Green Home

Home Diary – Playa Grande

Super Home #3 begins with a BIG MOVE!

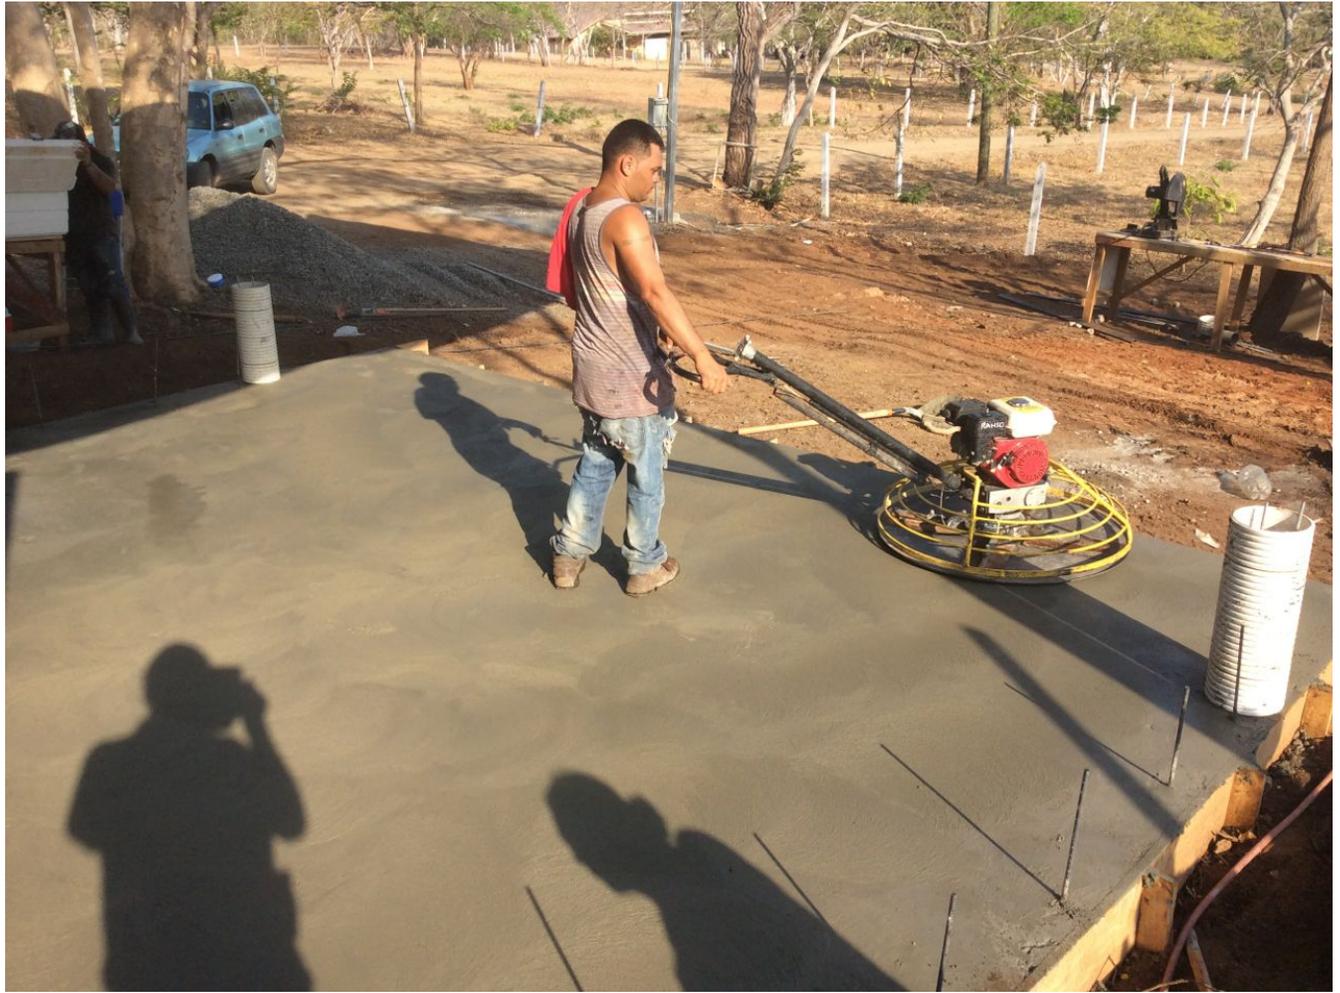
What you see here is a unicorn operated by Angel. A power trowel is not a common site here in the beach areas but fortunately as compared to down south we only had an hour drive to go locate one. MY guys had never used power trowels until this last year and had always done this work by hand. Both brutal as well as providing second rate results in any area over a couple of square meters. We were able to walk away from this floor by 7 pm after having to explain to the God that owns the development as to why we were working after 5 pm. The concept of the concrete Gods not waiting for morning seemed to be a bit perplexing to him.

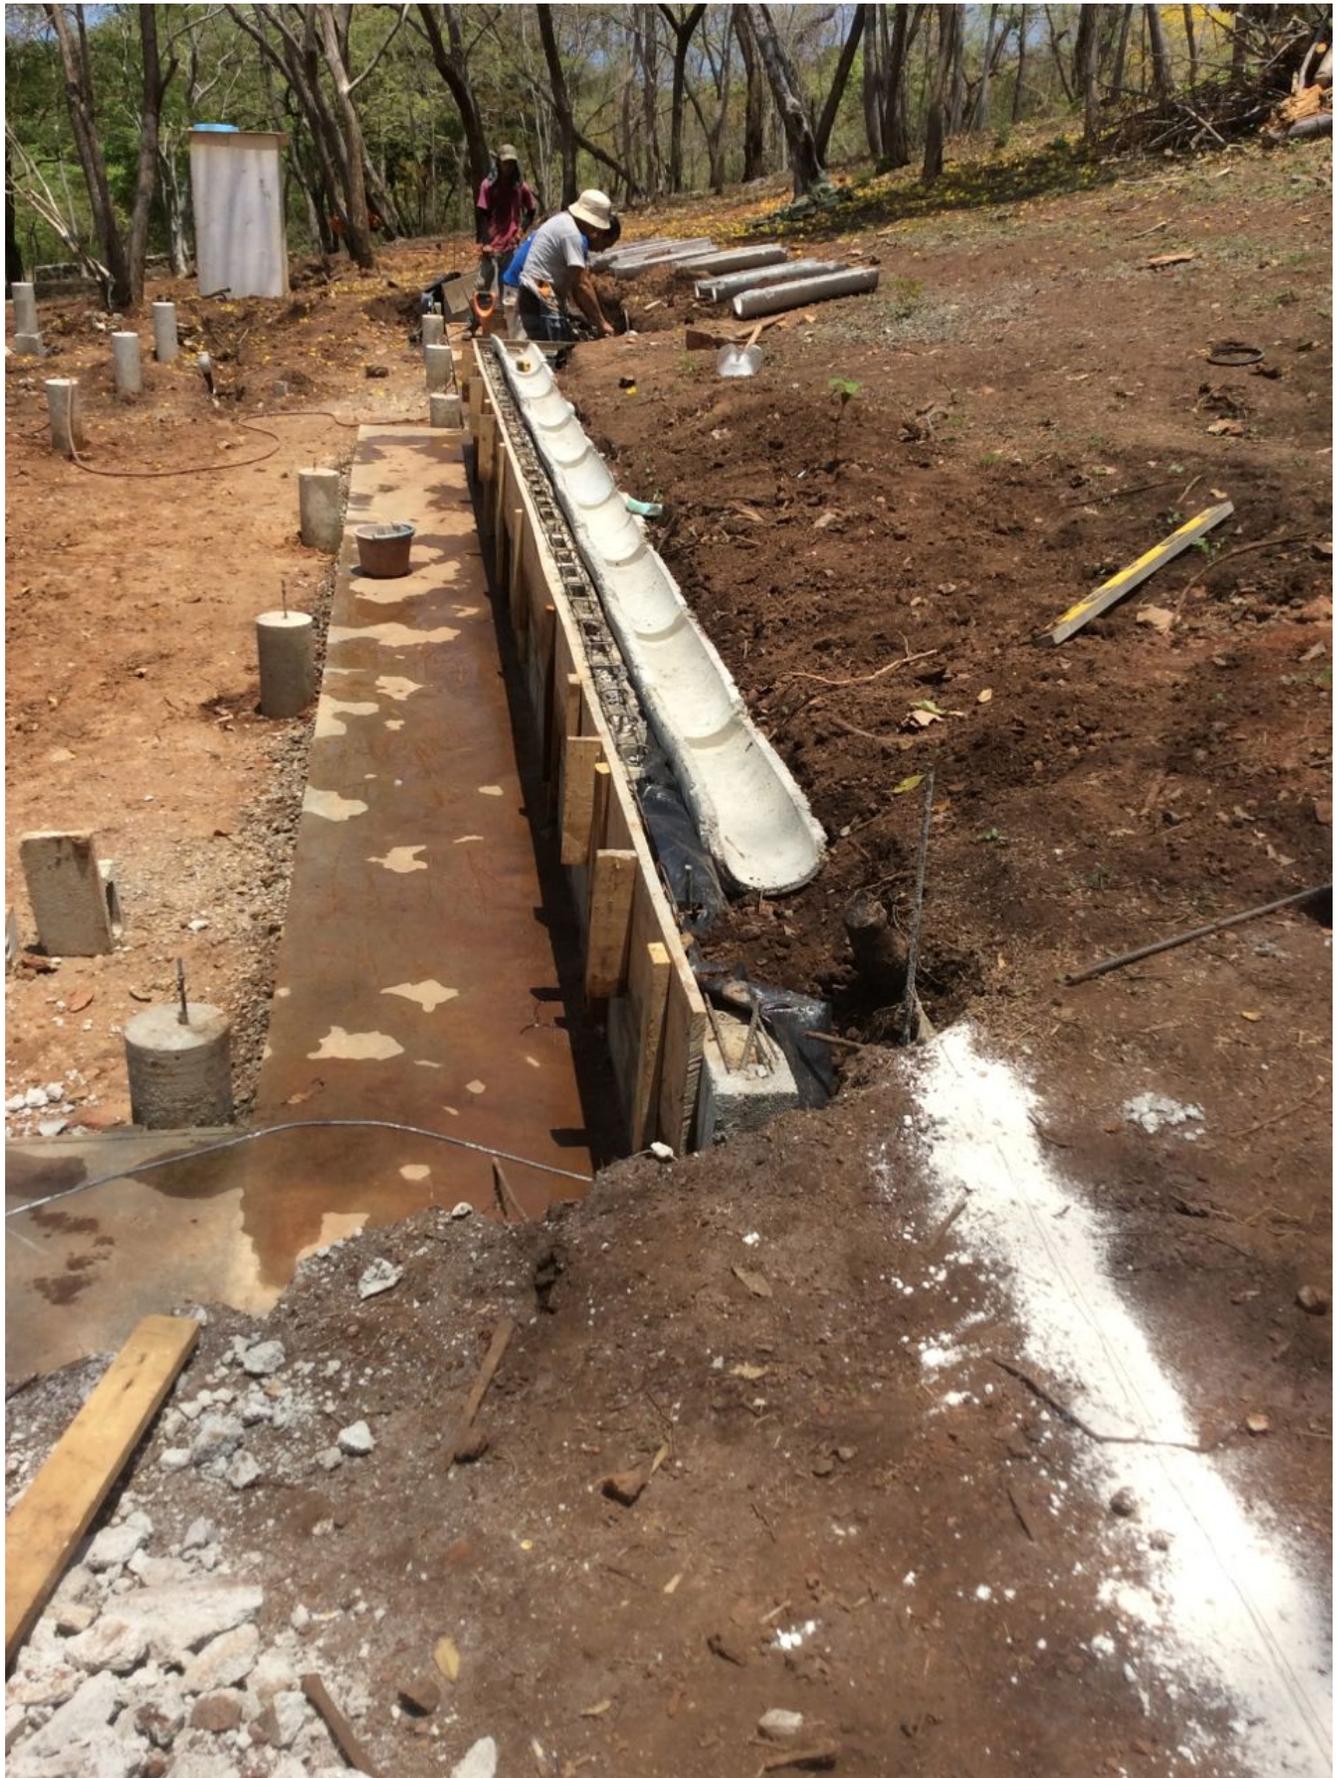
Three feet above the house footprint or in essence at the drip line of the roof we have installed a small retaining wall where we are now putting in place a concrete gutter so as to direct water away from the house

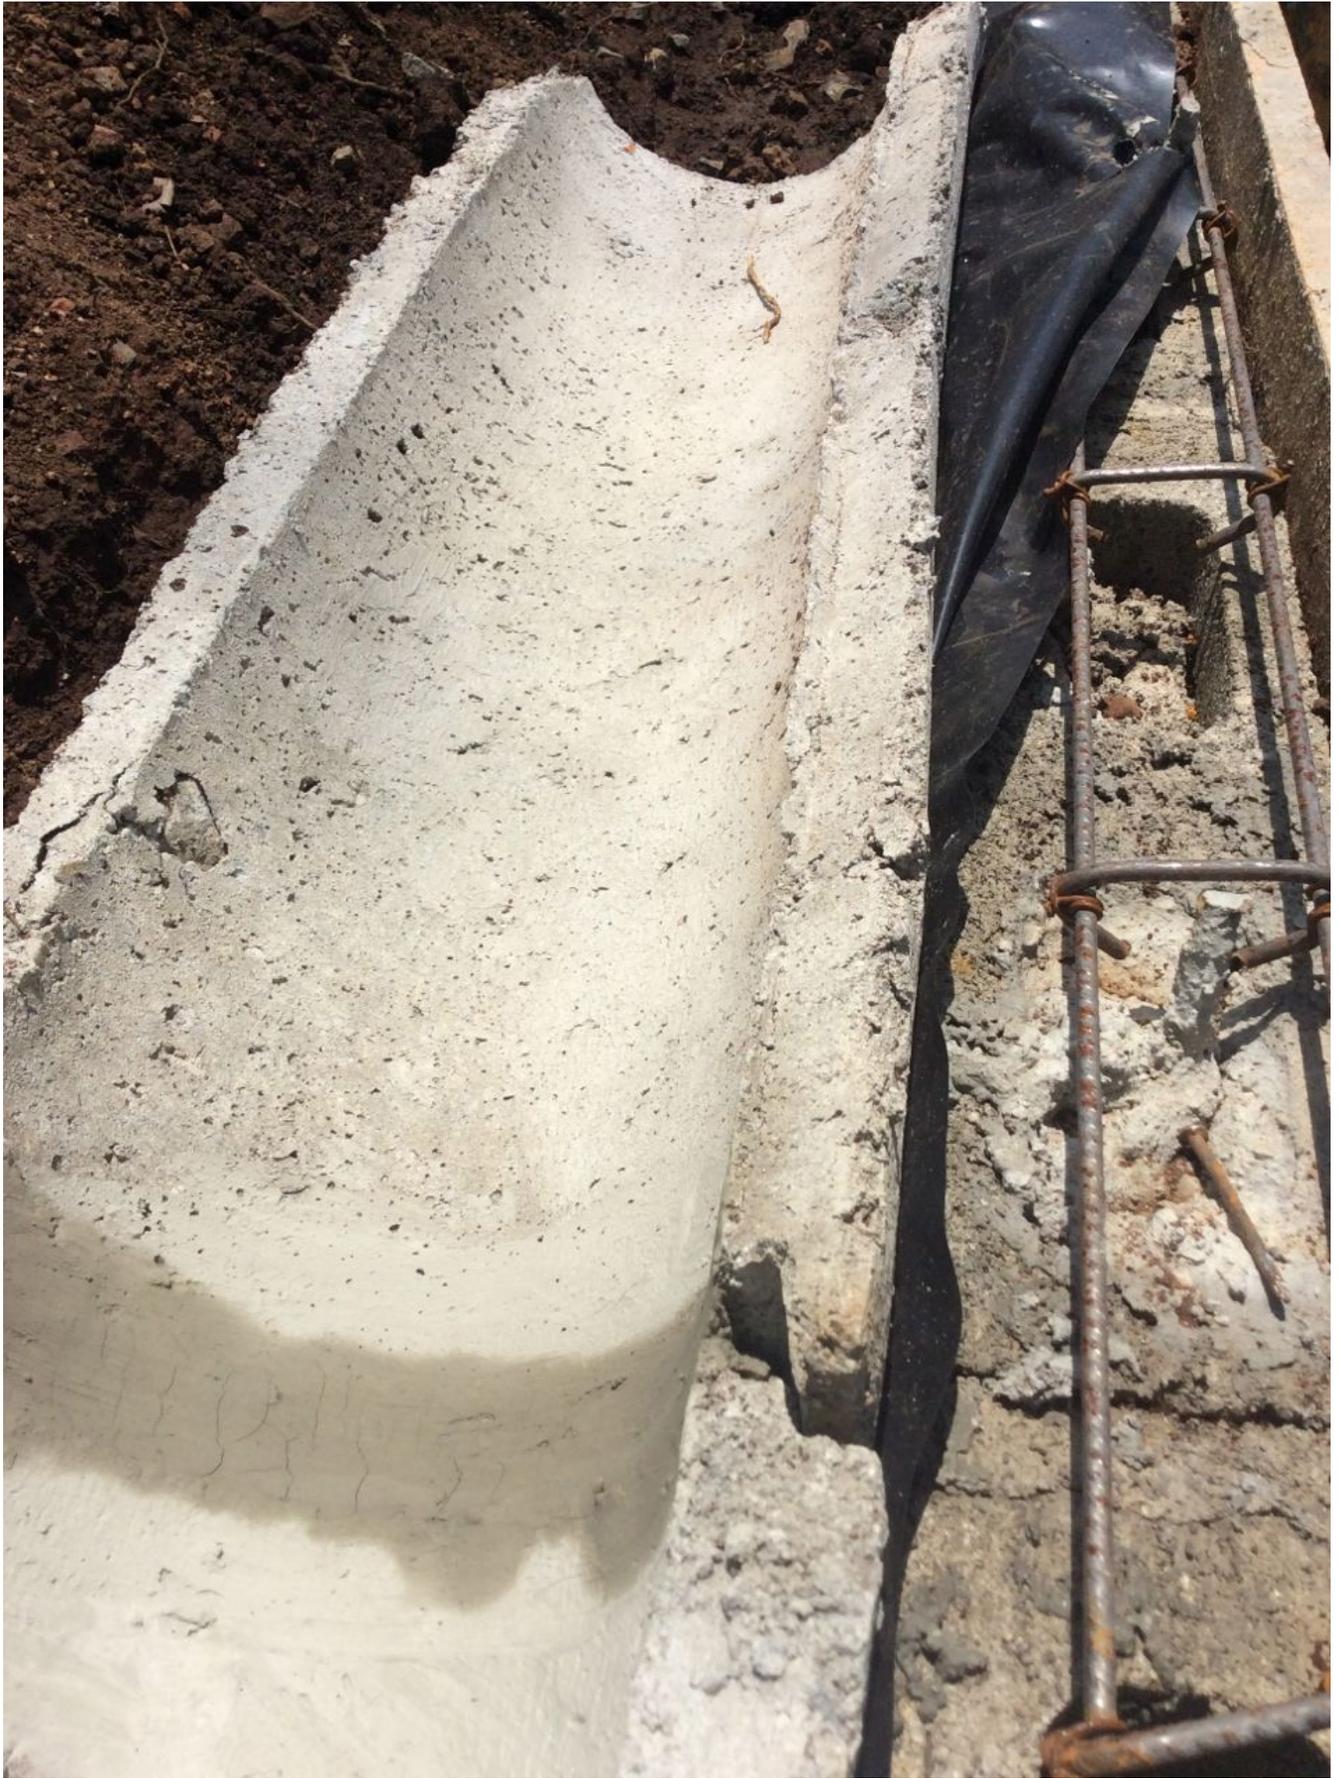
A close up of the concrete gutters but take note of the black plastic sticking out from below the gutter. This is here to prevent water filtration coming through the wall

during rainy season which inevitably leads to many more molds and lichens growing on all concrete surfaces. More importantly this saturation over time causes most stuccos to crack and drop off. With this being a small wall only 65 cm high or 26" not much is required to stop the inevitable filtration of ground waters hence black plastic is fast and cheap to do to avoid the future problems.

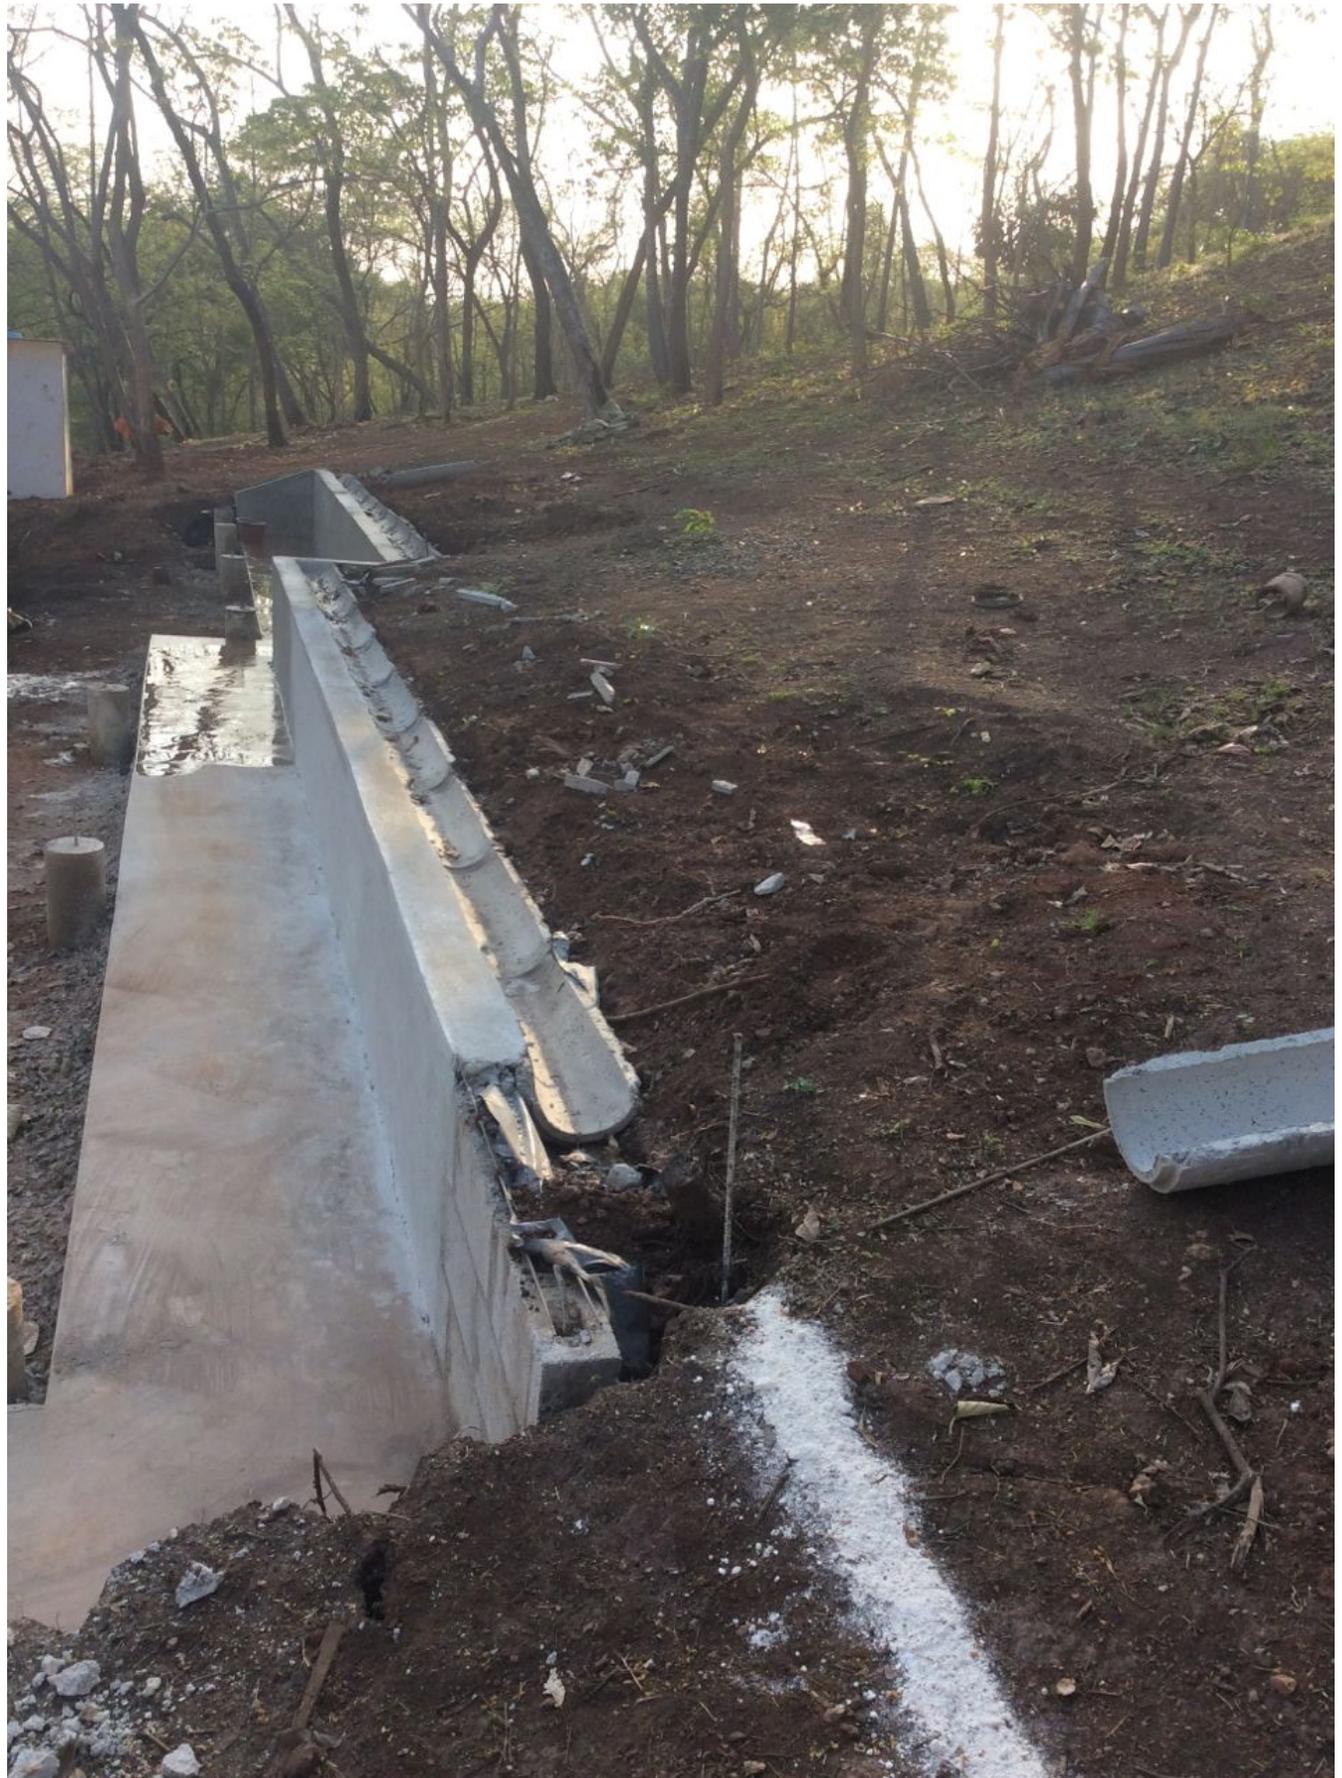
Gutter now installed and formed into the concrete beam that heads off this mini retaining wall.

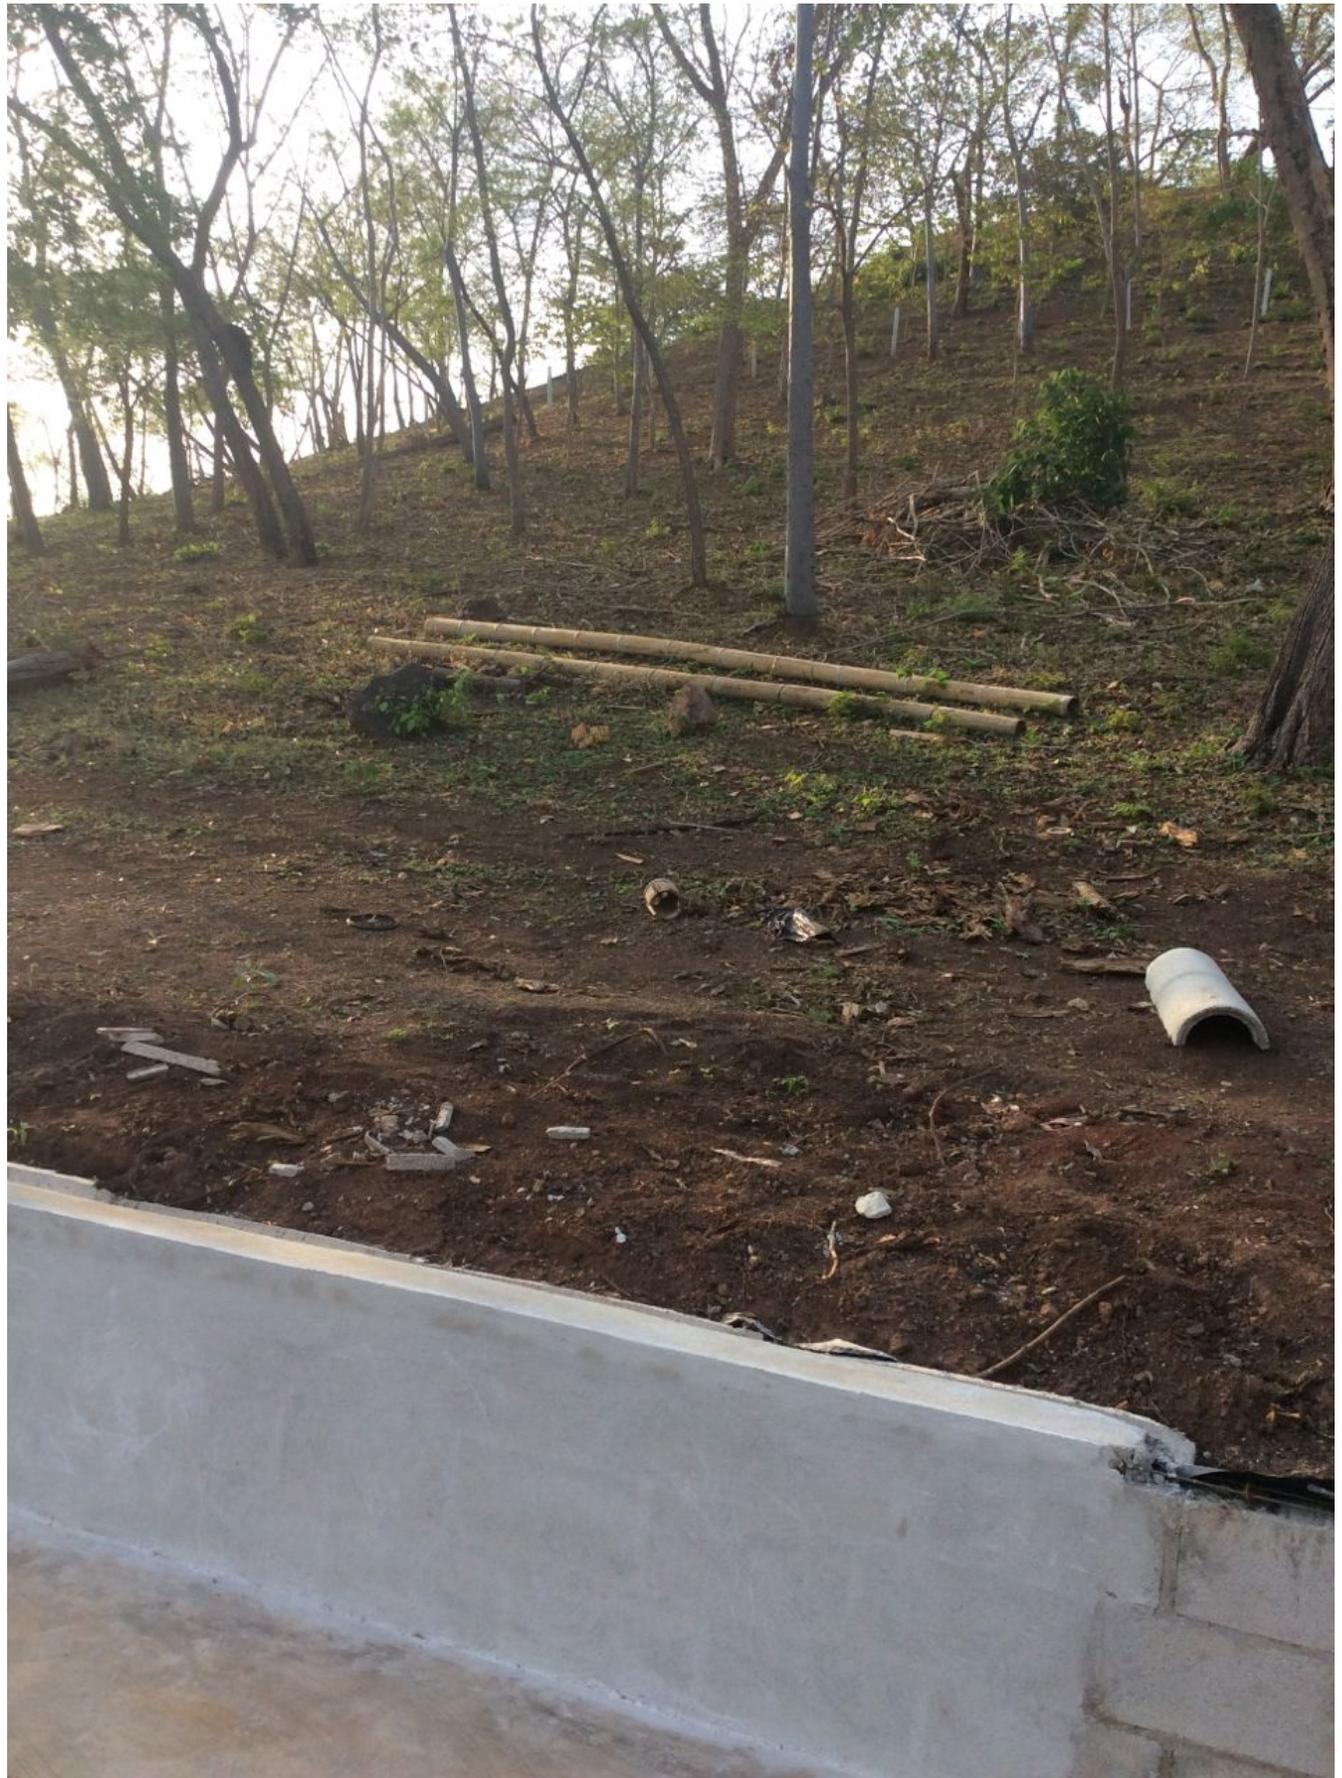
This is exactly why this is done and even though it is bone dry these days this hill side will change drastically in the next month so when those rains do come we most

certainly don't want the often daily thousands of gallons of water washing down the hillside and under the home. Hence this gutter is there to redirect that water flow around the home to both the west and east side of the home. This is so imperative yet often forgotten in the construction process to deal with the gifts from mother nature that will indeed come.

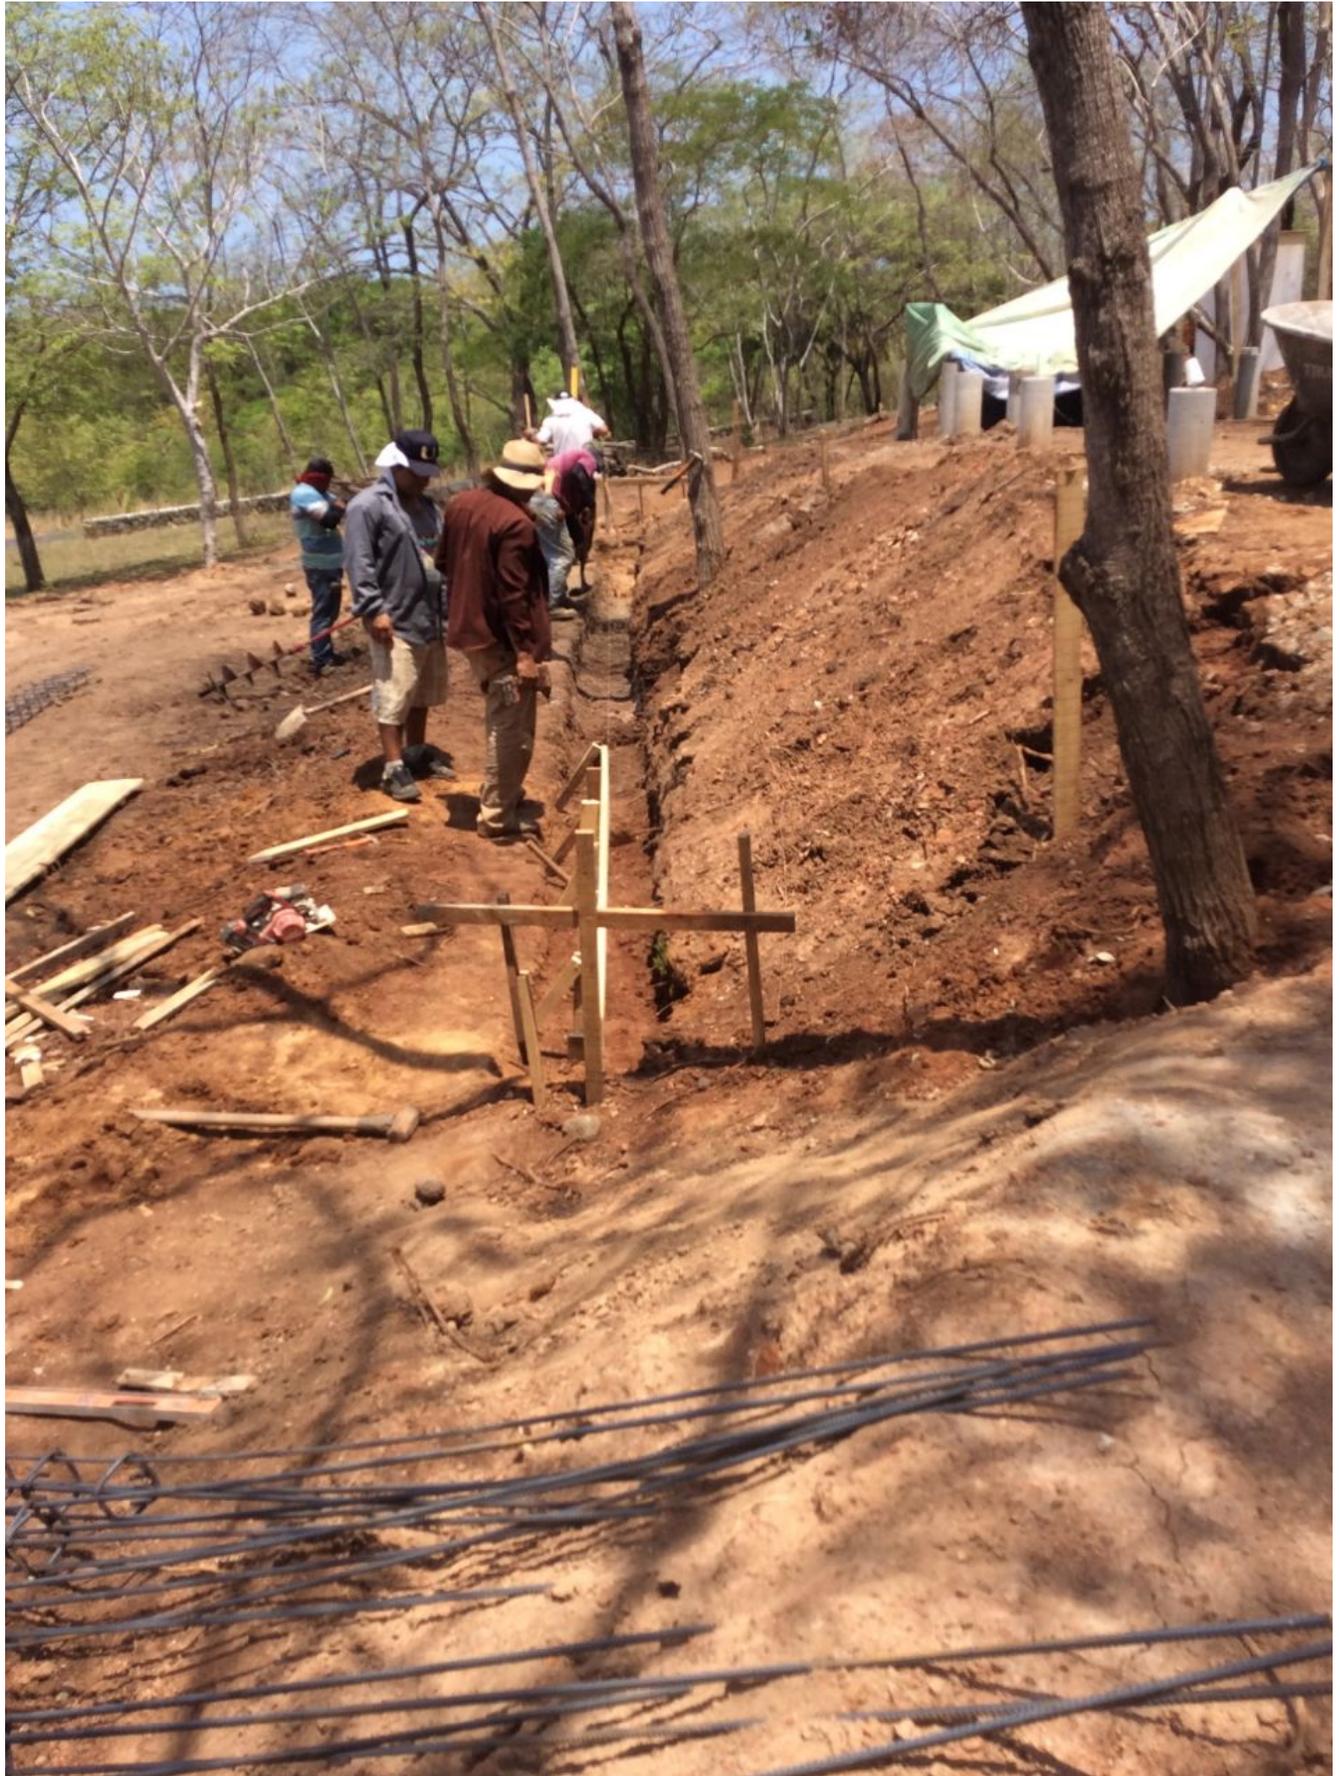
9 feet in front of the house we have cut a trench down to virgin soil for the beam and bored pilings that will sustain this retention wall of 4 1/2 ft or 1.4 m. This new level

will provide the sidewalk access to the front door step and a garden area that is now lifted up to the same level as the base under the house structure.

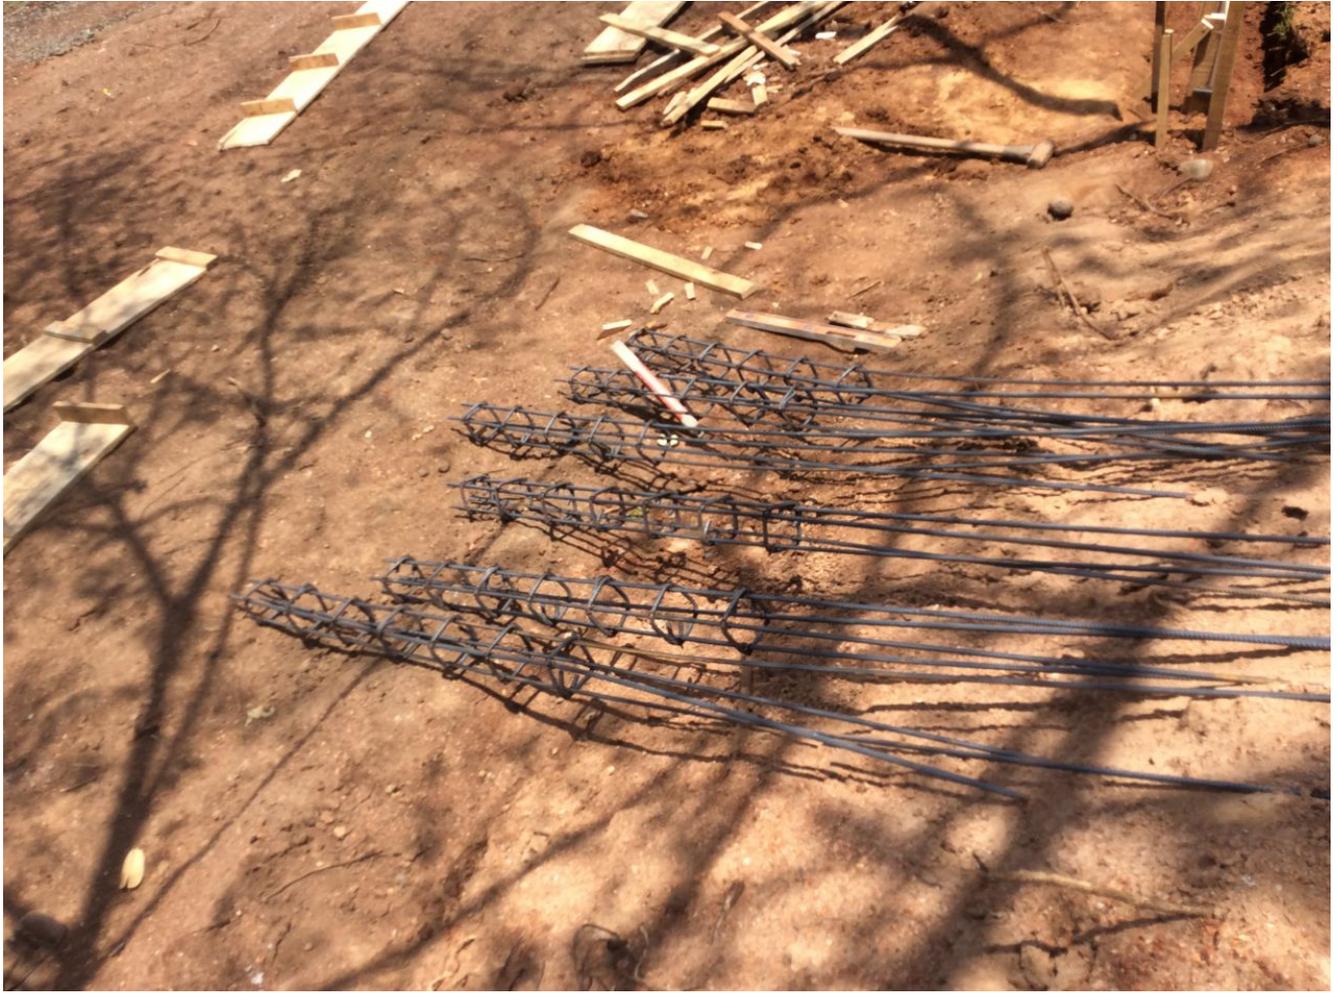
Rebar cages that will go into the pilings.

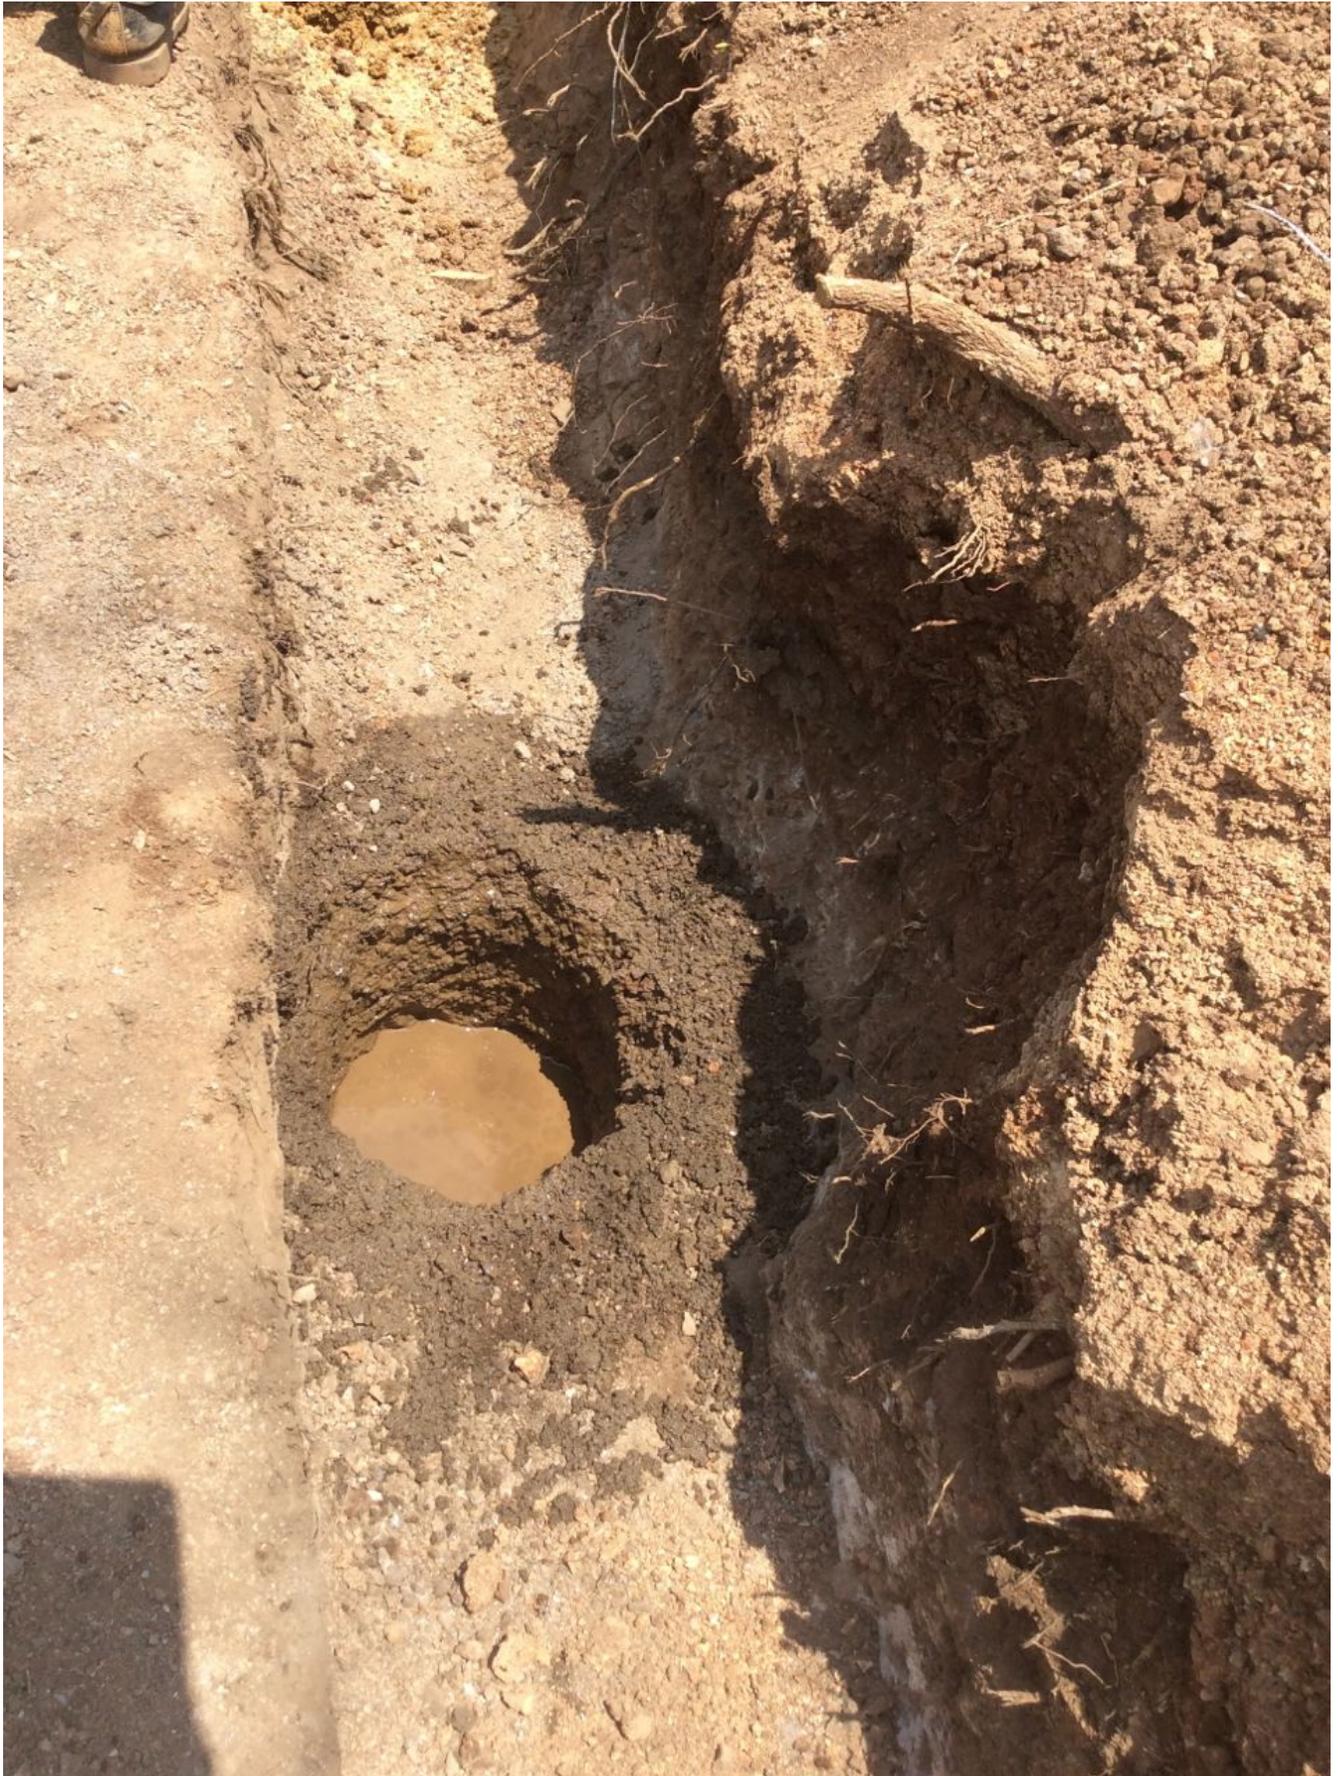
Boring the piling holes is not easy into this lower level of rock that is under the whole building site. IN fact without water and a bar it is pretty much impossible. However

with that said it also makes for a great base to support any load.

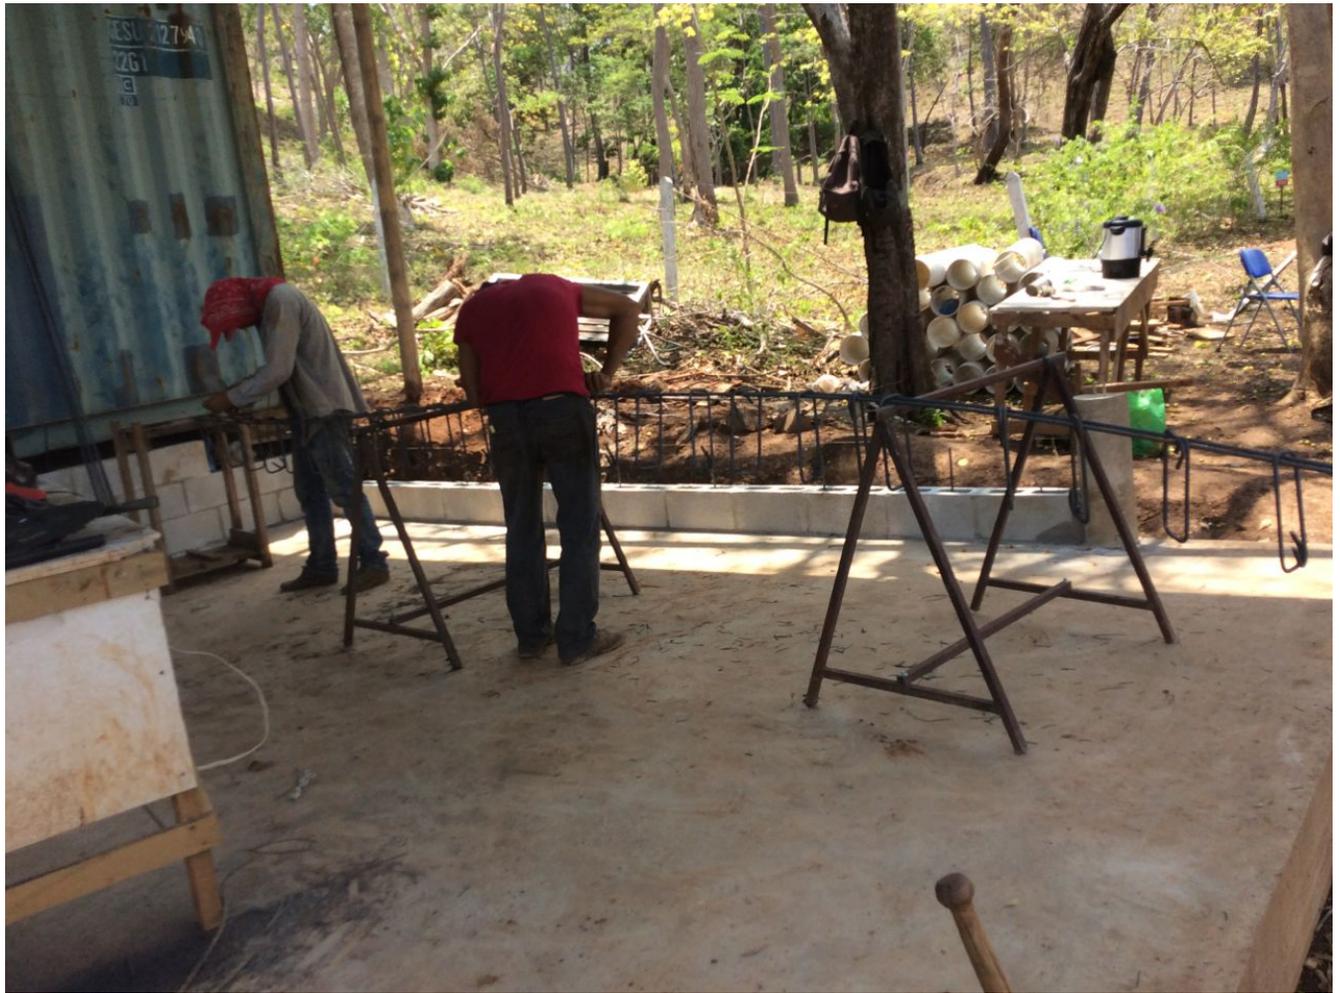
Making the cages that will go into the support beams that carry the weight to each piling.

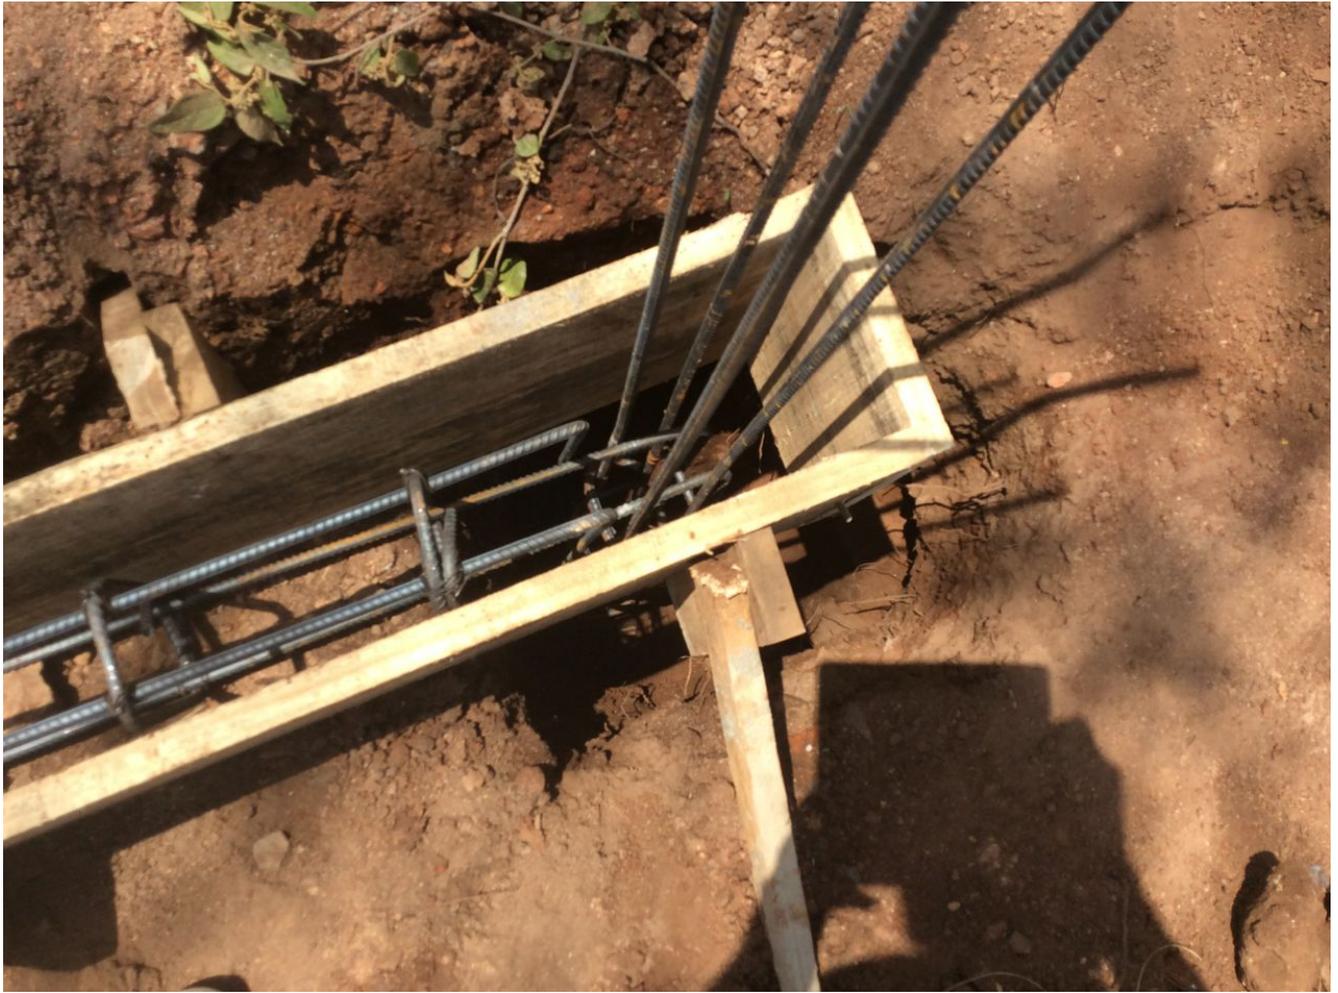
View down the piling hole once cage is installed along with forms. Ready to pour.

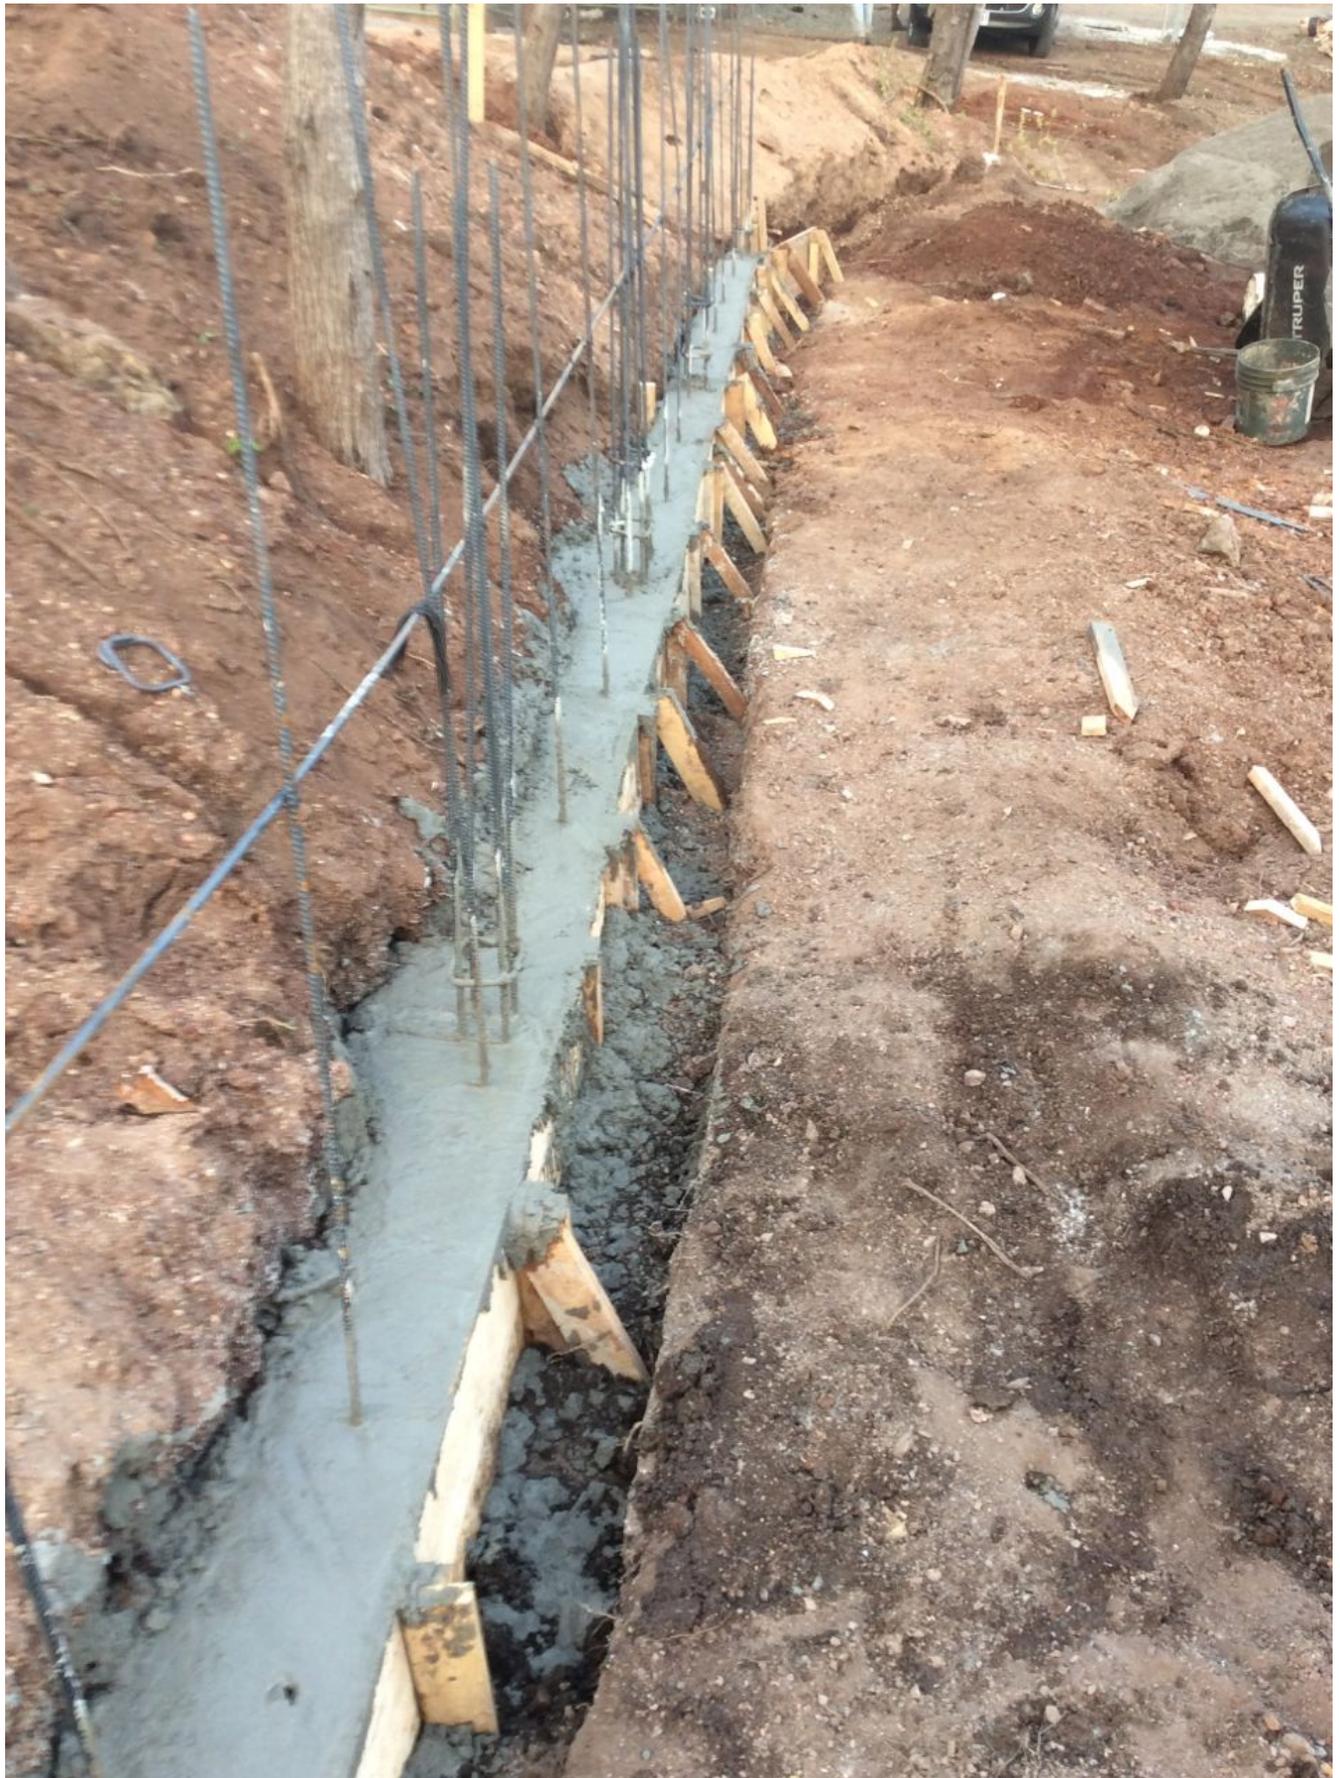
Main stretch of beam is poured.
