Techos Siglo XXI – Constructing Your Green Home

Home Diary – Playa Grande

Super Home #3 begins with a BIG MOVE!

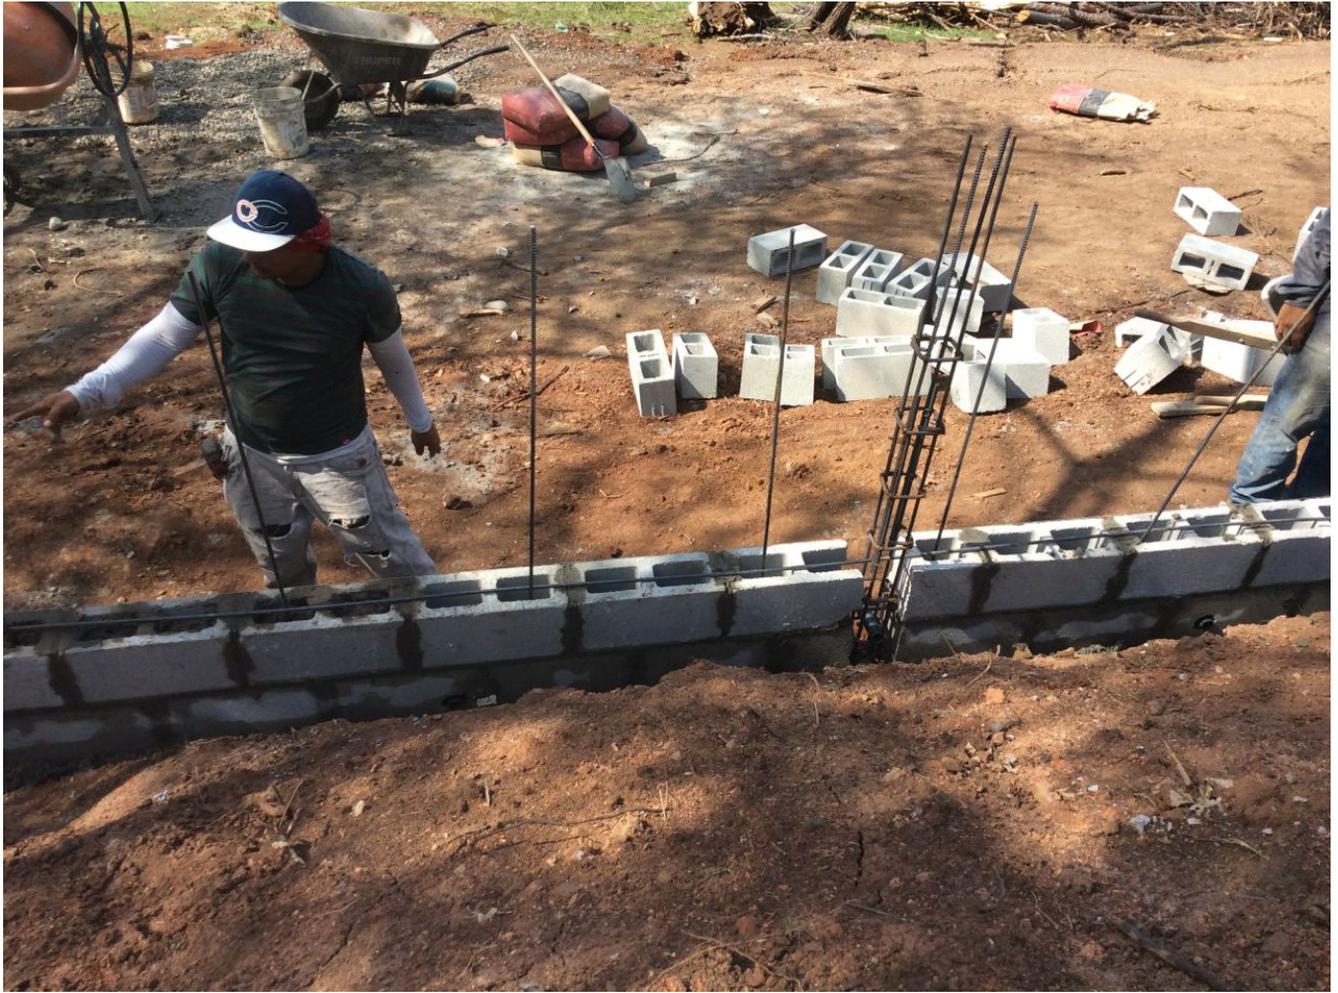
Next day the block starts to go up.

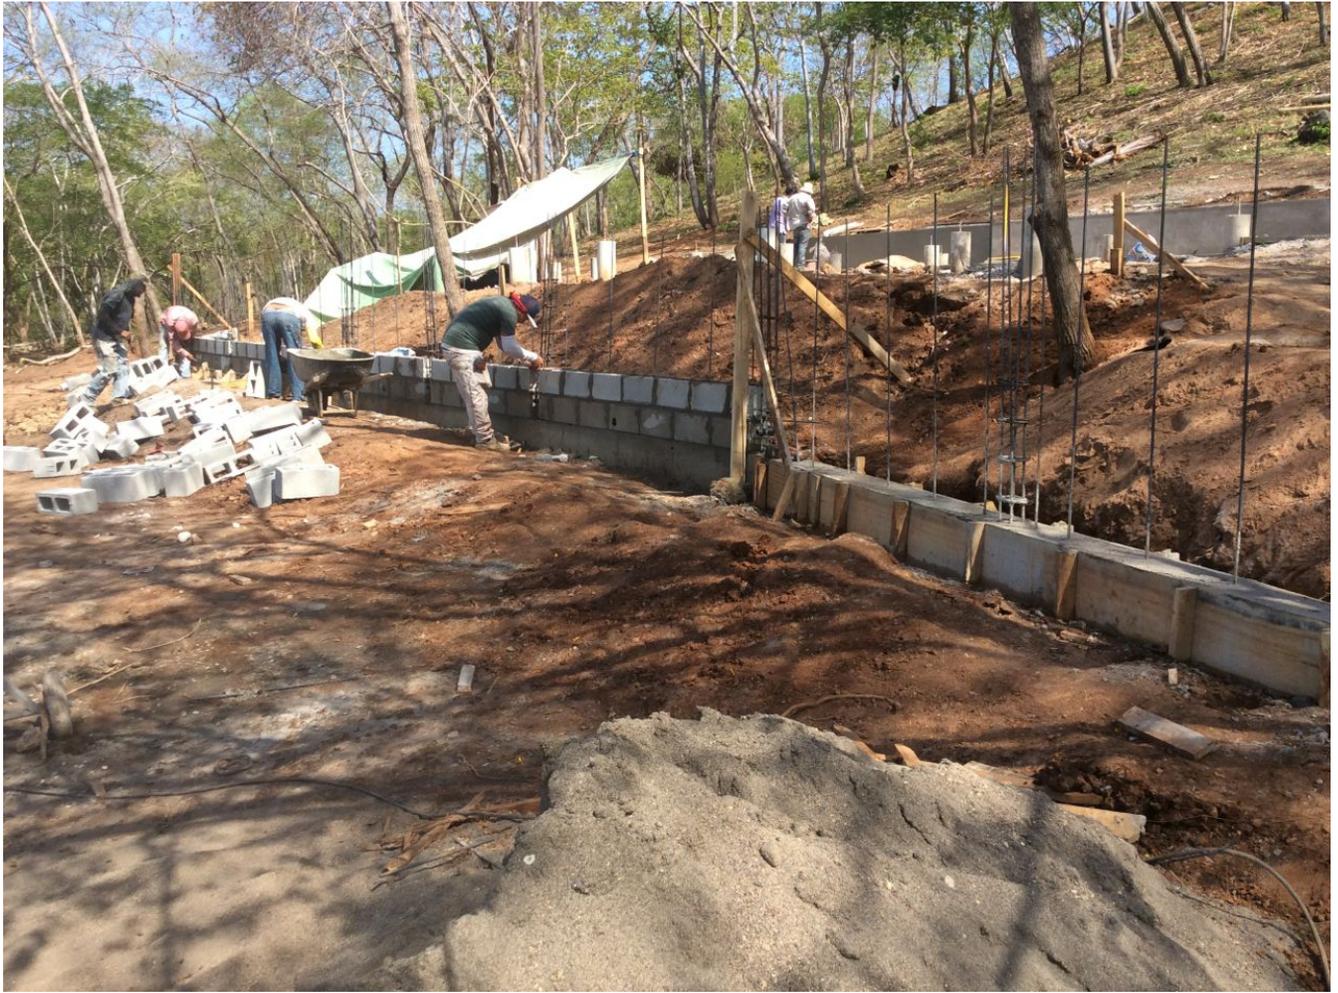
Last of beam poured as block proceeds.

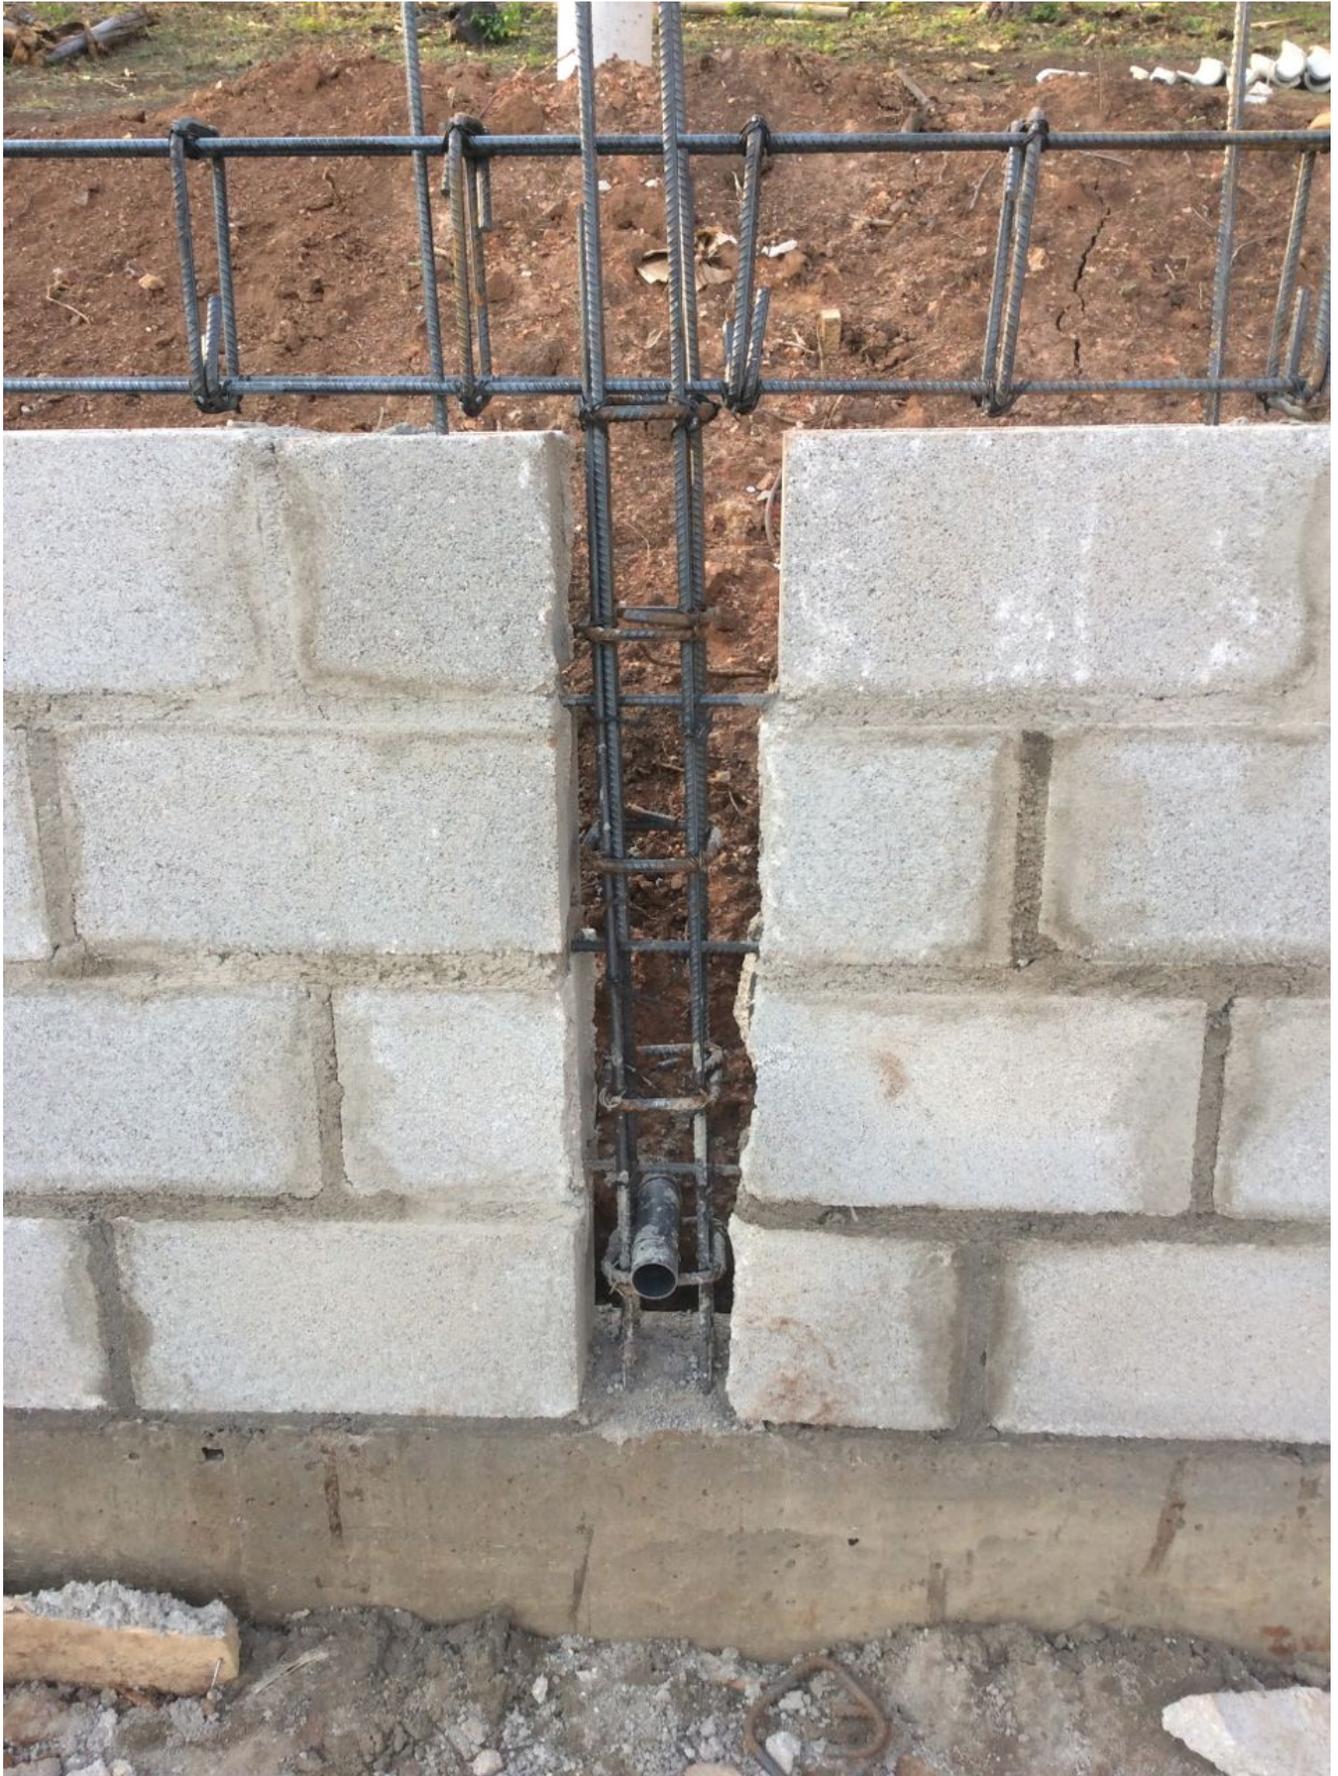
The cages extend up from the piling to create a column in the wall itself and tying all into an upper beam.

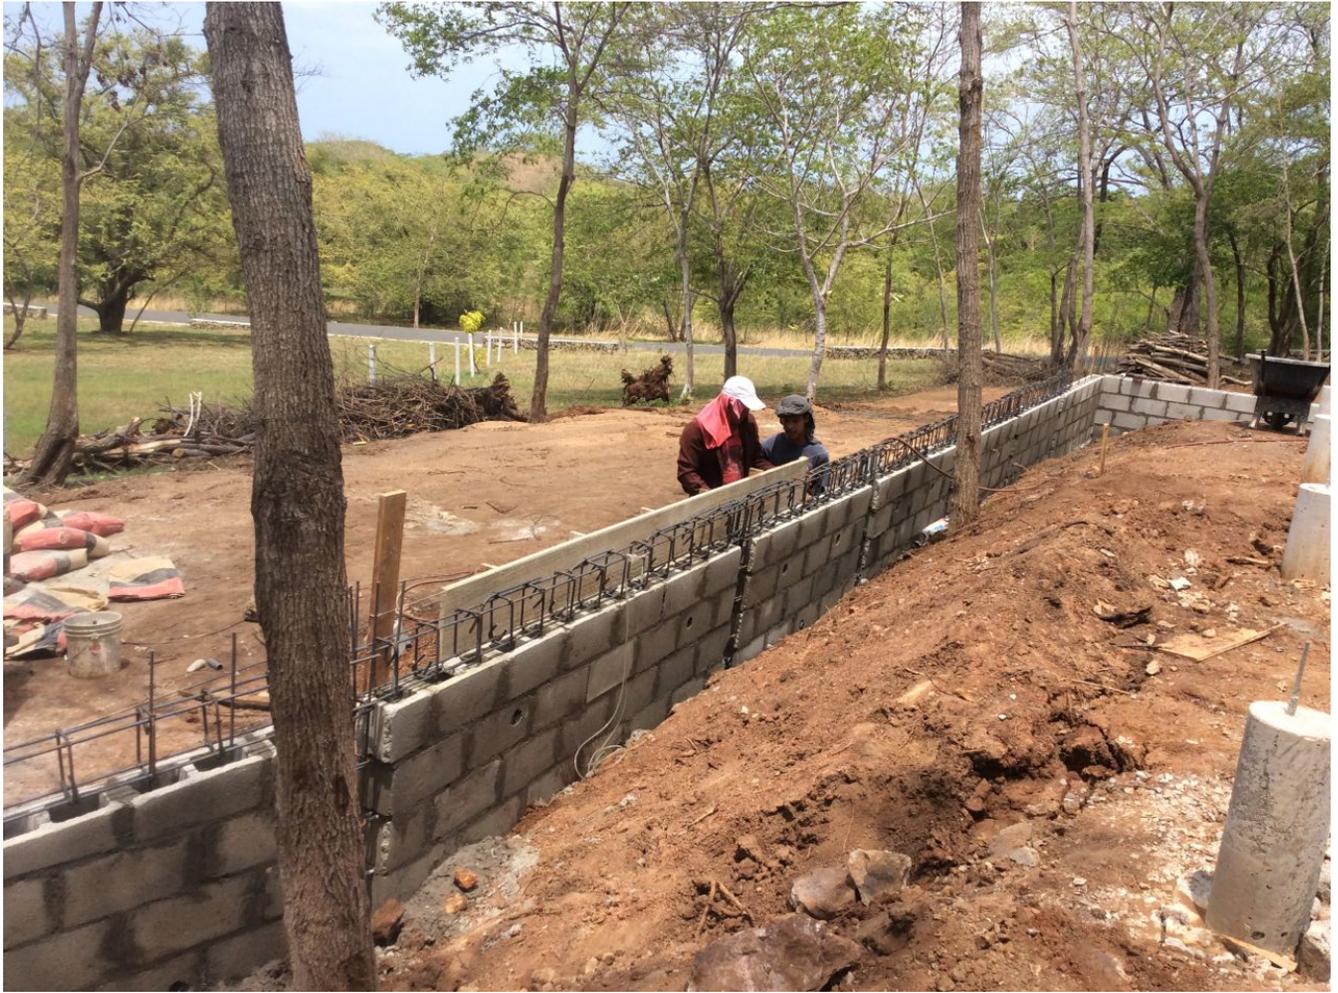
Starting to form up for the beam and column pour and filling of all the block in at the same time. Everything is vibrated as it is poured otherwise you end up with large air pockets hence not very strong support.

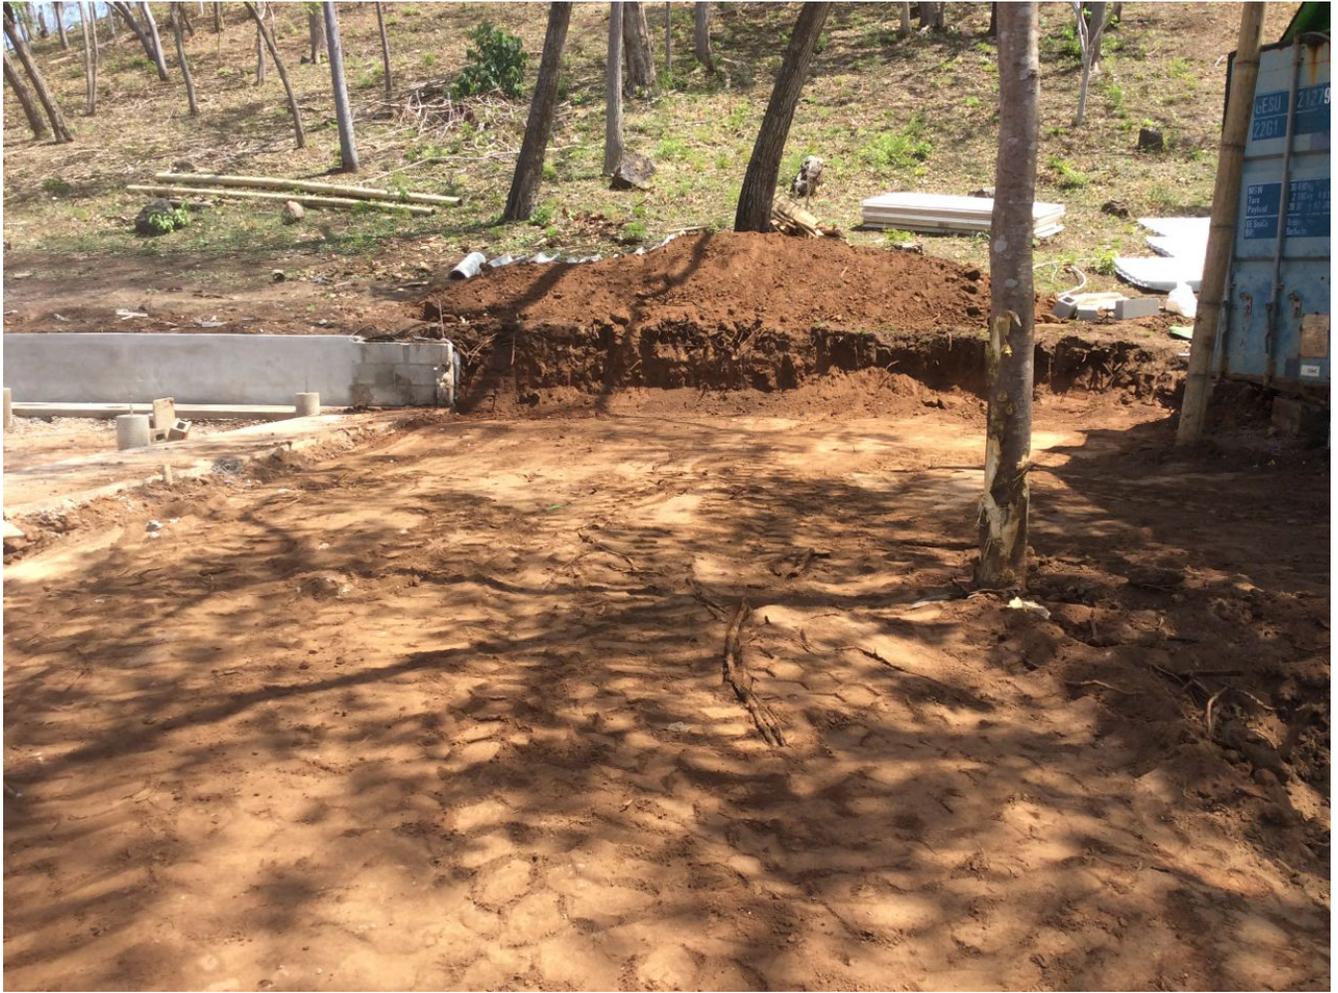
Okay platform ready for the eventual front yard and access to carport and storage. Now the retaining wall and gutter has to be extended to avoid the upper hill from flooding this area every time it rains.

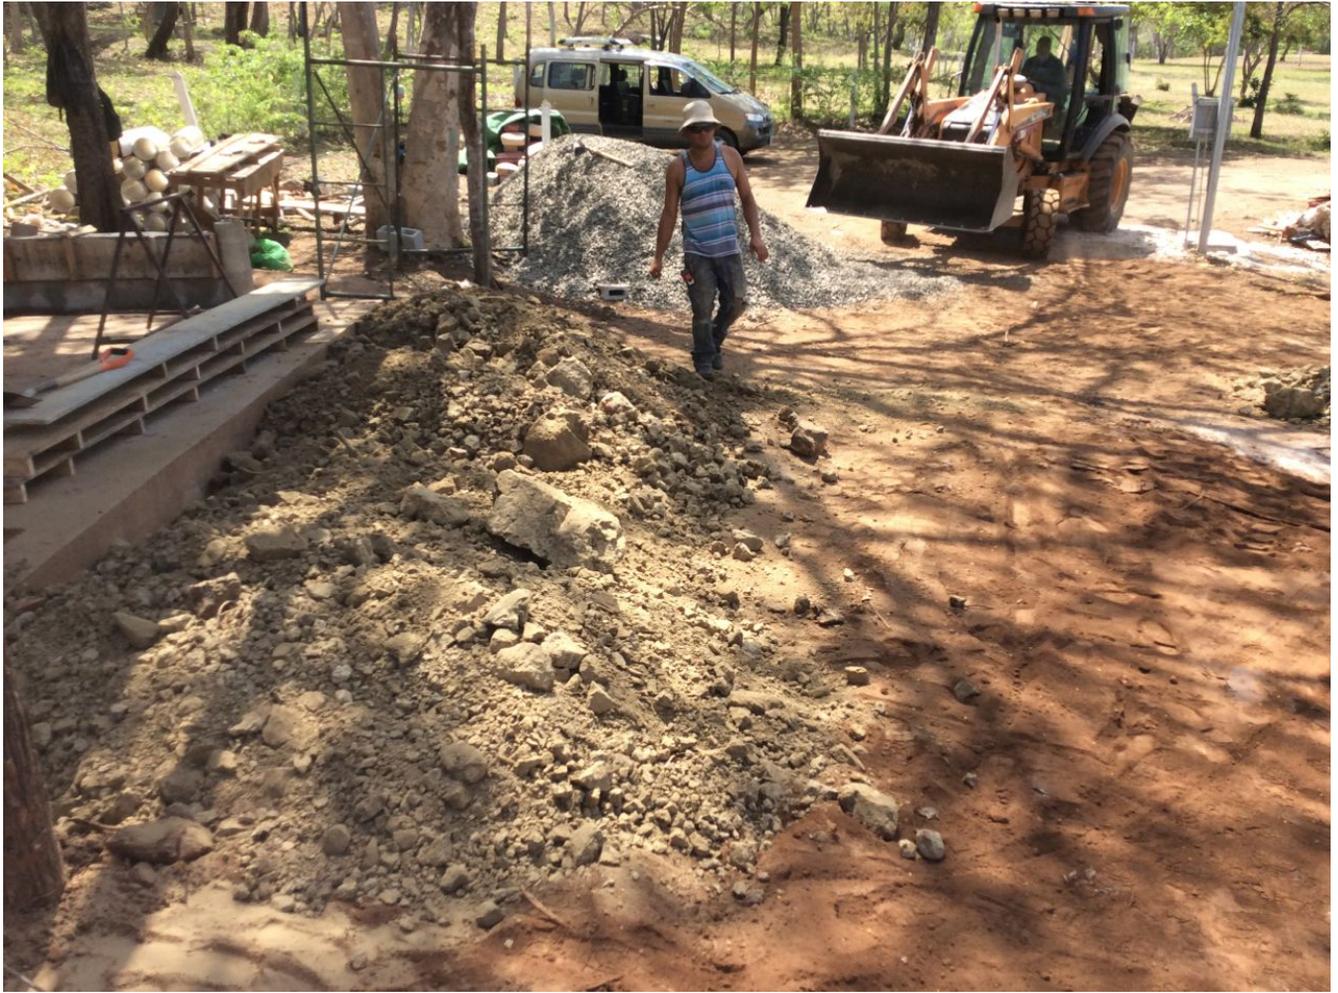
Now to make a driveway with this fine gravel we got but ti does make an excellent base with great drainage after the back hoe breaks it up and packs it in place.

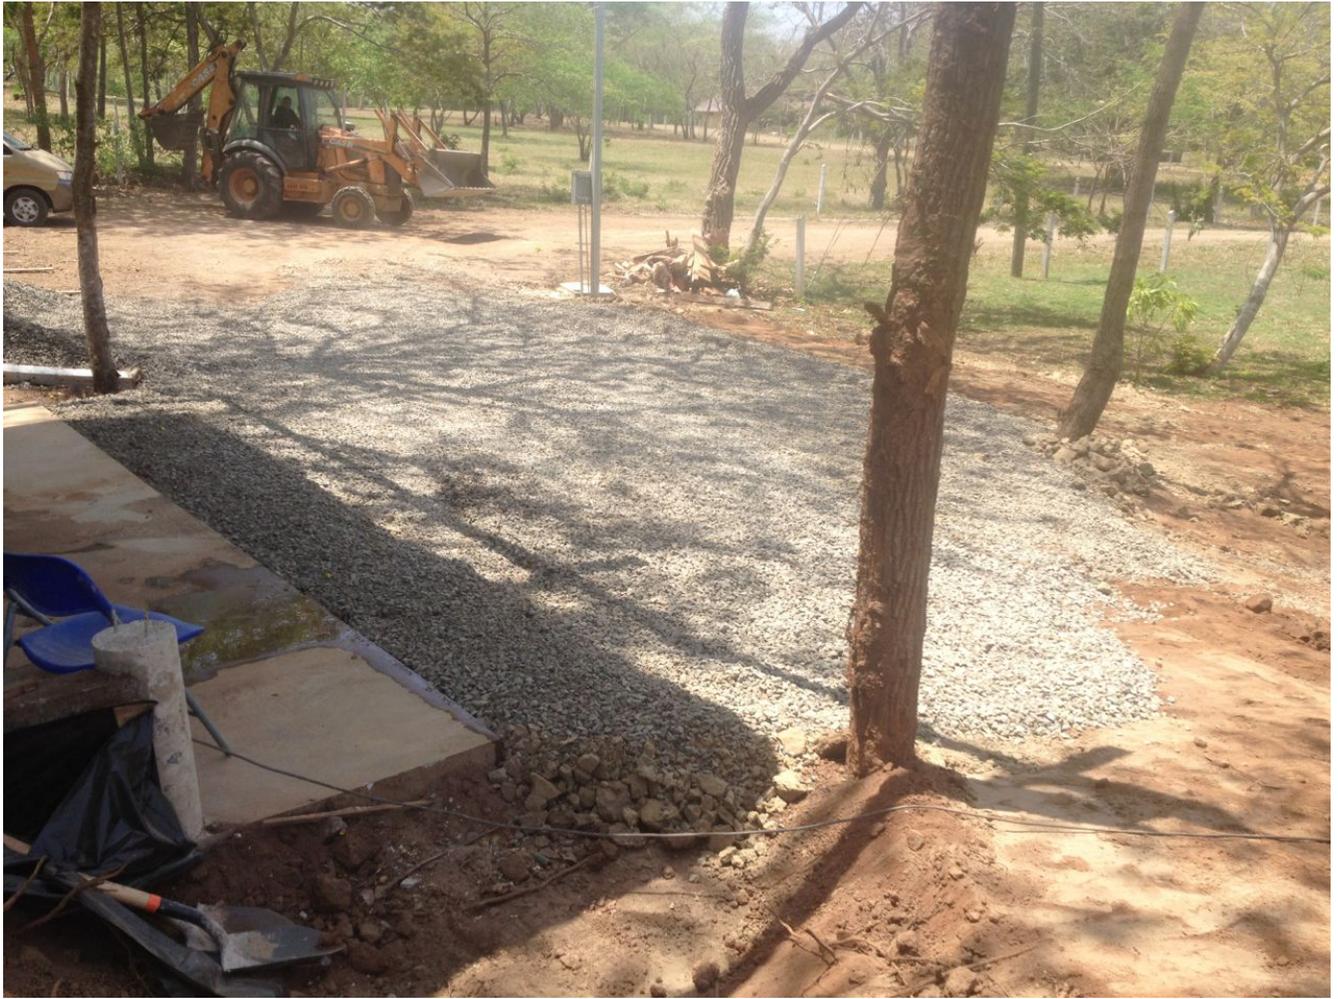
Now with crushed rock laid down over that we have a clean driveway not affected by rain.

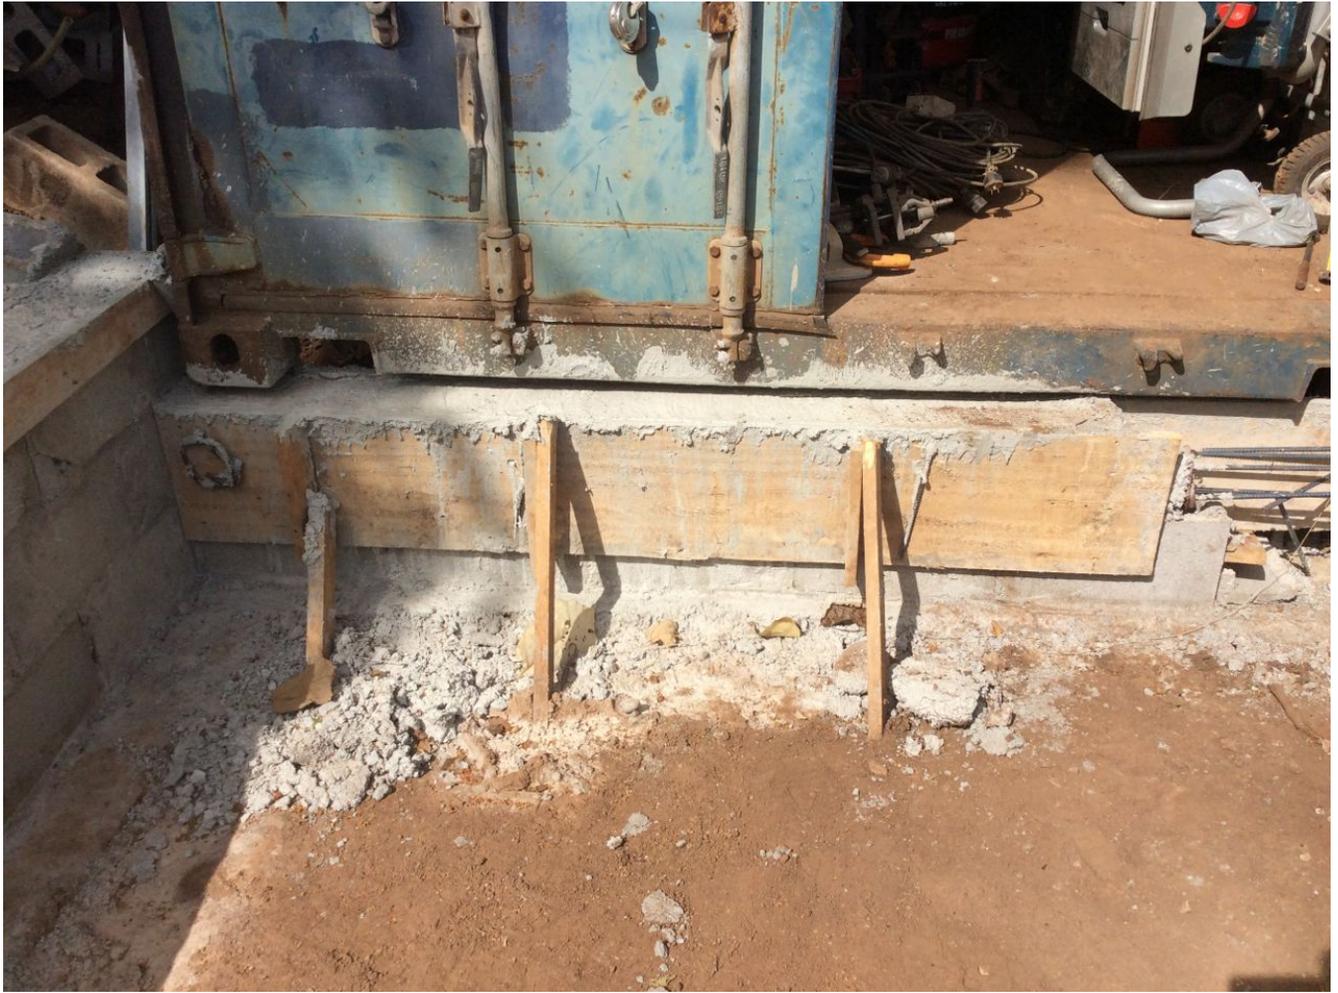
Also a permanent foundation is added to support the container as it metamorphasizes into a storage shed in front of the carport. Here we had to become building movers and lift the container out of the way so we had enough room to make the beam that will be supporting it.

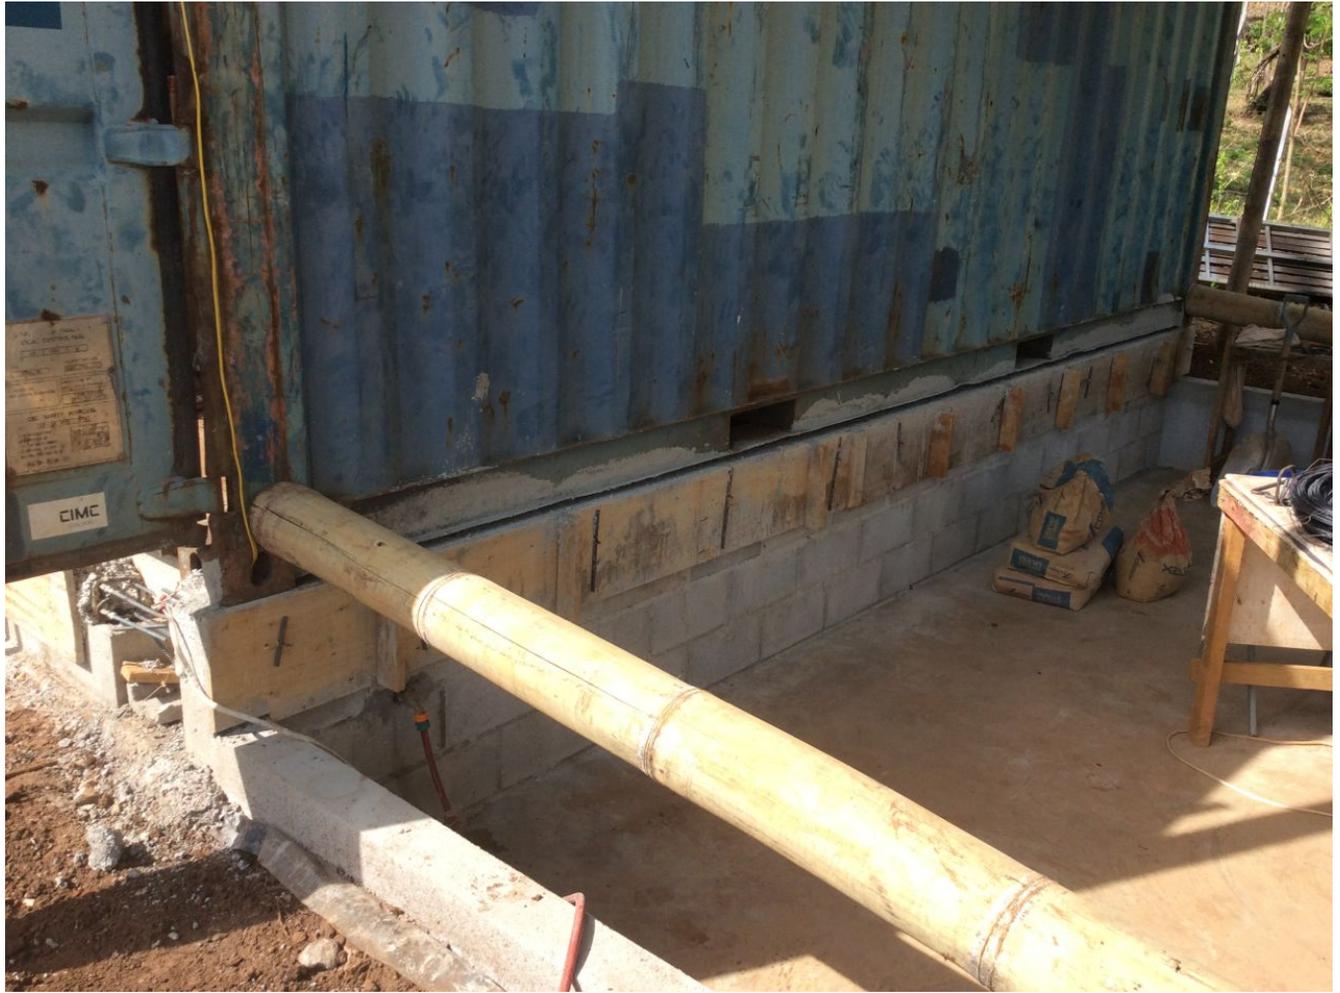
We have formed up the supporting beam and used our bamboo poles to keep the container in perfect alignment with the surrounding walls.

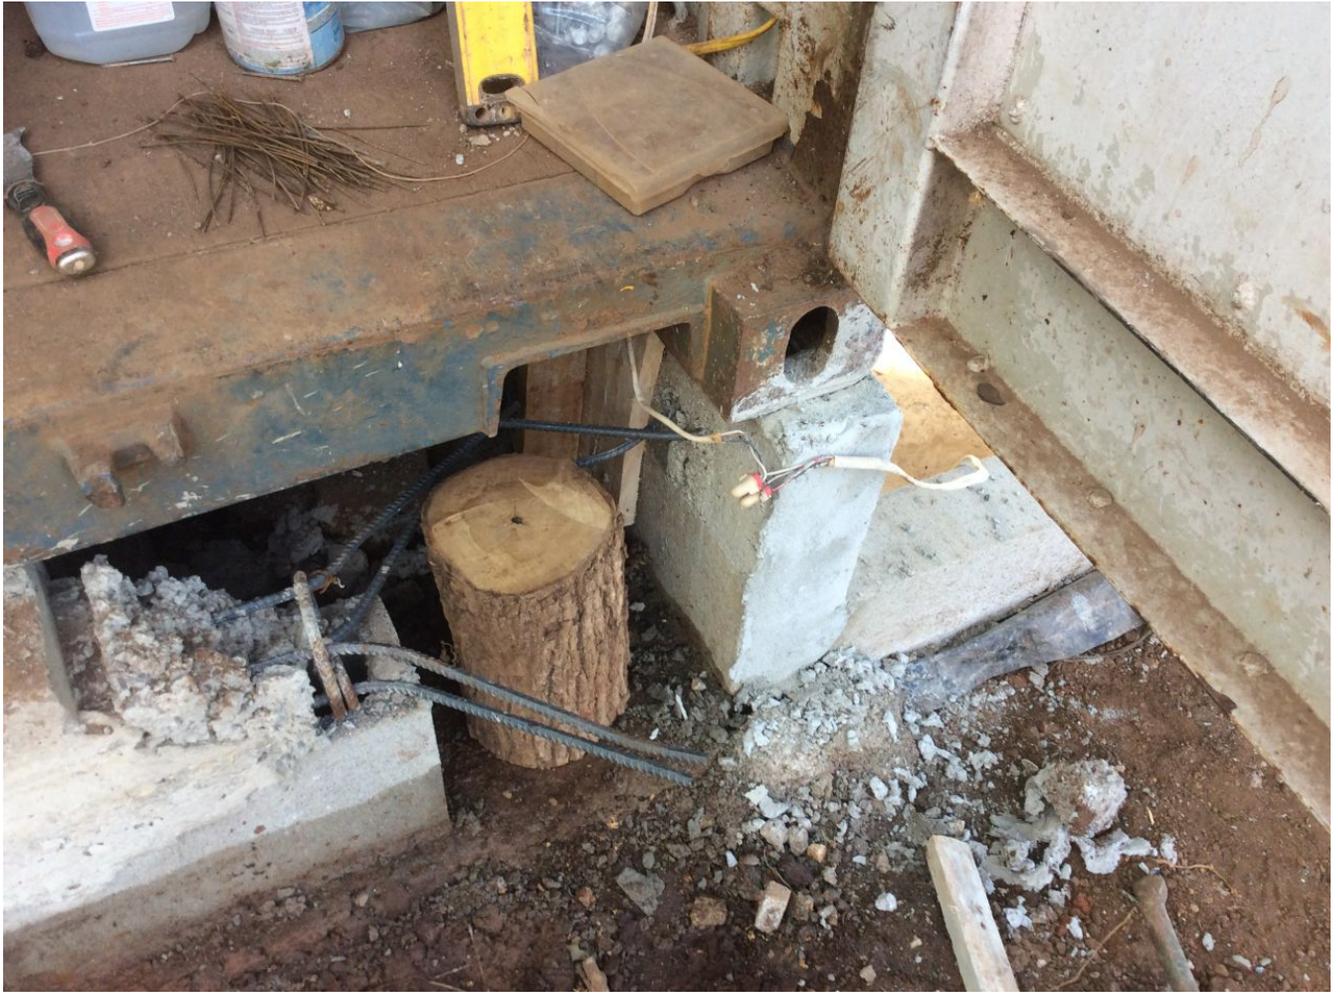
This took a bit of strategizing hence this spot had to be left out so we had a location to jack from once the walls were cured enough to put the weight of the container and contents back down on it in its permanent position.

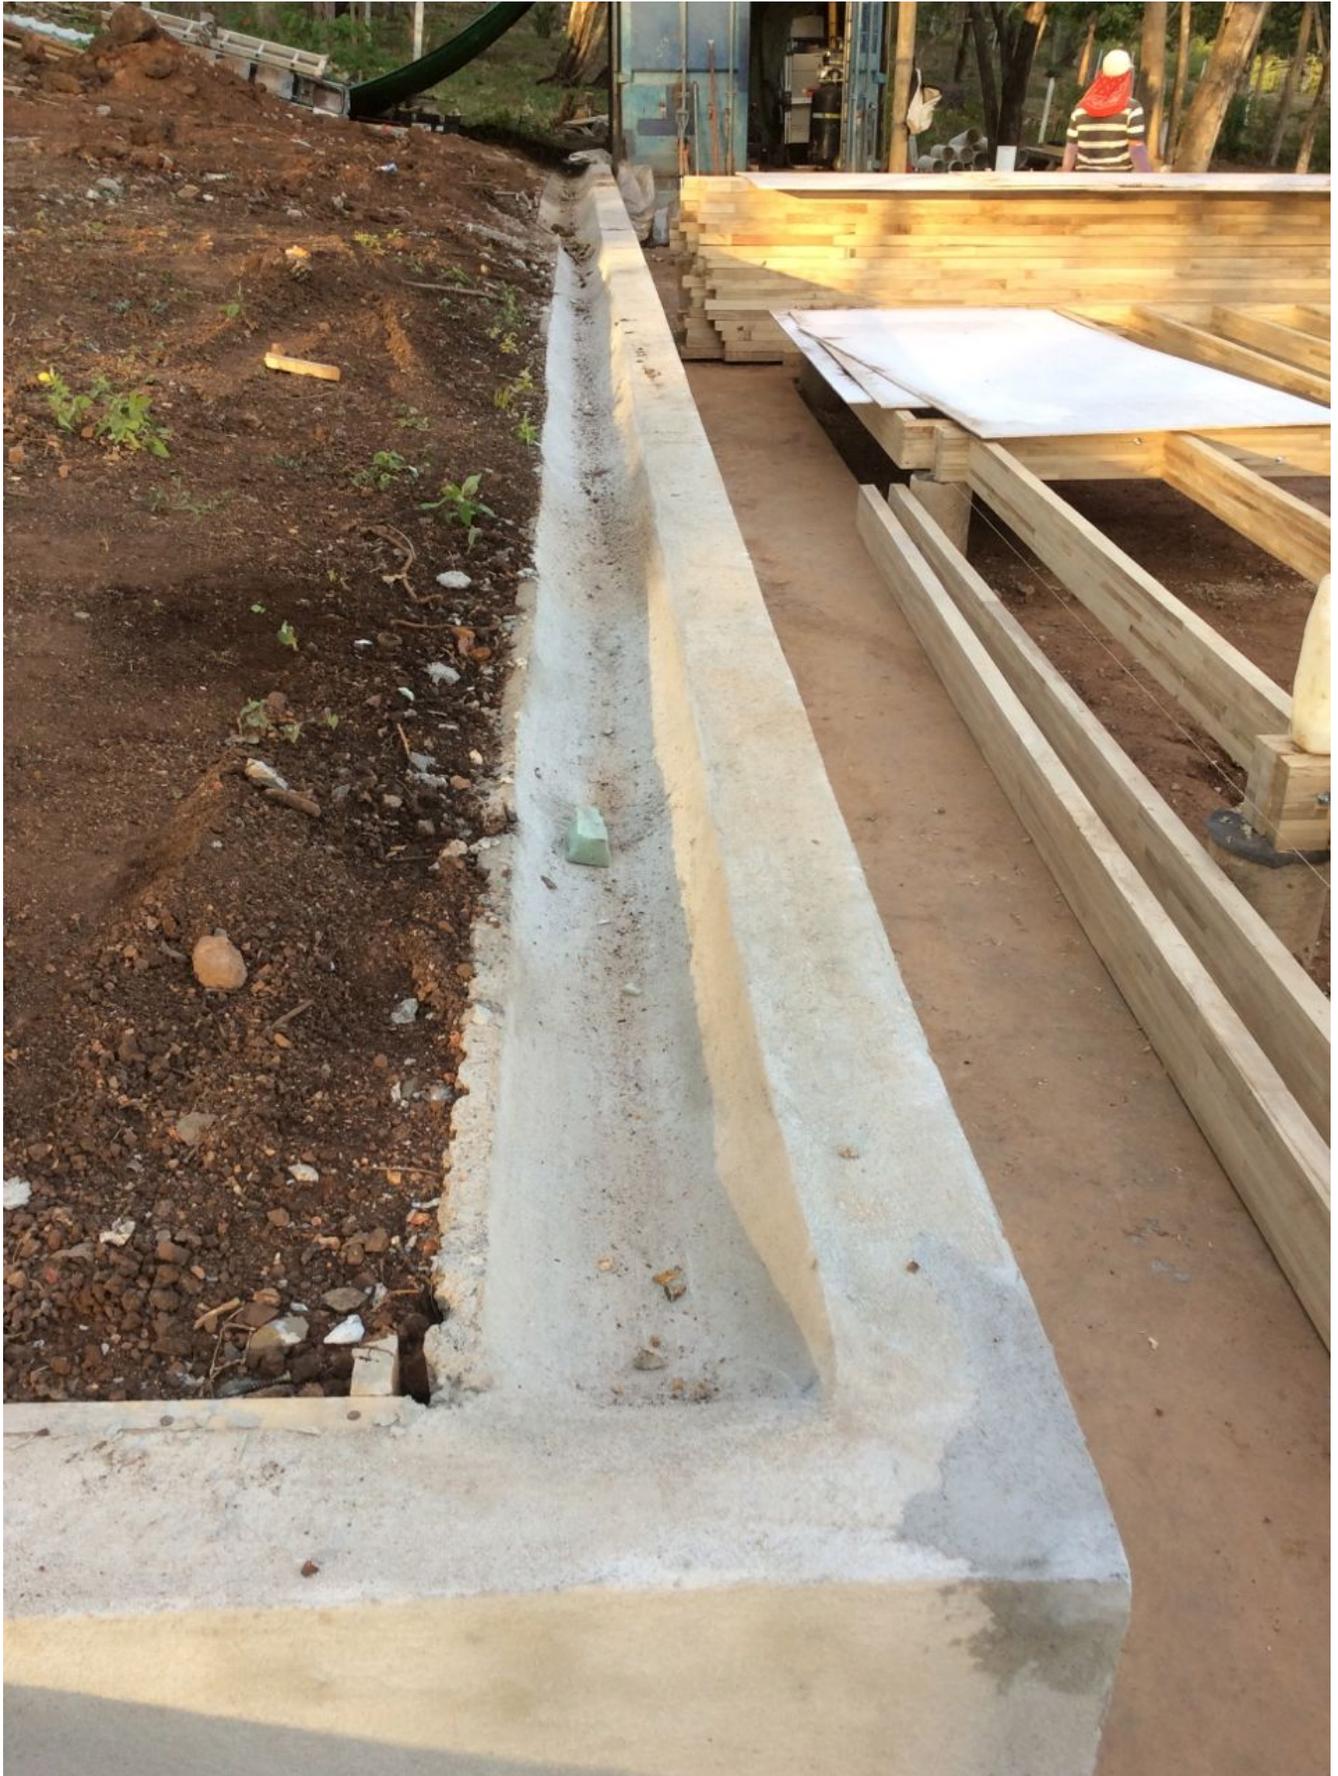
The gutter has now been poured in to become part of the wall so that all the water that is going to come down this hillside of roughly 1,200 m² will get diverted to the side of

the lot and not flood the building site.

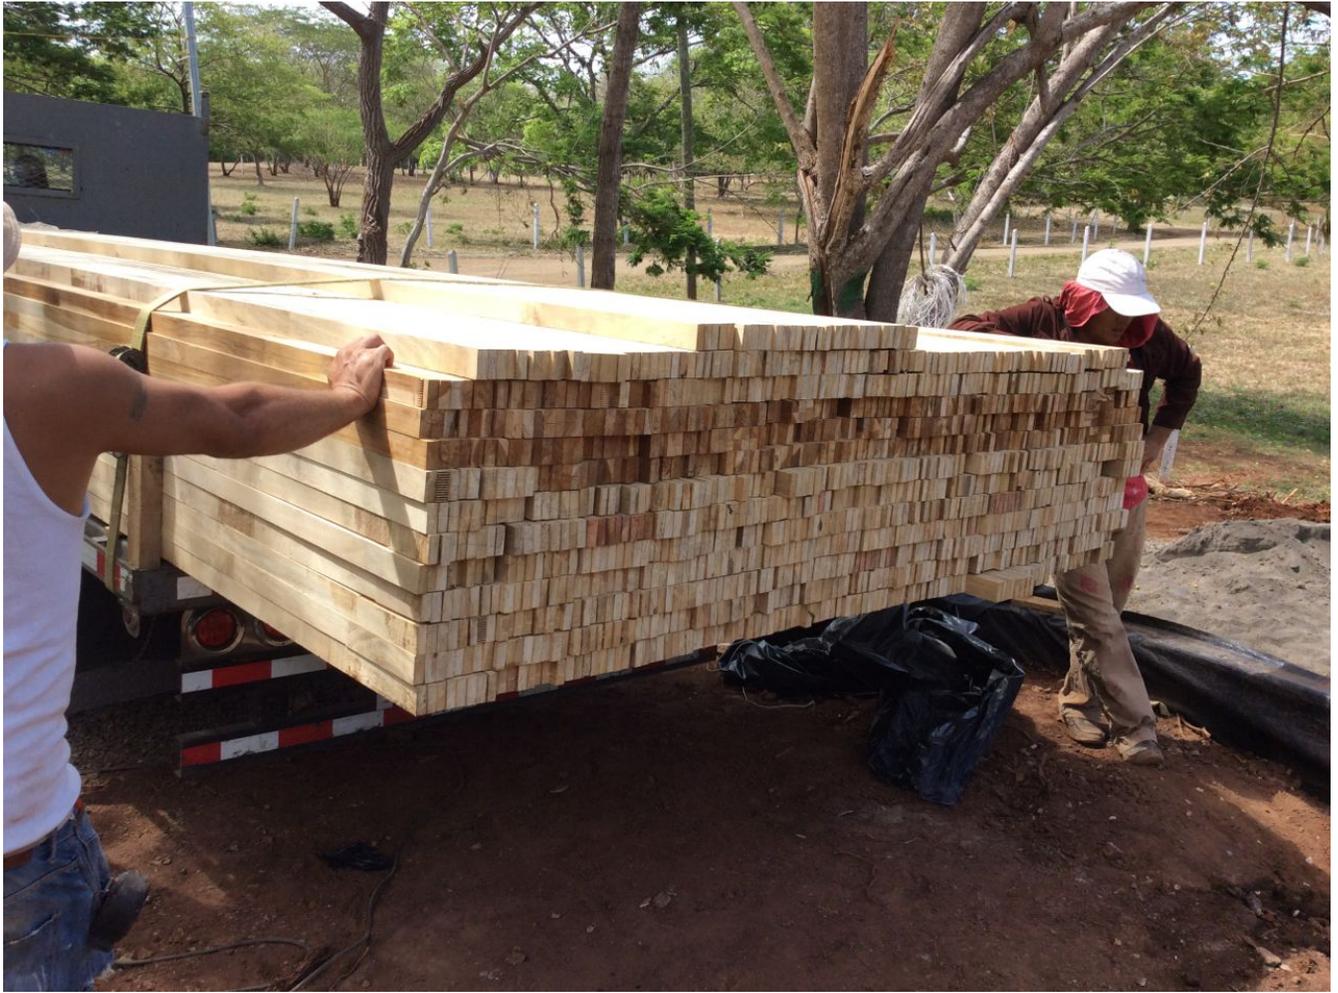
There you go the butt end of a pile of flu-lam beams to make up the floor in structural grade Melina as well as the 2 x 4's that will support on the SIP panels. Also included are the Teak rafters as you will note by the much darker color.

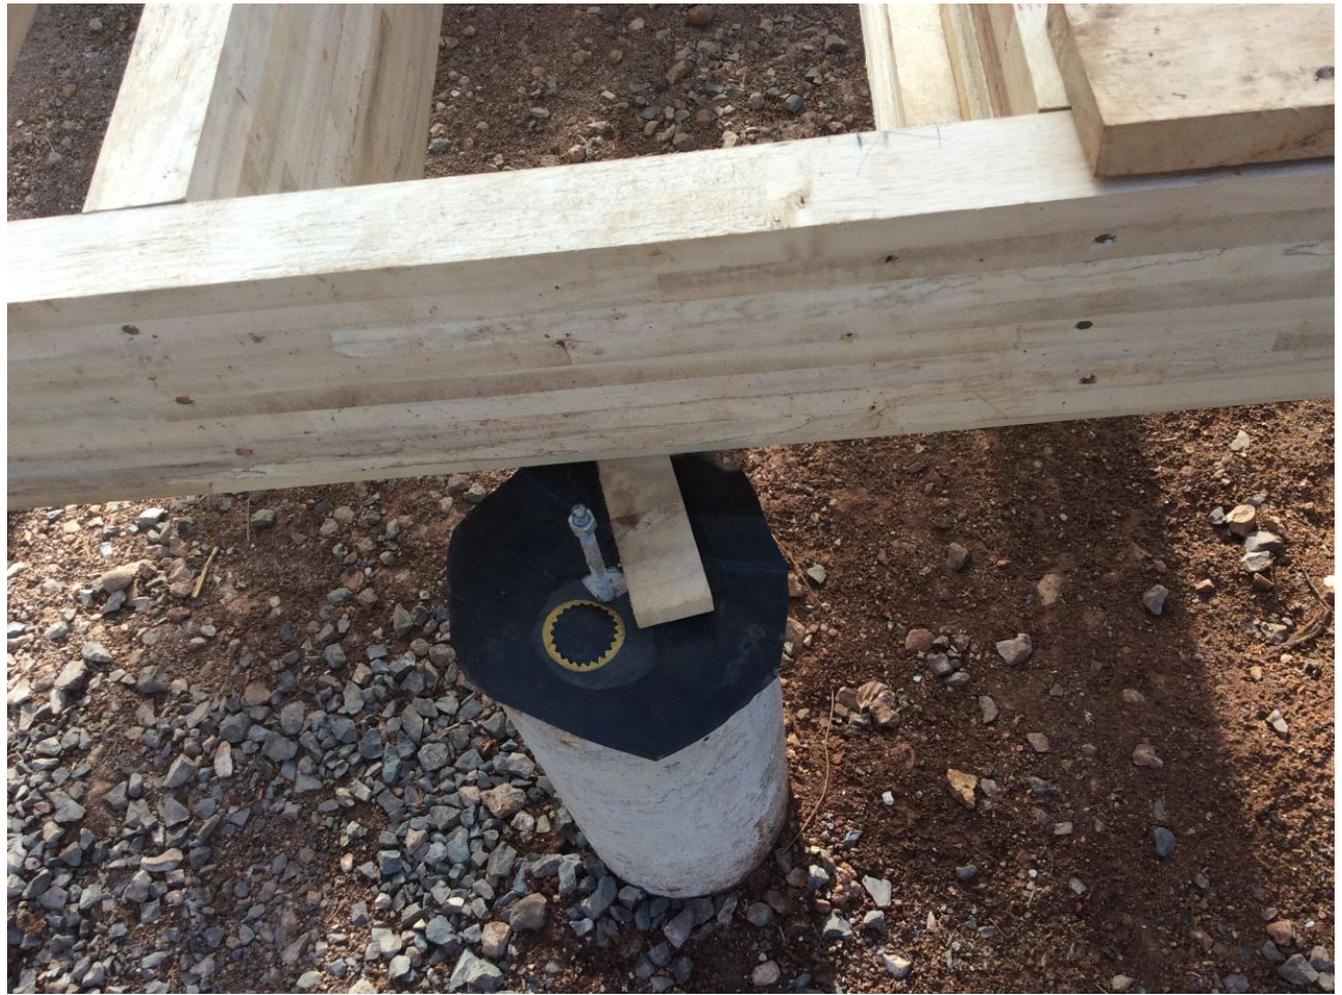
Here is part of our recycling program where we put dead tire tubes to work in protecting our wood from the constant moisture leaching of concrete. Wood and concrete do not play well together so we always keep them separated to prevent that transfer of moisture or wicking as it is referred.

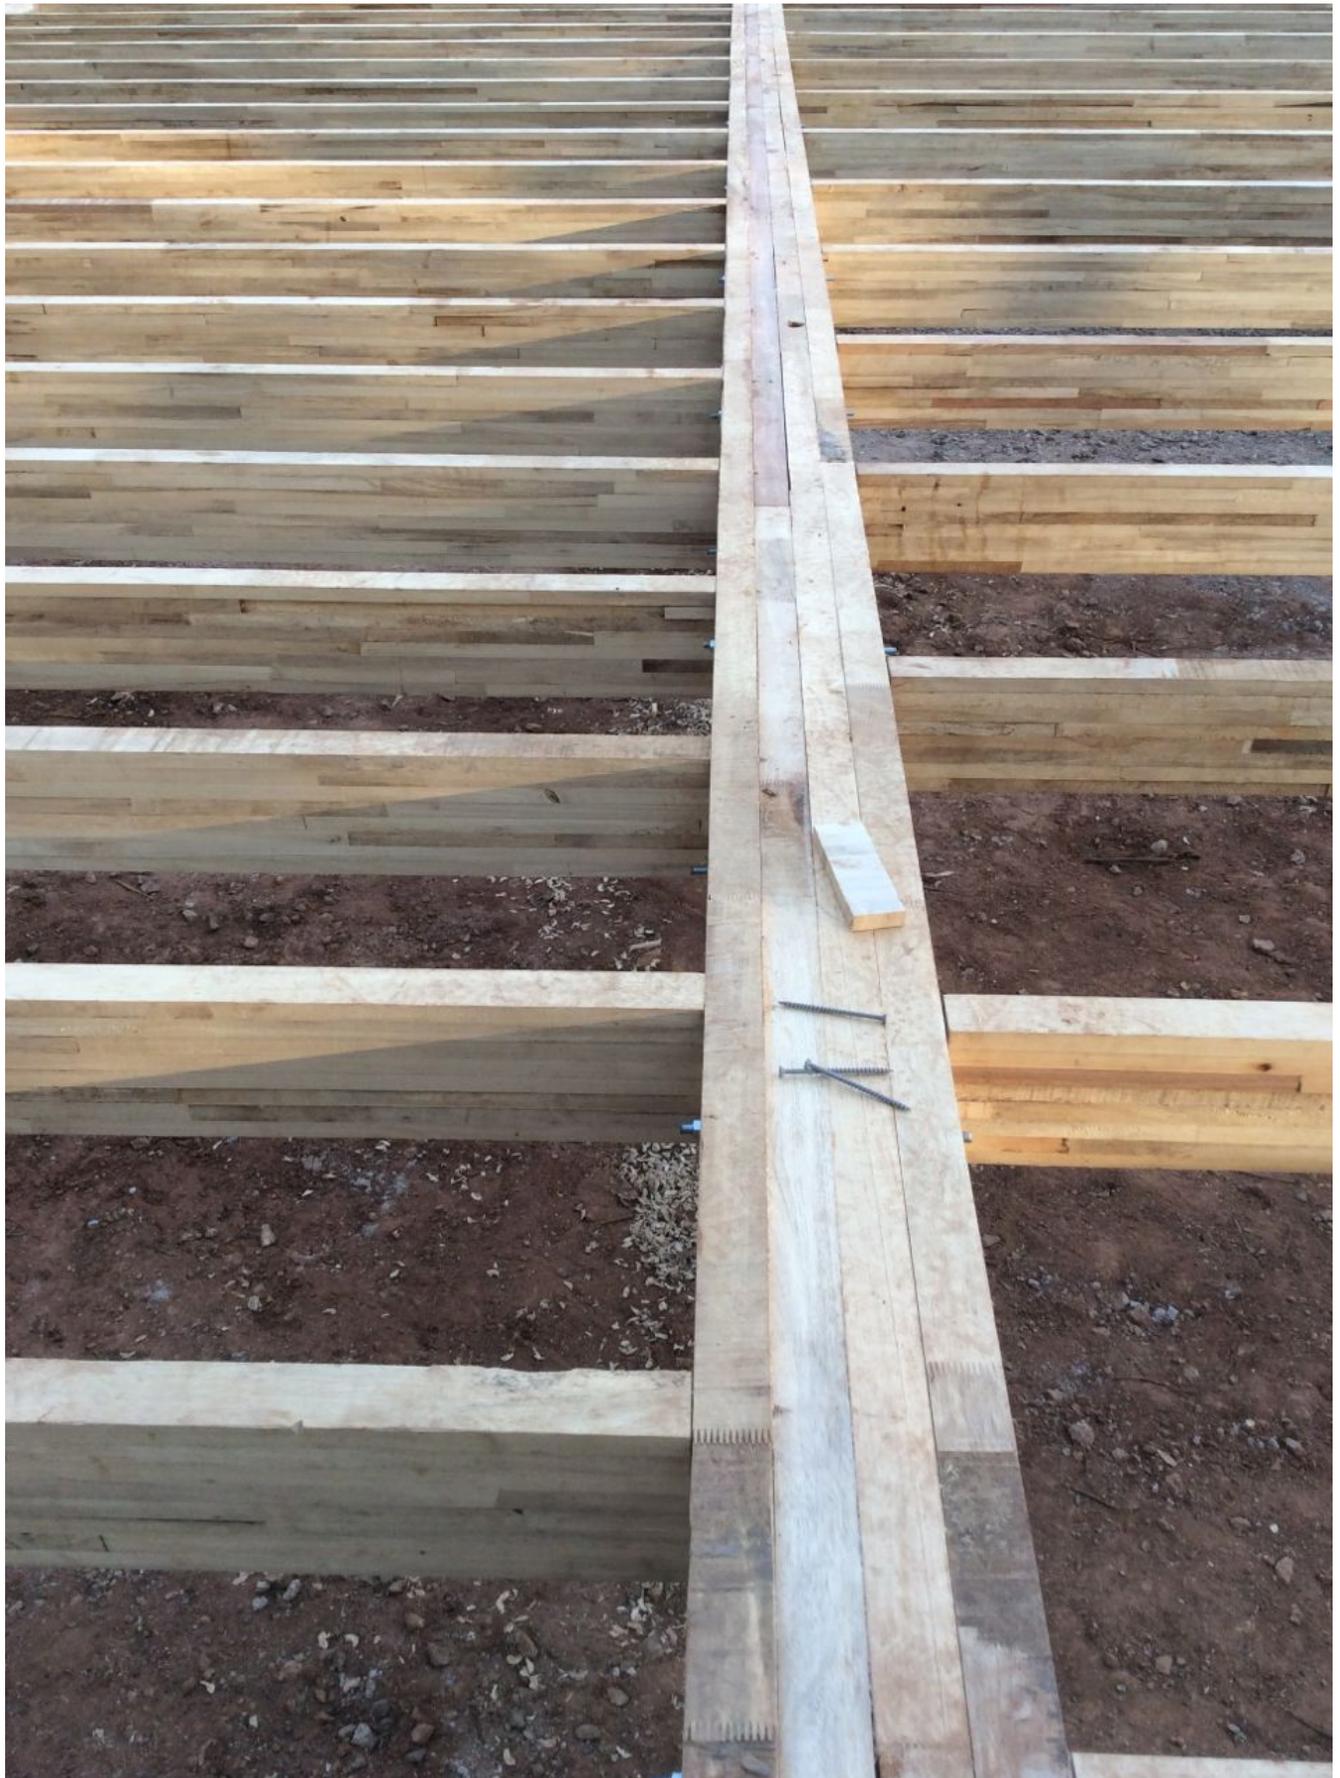
Our deadly straight four ply beam that goes below the wall of the house as it transitions into the screened in deck.
