Techos Siglo XXI – Constructing Your Green Home

Home Diary – Playa Grande

Super Home #3 begins with a BIG MOVE!

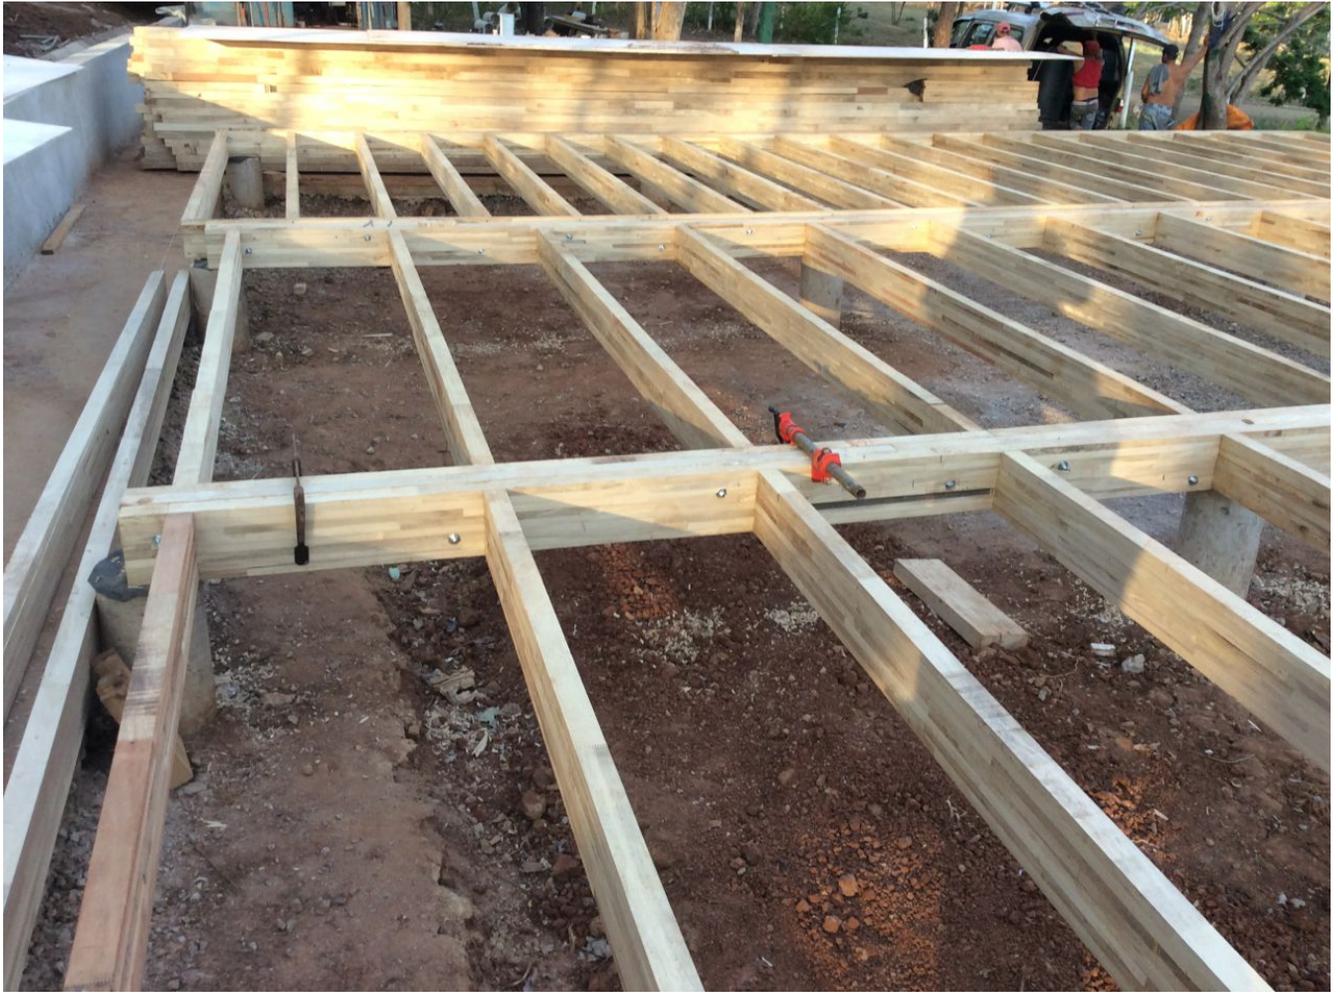
The whole floor system is quickly coming to life. Note the clamps and bolts that hold these built up beams together that are all glued as well to make certain they behave as one solid piece.

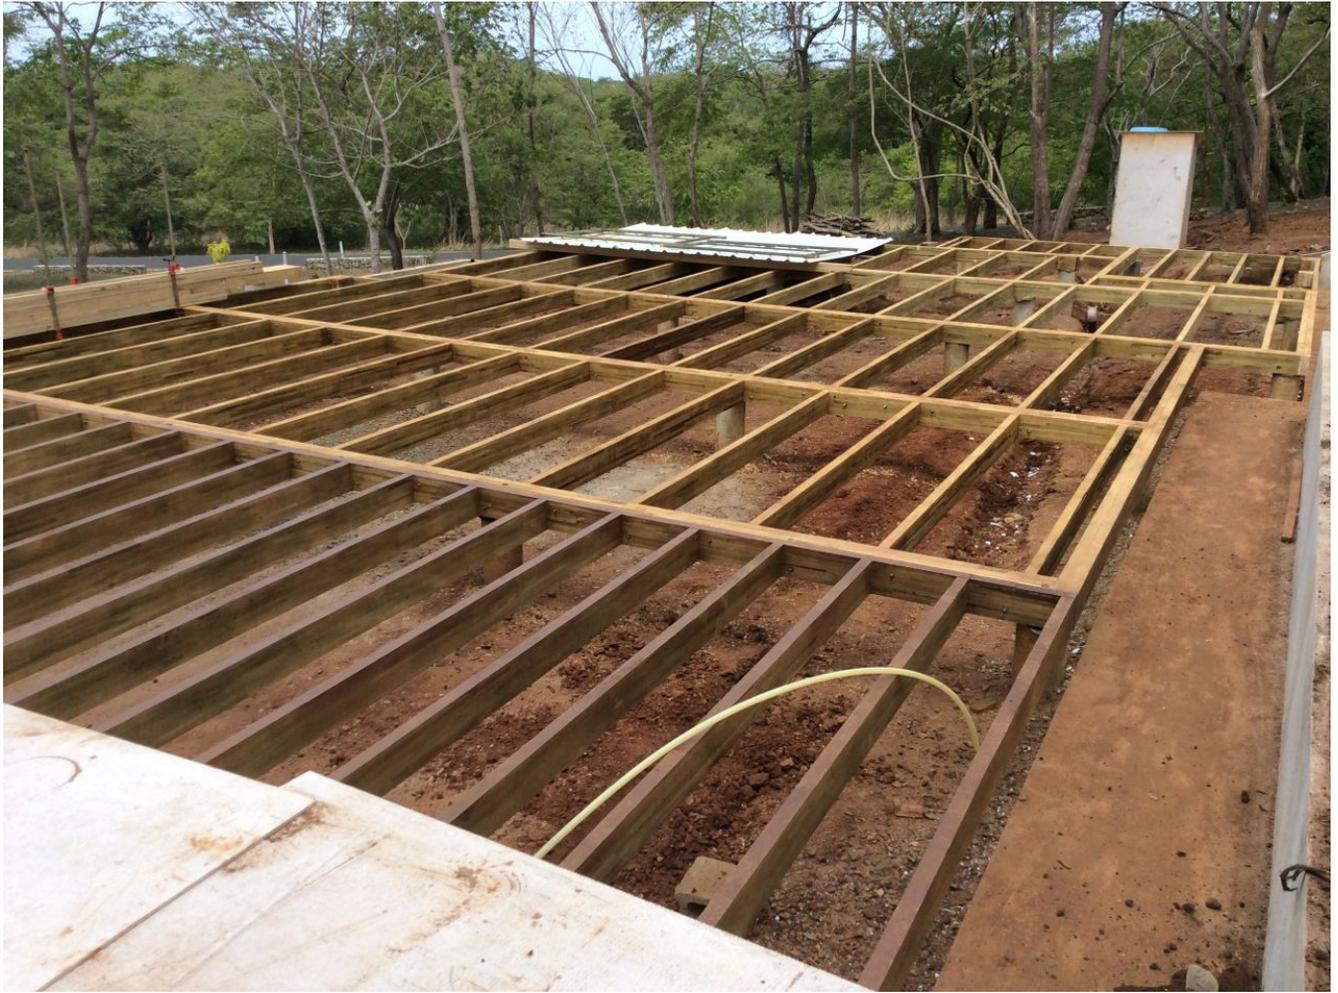
The floor is now complete awaiting sub-floor and decking. Note the oiled joists in the fore ground is the deck hence these needed to be stained to match the eventual Teak decking. As you will see from the no longer white Melina that we have added two layers of preservatives to the wood to stop mold growth, insects as well as to just stop the glu-lams from drying out excessively in the beach heat.

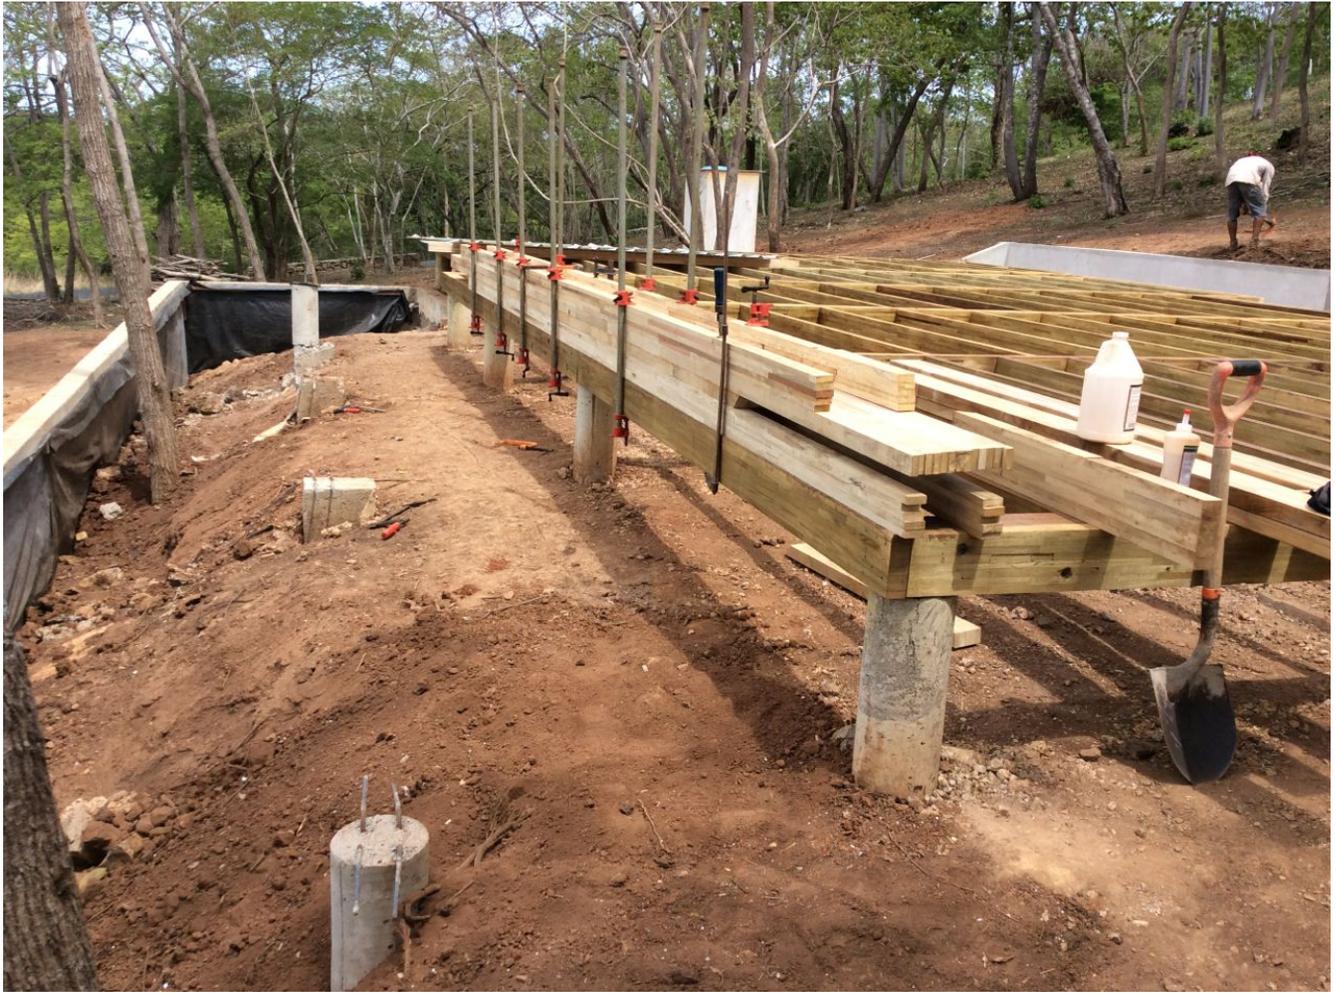
A small error in the sawmill order meant that the main beam of the carport came in two 2 x 10's rather than one 4 x 10 so here we are gluing these two together as well as stretching them out another meter longer to support the eaves of the carport as well.

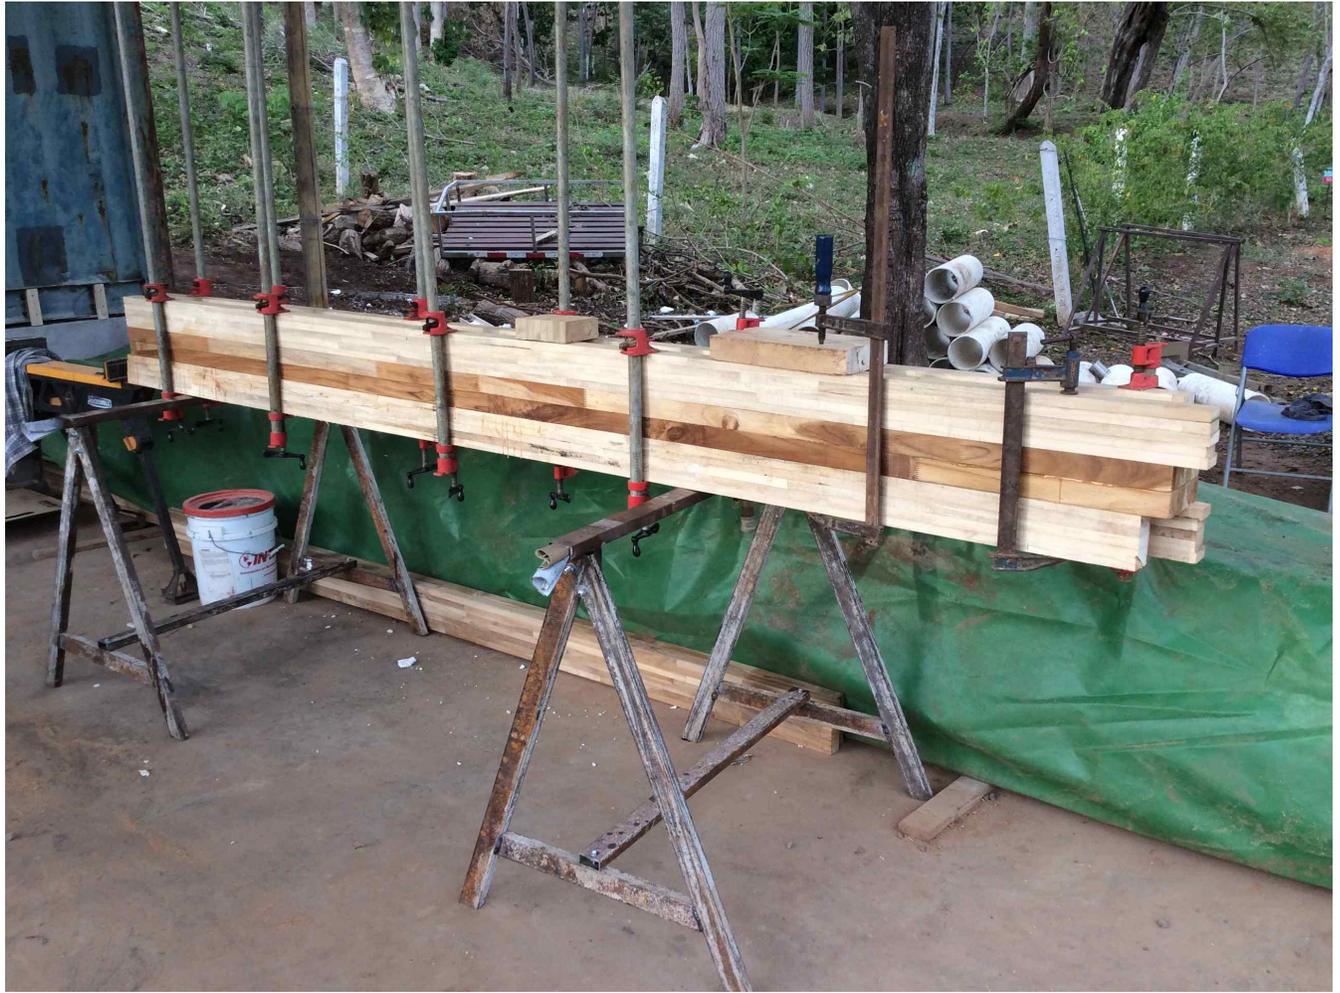
Another error caught well in advance. The original outside architect made a blunder on the roof structure which had a big piece of master deck roof without anywhere near enough support. Here we are laminated some 2 x 6 Teak to make up the post and beam that had been left out. Here you see the strong contrast in colors of natural Teak and the Melina 2 x 4 panel connectors being temporarily put to use as strong backs.

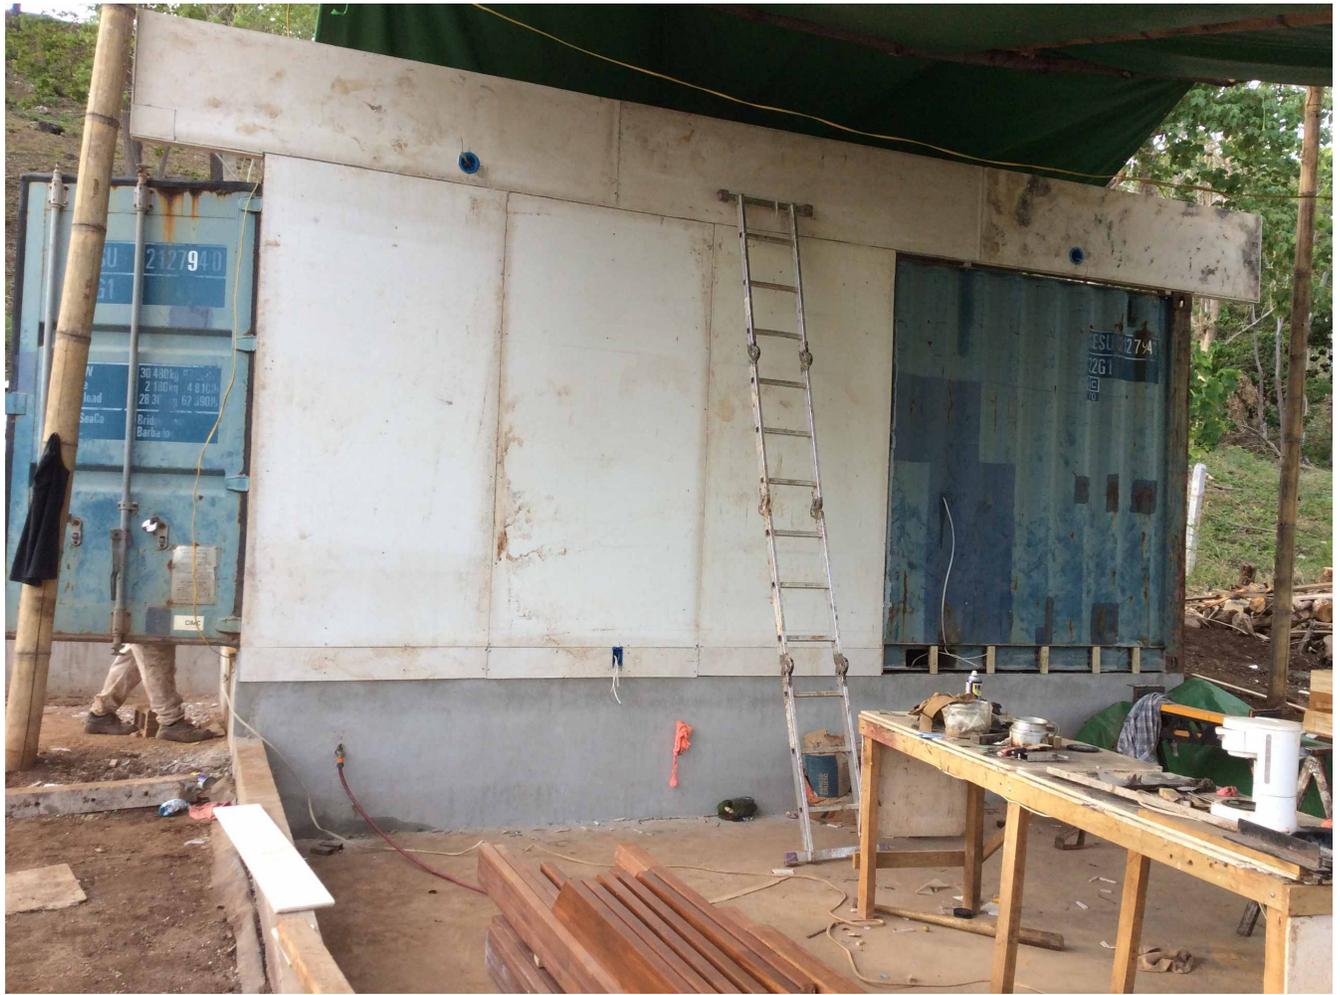
That container look is rapidly loosing out as we sheet it in to make what will be the very tough storage shed and carport roof structure. This roof is designed to coordinate with the same style of the roof on the house. You can see here where I have built a support beam out of SIP panels to extend the support out 2 feet on each side of the shed for the extended eaves to provide rain protection. Also note in the foreground the first rafters nearing completion of their furniture finish.

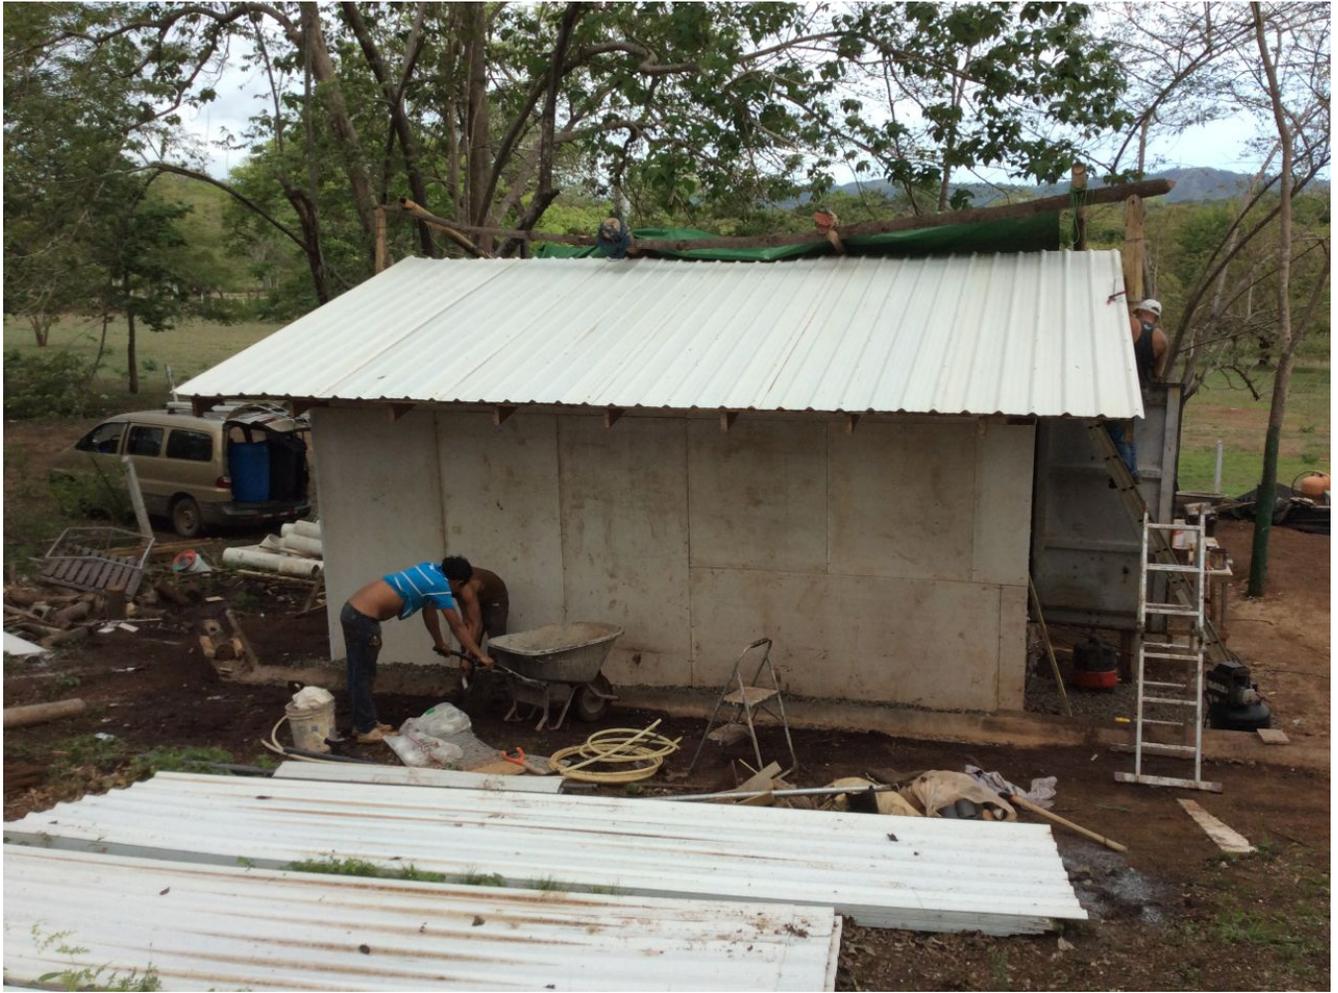
The roof is near to complete. This is our first PVC laminated roofing we have used, the product is from Japan and has been used extensively in the Central Valley over the past six years especially in commercial buildings. White is the only stocked color but red and green are available by special order. The product is very tough and due to its color and lamination it is a pretty good insulator which is very critical in this location. Not to mention it will not rust which is highly critical we are less than 2 kms to the beach. Comes in very large sheets so that reduces the number of joints as well. In this case it cost for this house about \$1,000 more than tin but I would call that an incredible bargain especially when it is raining hard and they won't have the constant drumming in the ears to tolerate. Also makes for a massively cooler roof than any metal could ever hope to be. Also workers can actually walk on the roof without it caving in under them which is a serious consideration as it is always only a matter of time before someone is up there to service something.

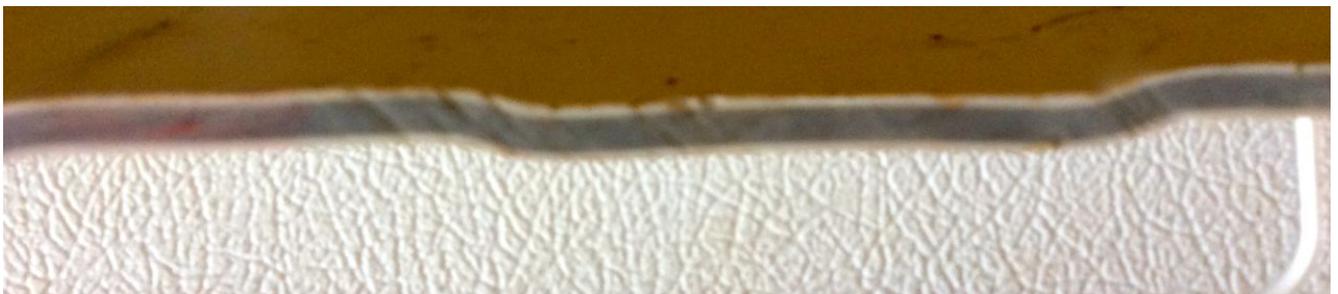
This is what the laminations of this product look like with the polymer carbon fiber core sandwiched between two layers of UPVC.

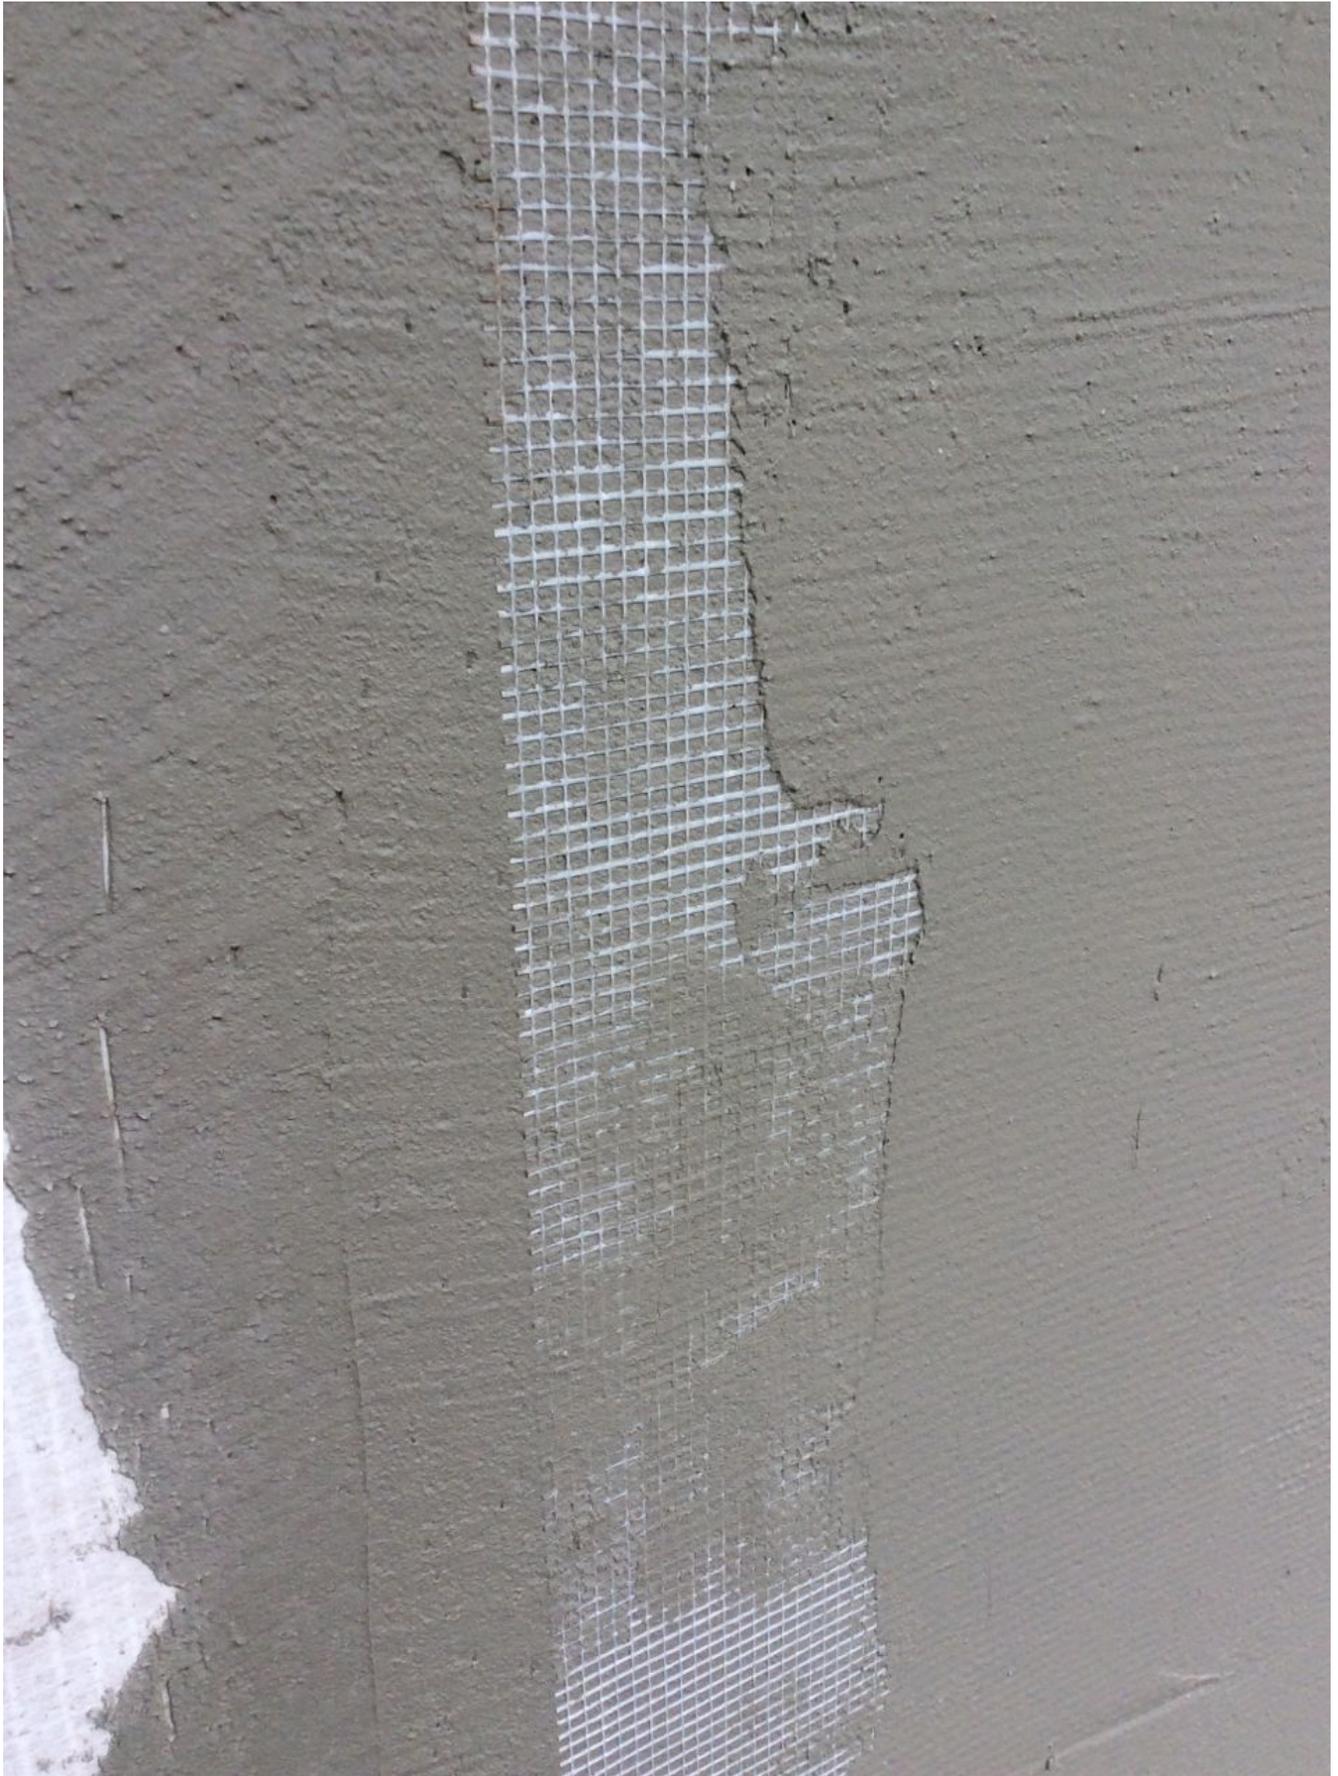
First coat of stucco is started on the storage shed and here we see the heavy fiberglass mesh being embedded into the stucco to make it behave as one solid membrane protecting the building from rain. Later on this will have an acrylic stucco put on top of it as the final color coat.

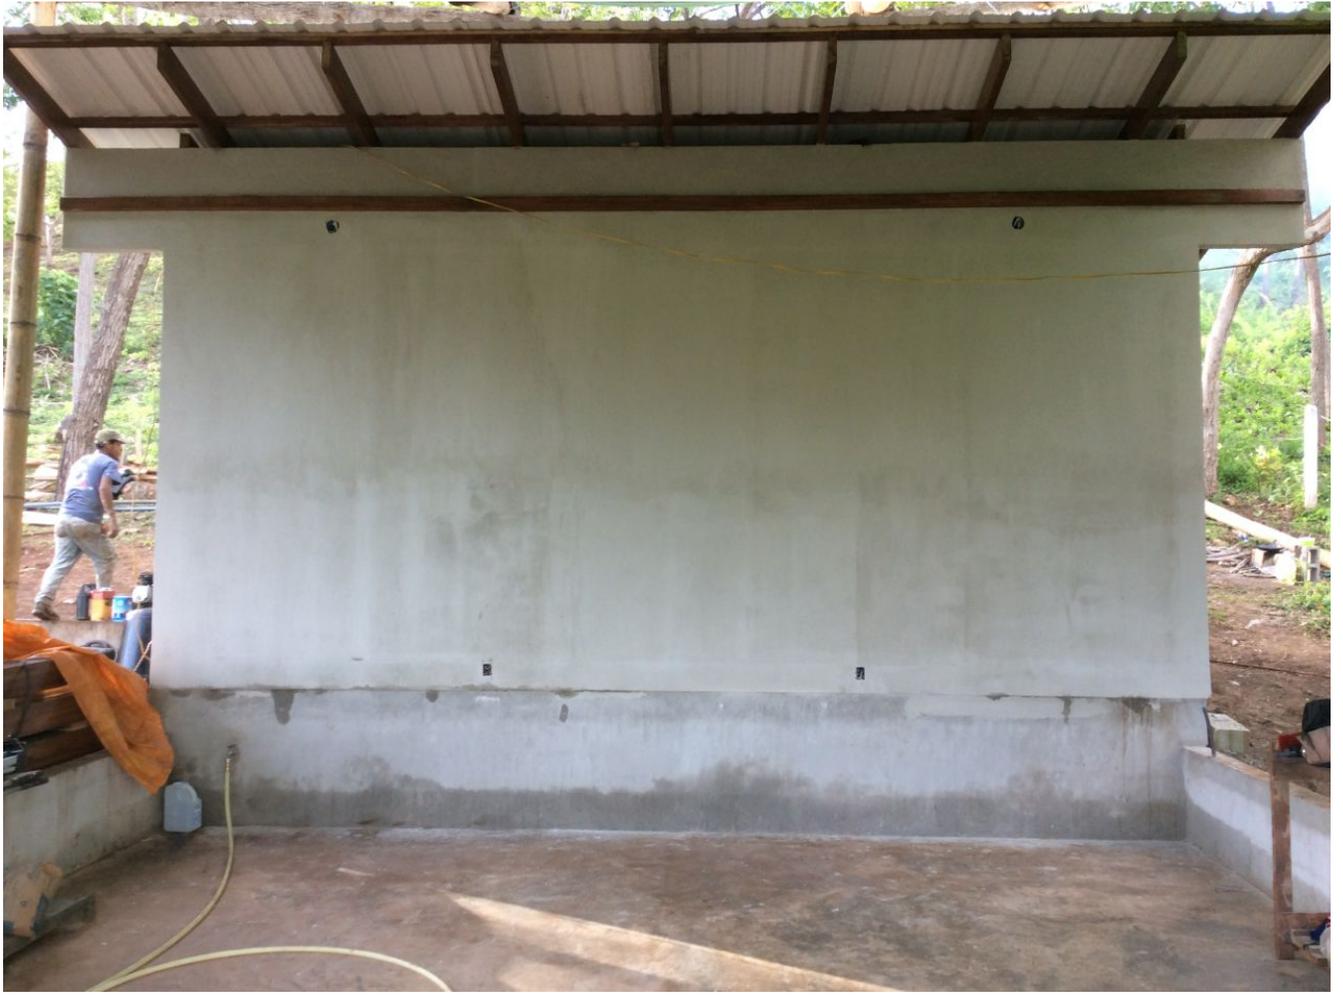
View from the carport of completed wall which is 8mm MgO board riveted to the old container.

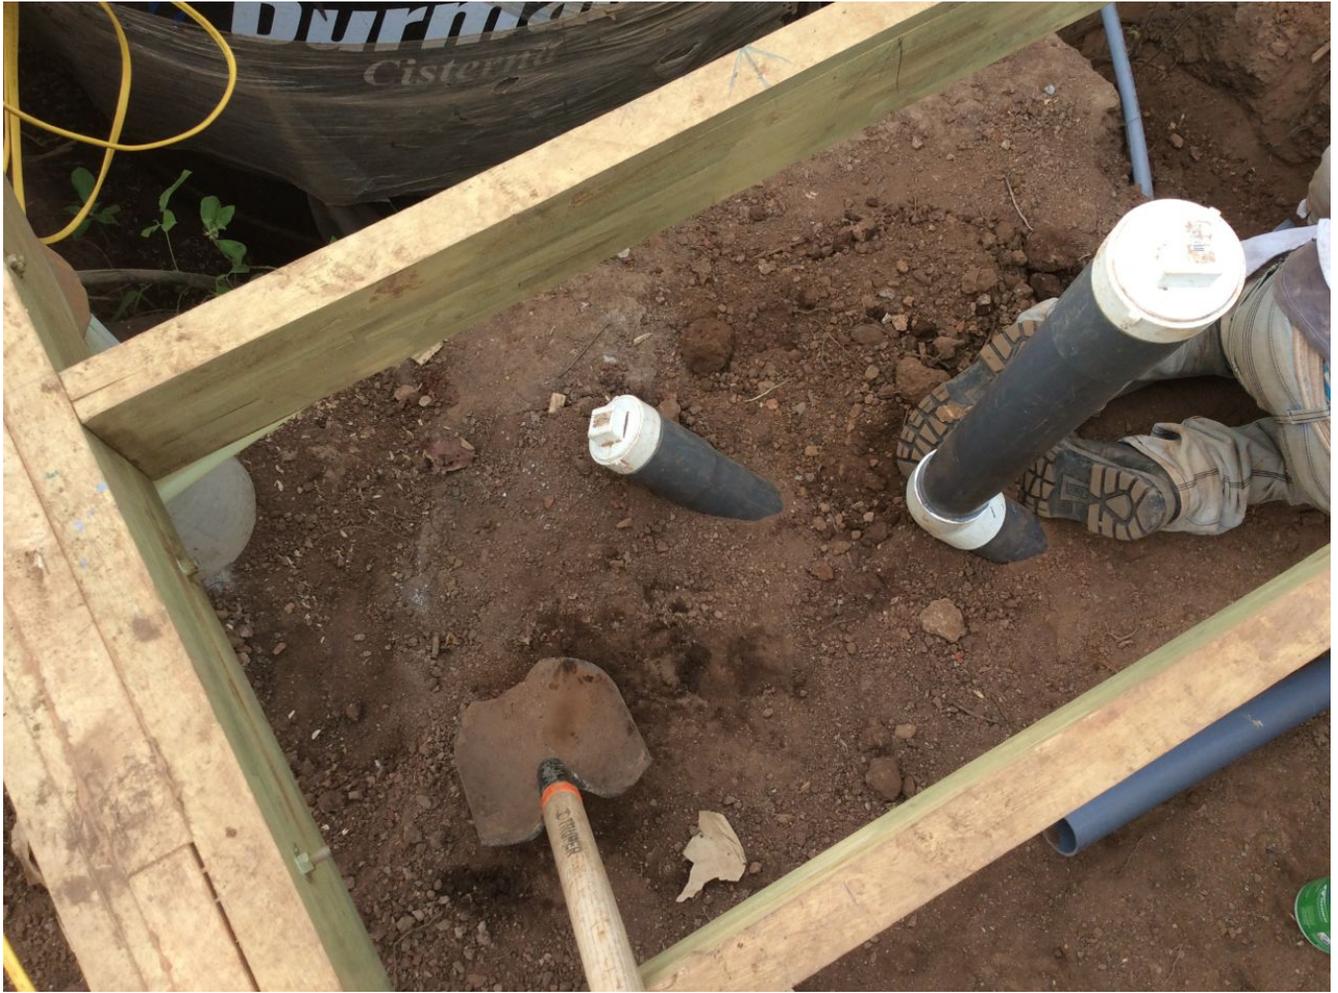
Toilet line with take note a clean-out there if and when needed.

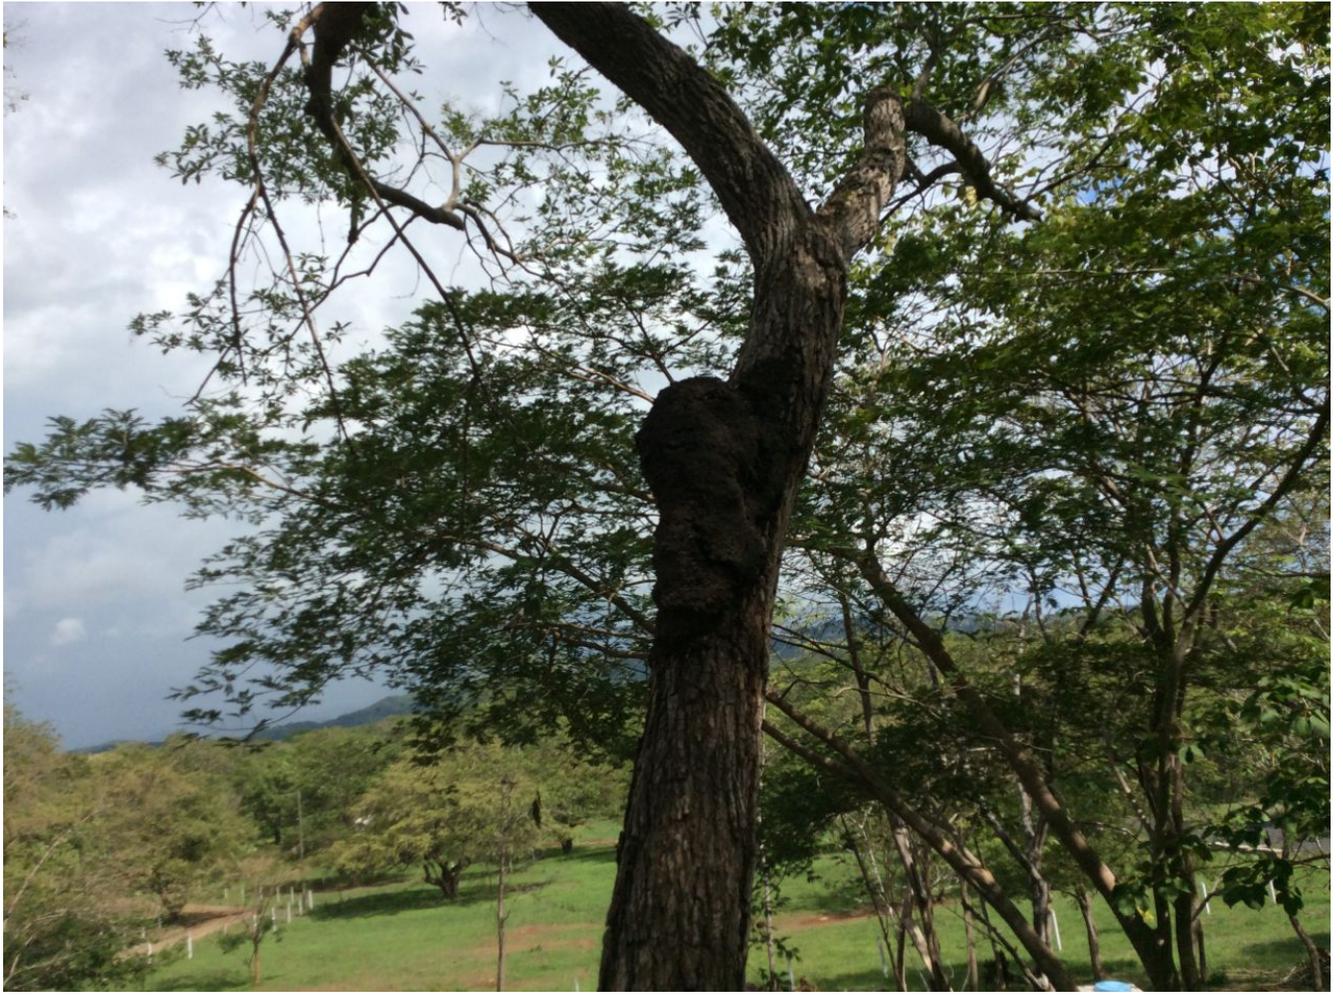
This is a termite nest not more than 40 feet from the dead Melina.

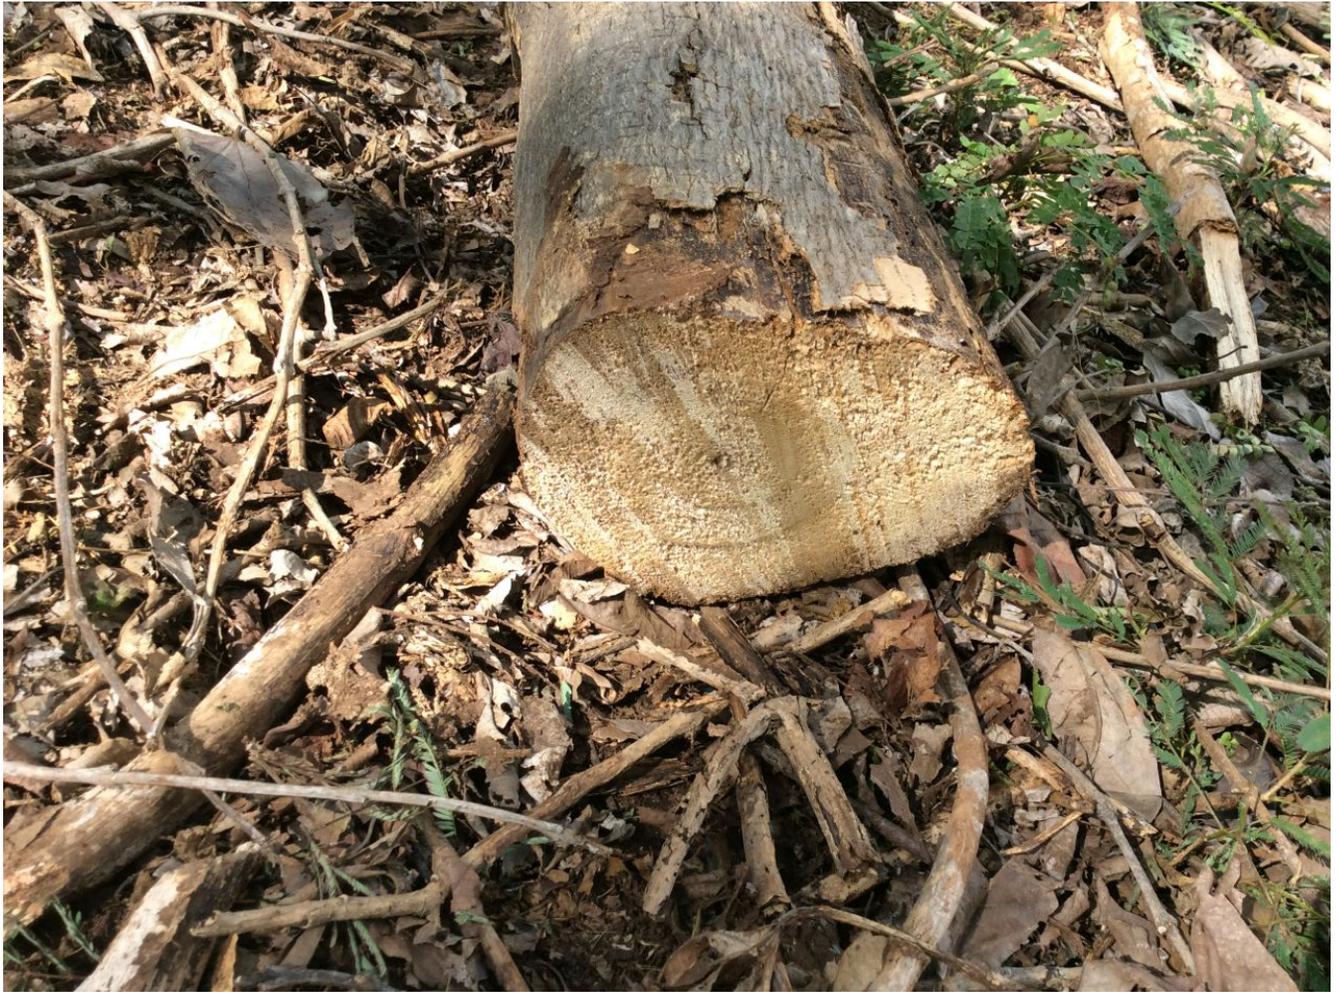
Higher up this part of the trunk also shows a similarly unaffected by insects character in this nice dry Melina wood. What more evidence could we have than this to prove that bugs do not especially like eating Melina. Anyone else's opinion is of little relevance when we see empirical proof like this showing what this formidable enemy has to say on the subject.

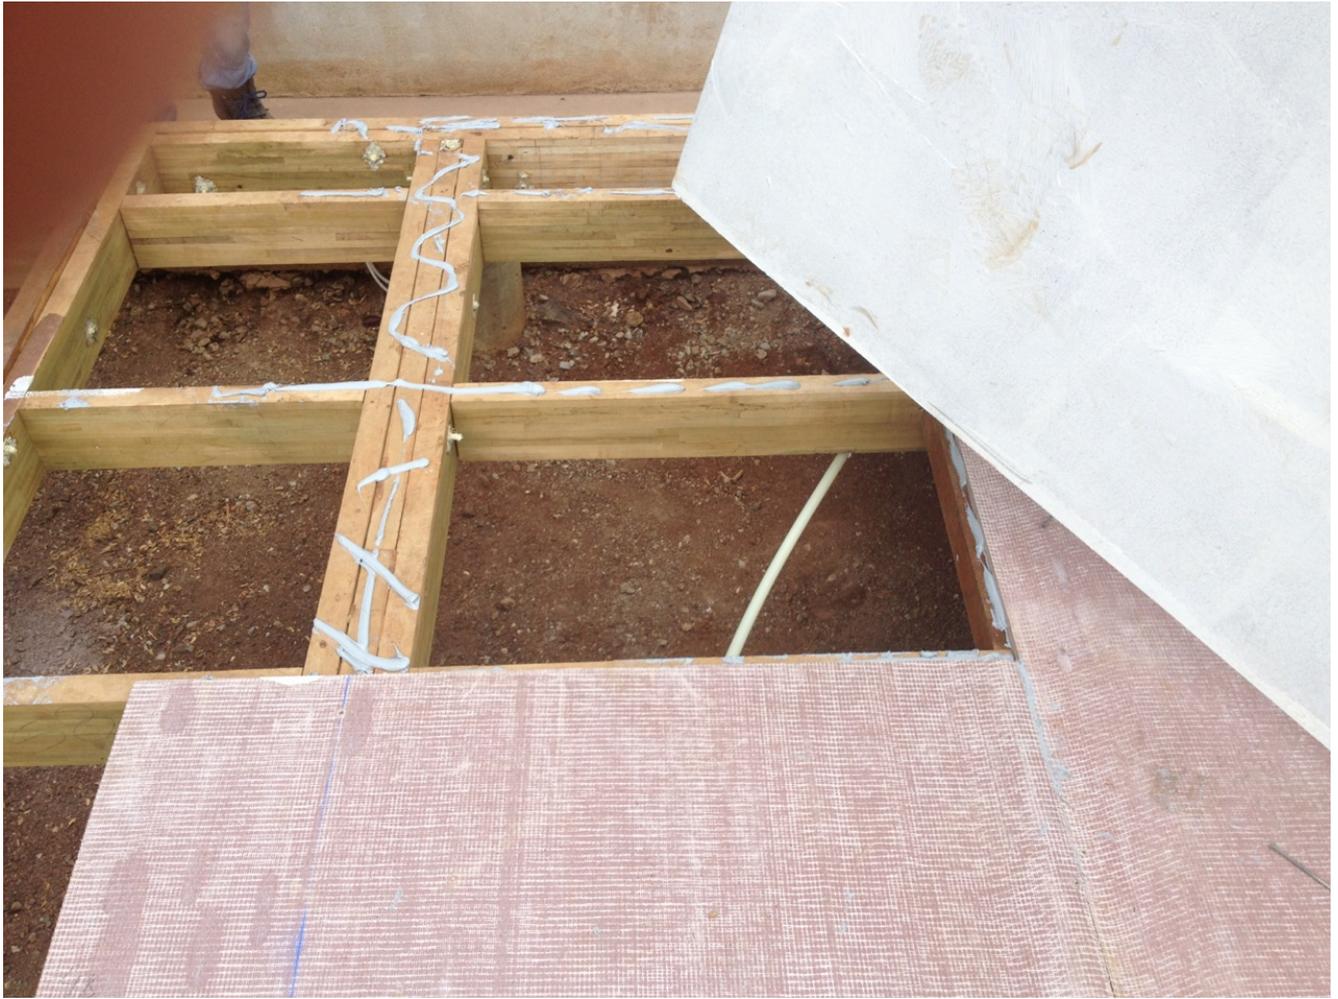
Down goes our first shipment of the latest Rescom MgO flooring. A massive improvement over the old as it is much harder, way more fiber and mesh weave in it hence way less flex than any competing sub-flooring product on the market like cement board (YUCK) or plywoods (termite food). Take note all joints glued down with Manisbond.

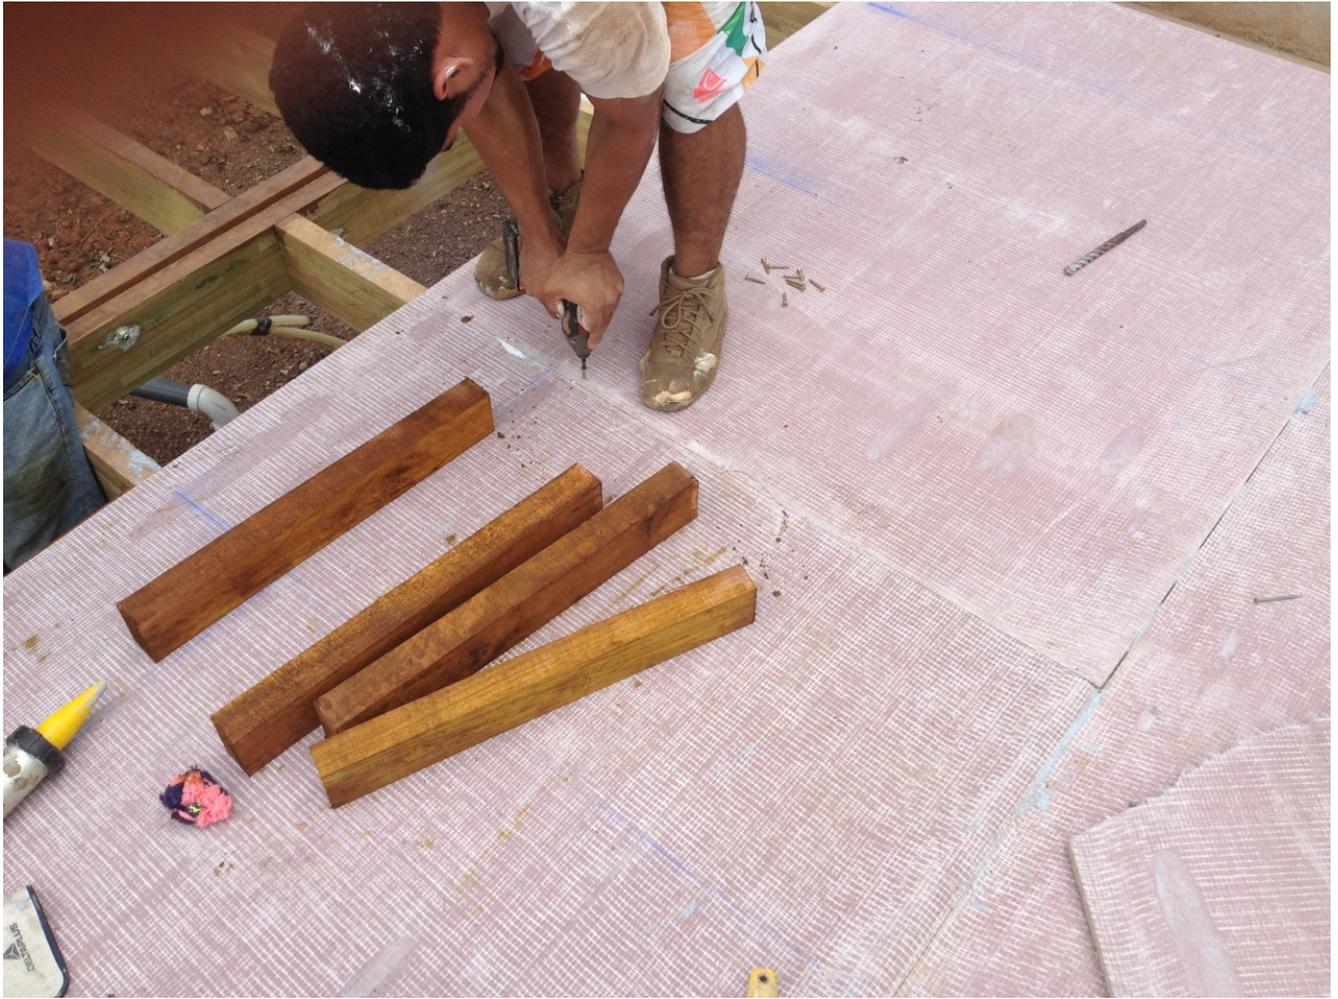
Here we are screwing down the sub-floor so as to get a good compression on the glue. The bridging blocks waiting for the next step in the process.

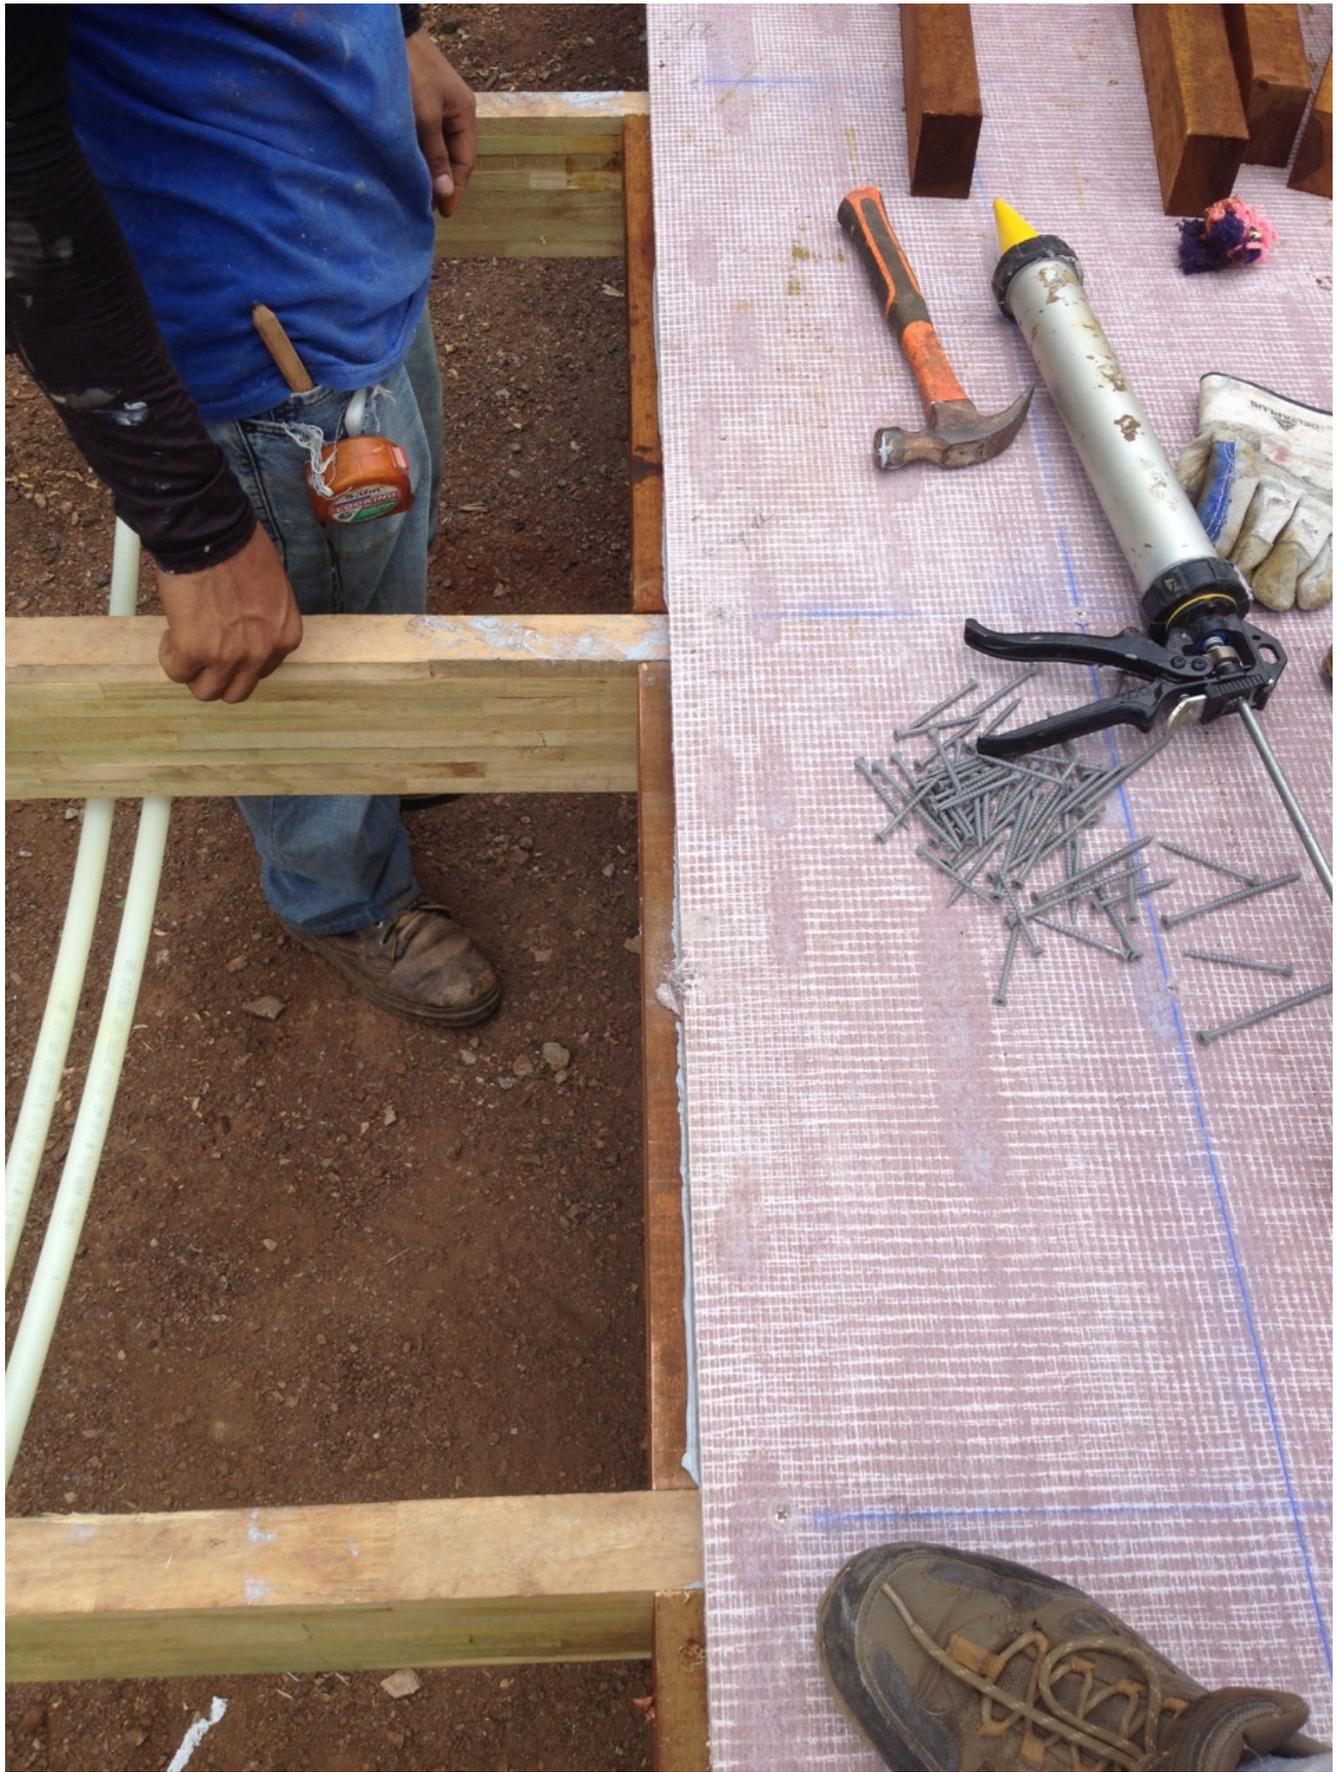
Okay now the bridging blocks screwed between joists and glued and screwed in place. This of course eliminates any flex between sheets as well as adding to the overall rigidity of the floor structure.
