Techos Siglo XXI – Constructing Your Green Home

Home Diary – Playa Grande

Super Home #3 begins with a BIG MOVE!

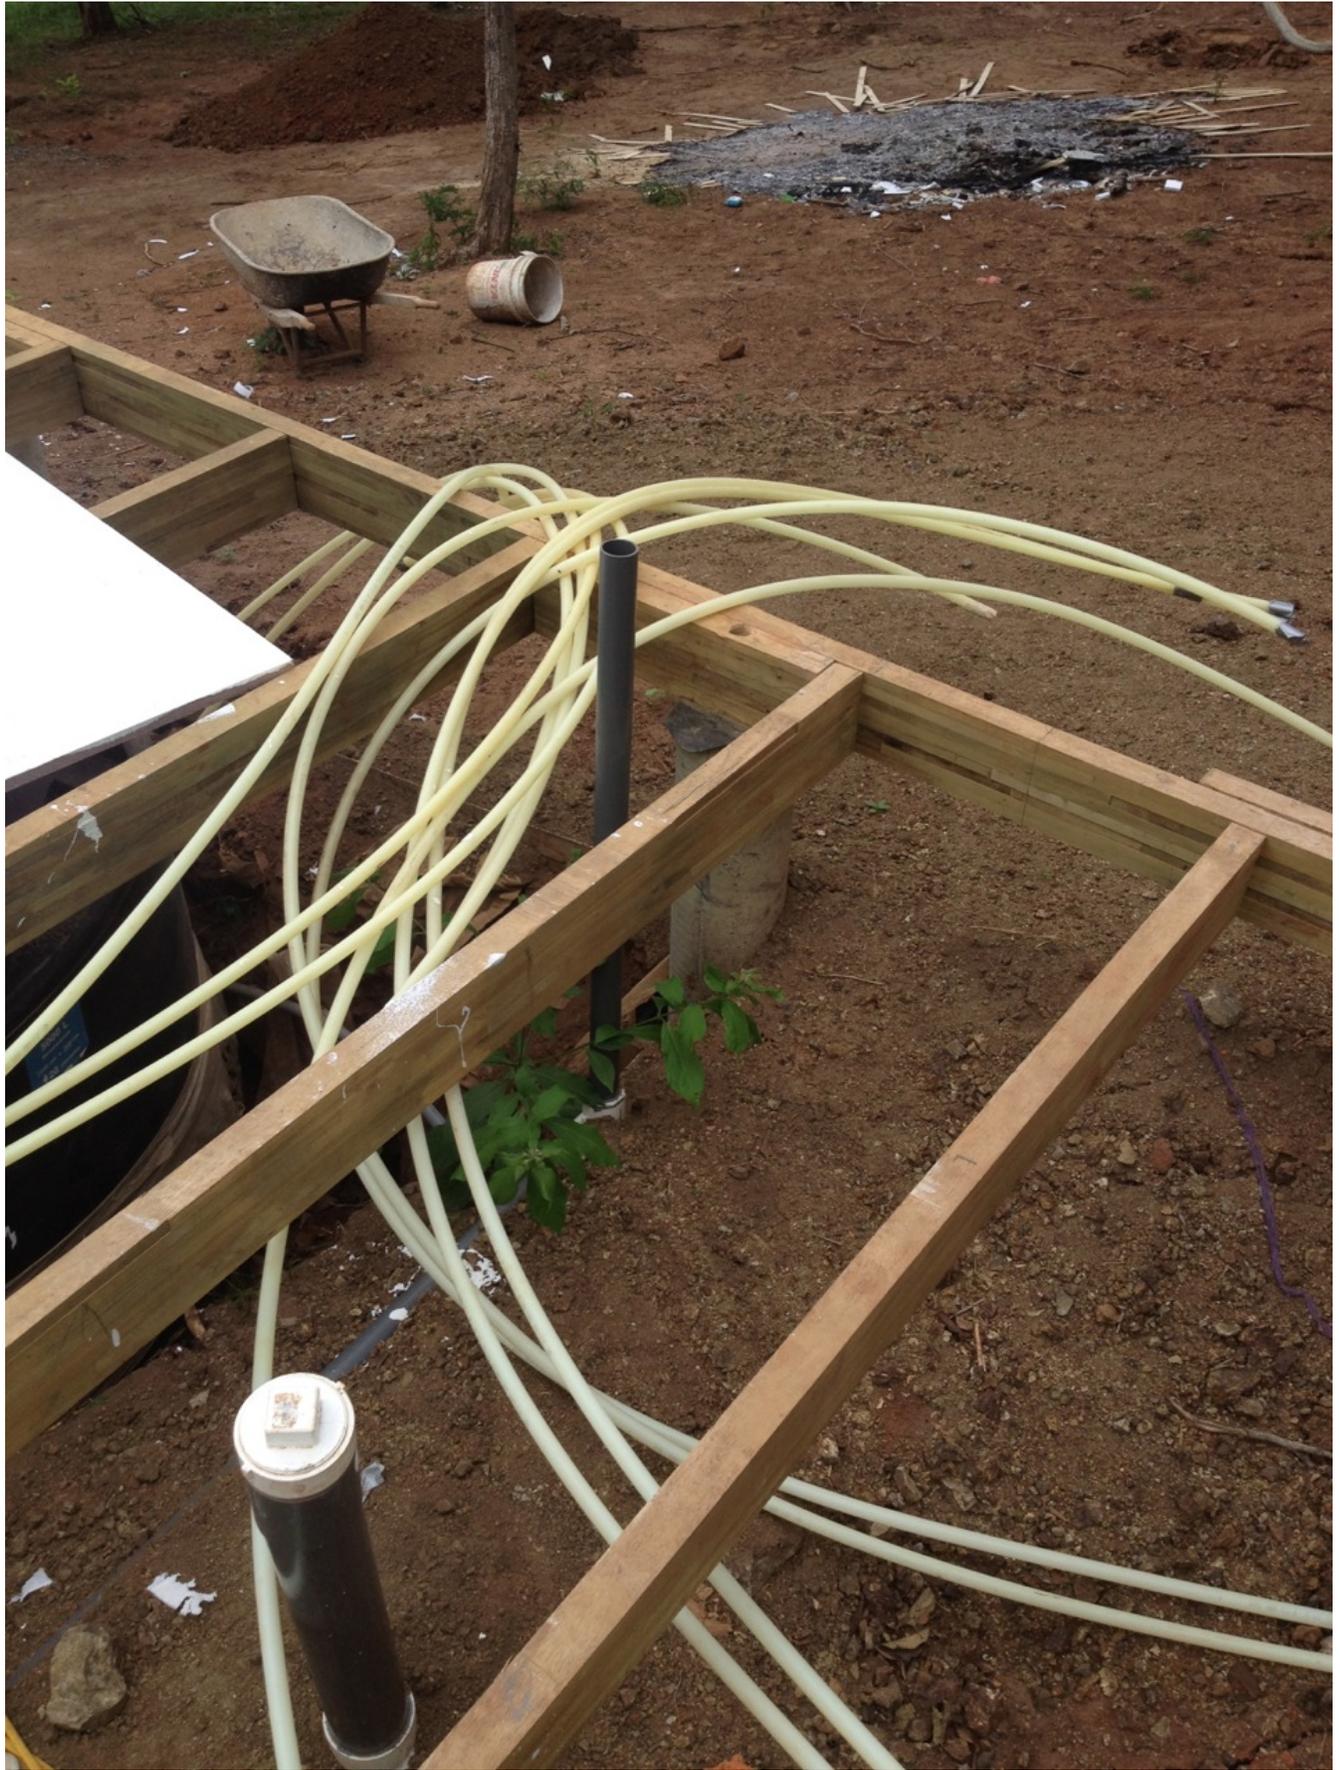
Here we have all the PEX water lines converging in the utility room area where they will connect to the manifolds.

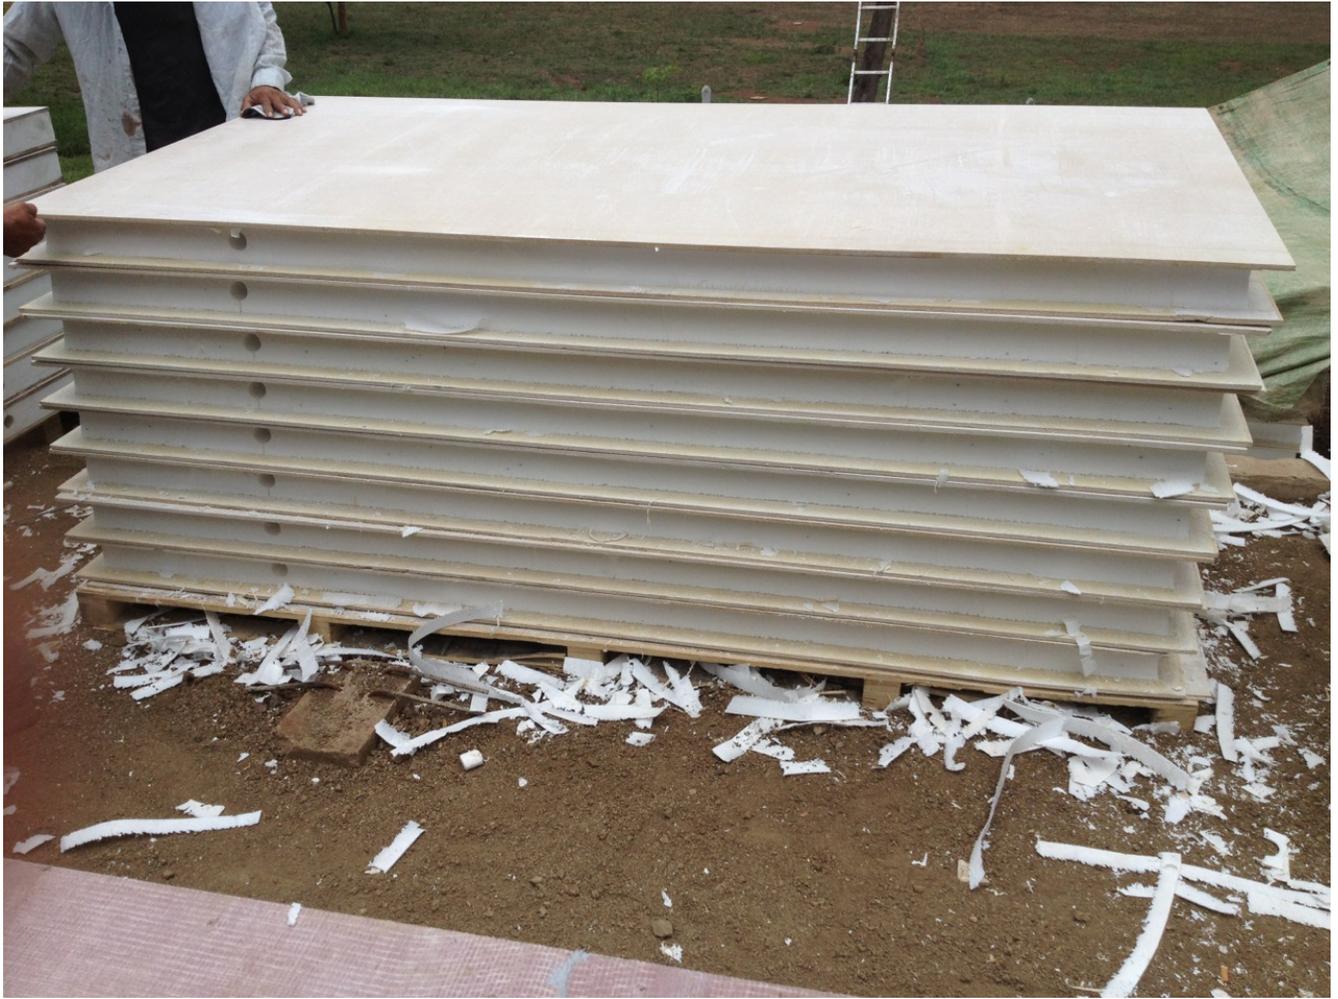
As tack of panels that have been processed using a hot knife to remove the styrofoam where the plates will be inserted at both the floor and top of wall. Note the channels cut in the styrofoam to accommodate electrical runs.

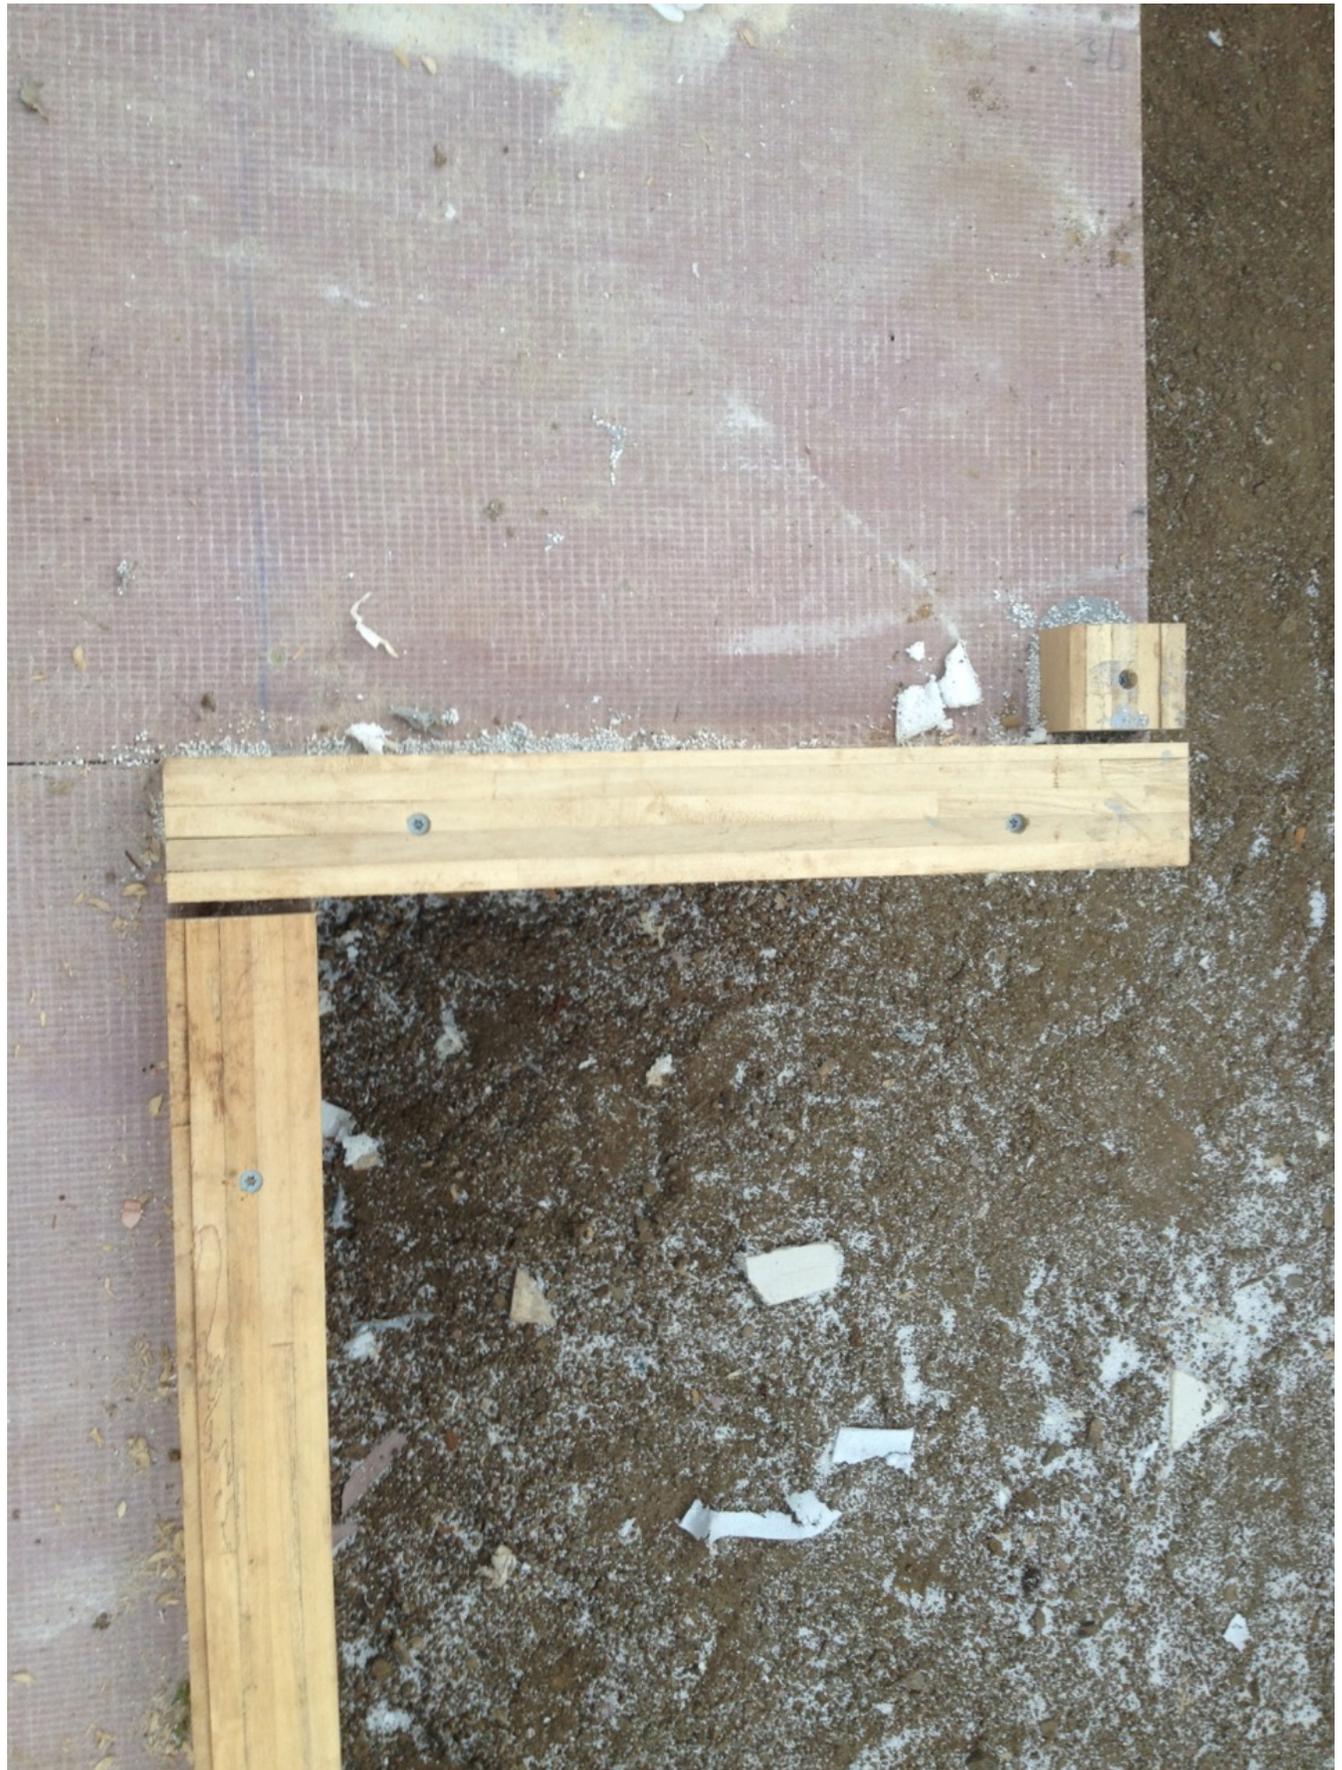
Next the tracks or plates if you prefer are laid out on the floor establishing all the wall lines. Take note these are screwed down with beefy #14 screws and of course as always glued down with Manisbond. Technically our homes stay together as a result of this glue and sealer and we could remove all the

screws and staples the next day and have no affect upon the structural integrity. Also when all components are glued together there is no pressure points created during the stress of an earthquake such as would be the case when only using screws since each screw then becomes a pressure point that could cause fracturing of panel skins. In essence the whole body of the home behaves like the unibody on your car hence will move and flex together during a time of stress.

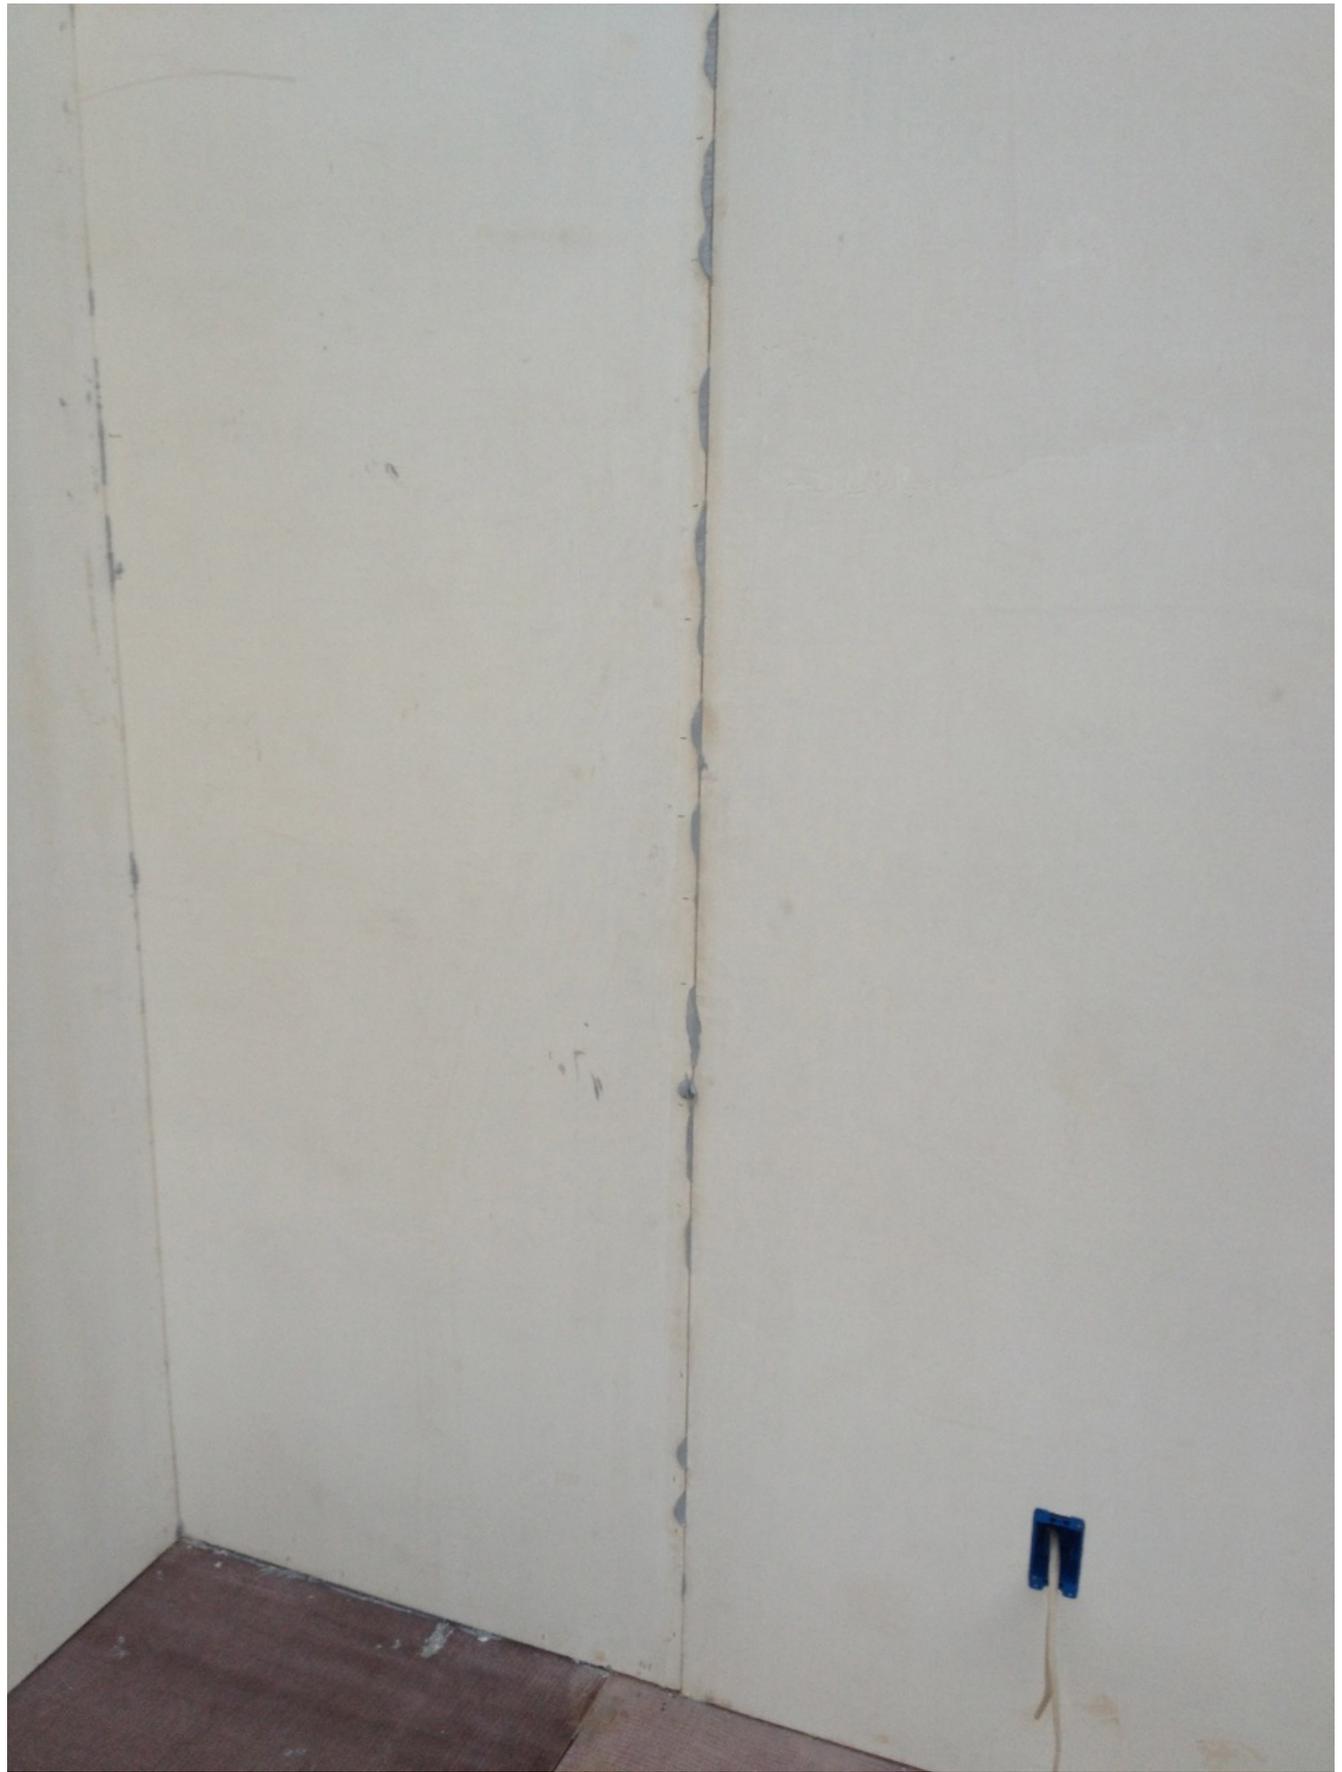
Note the glue oozing out of the joint between panels as once again absolutely everything is glued together so that Ian and Corynne's home will be most capable of dancing the next time the ground decides to do a little dance.

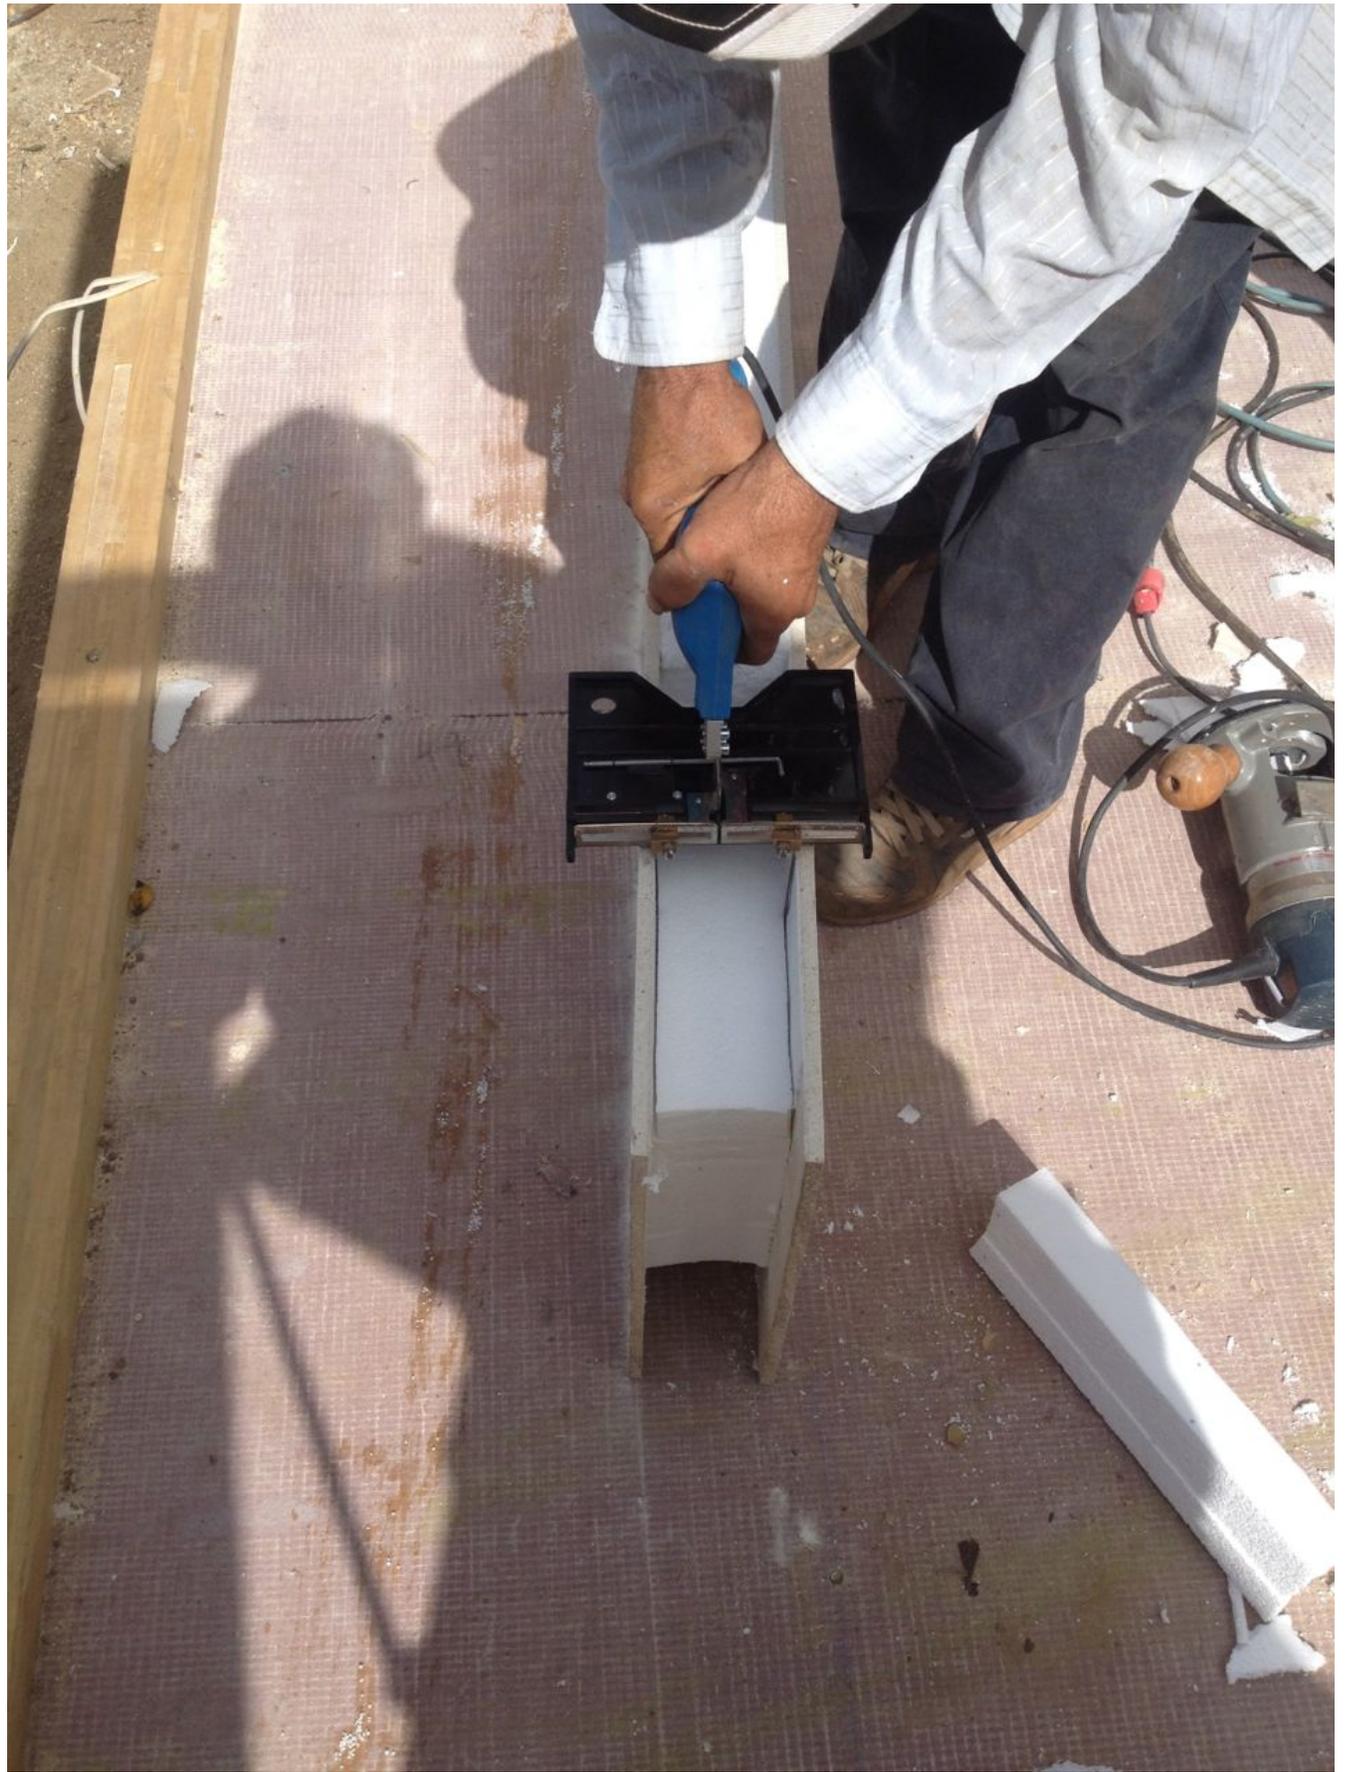
Cutting of a stud track out of a panel with the hot knife.

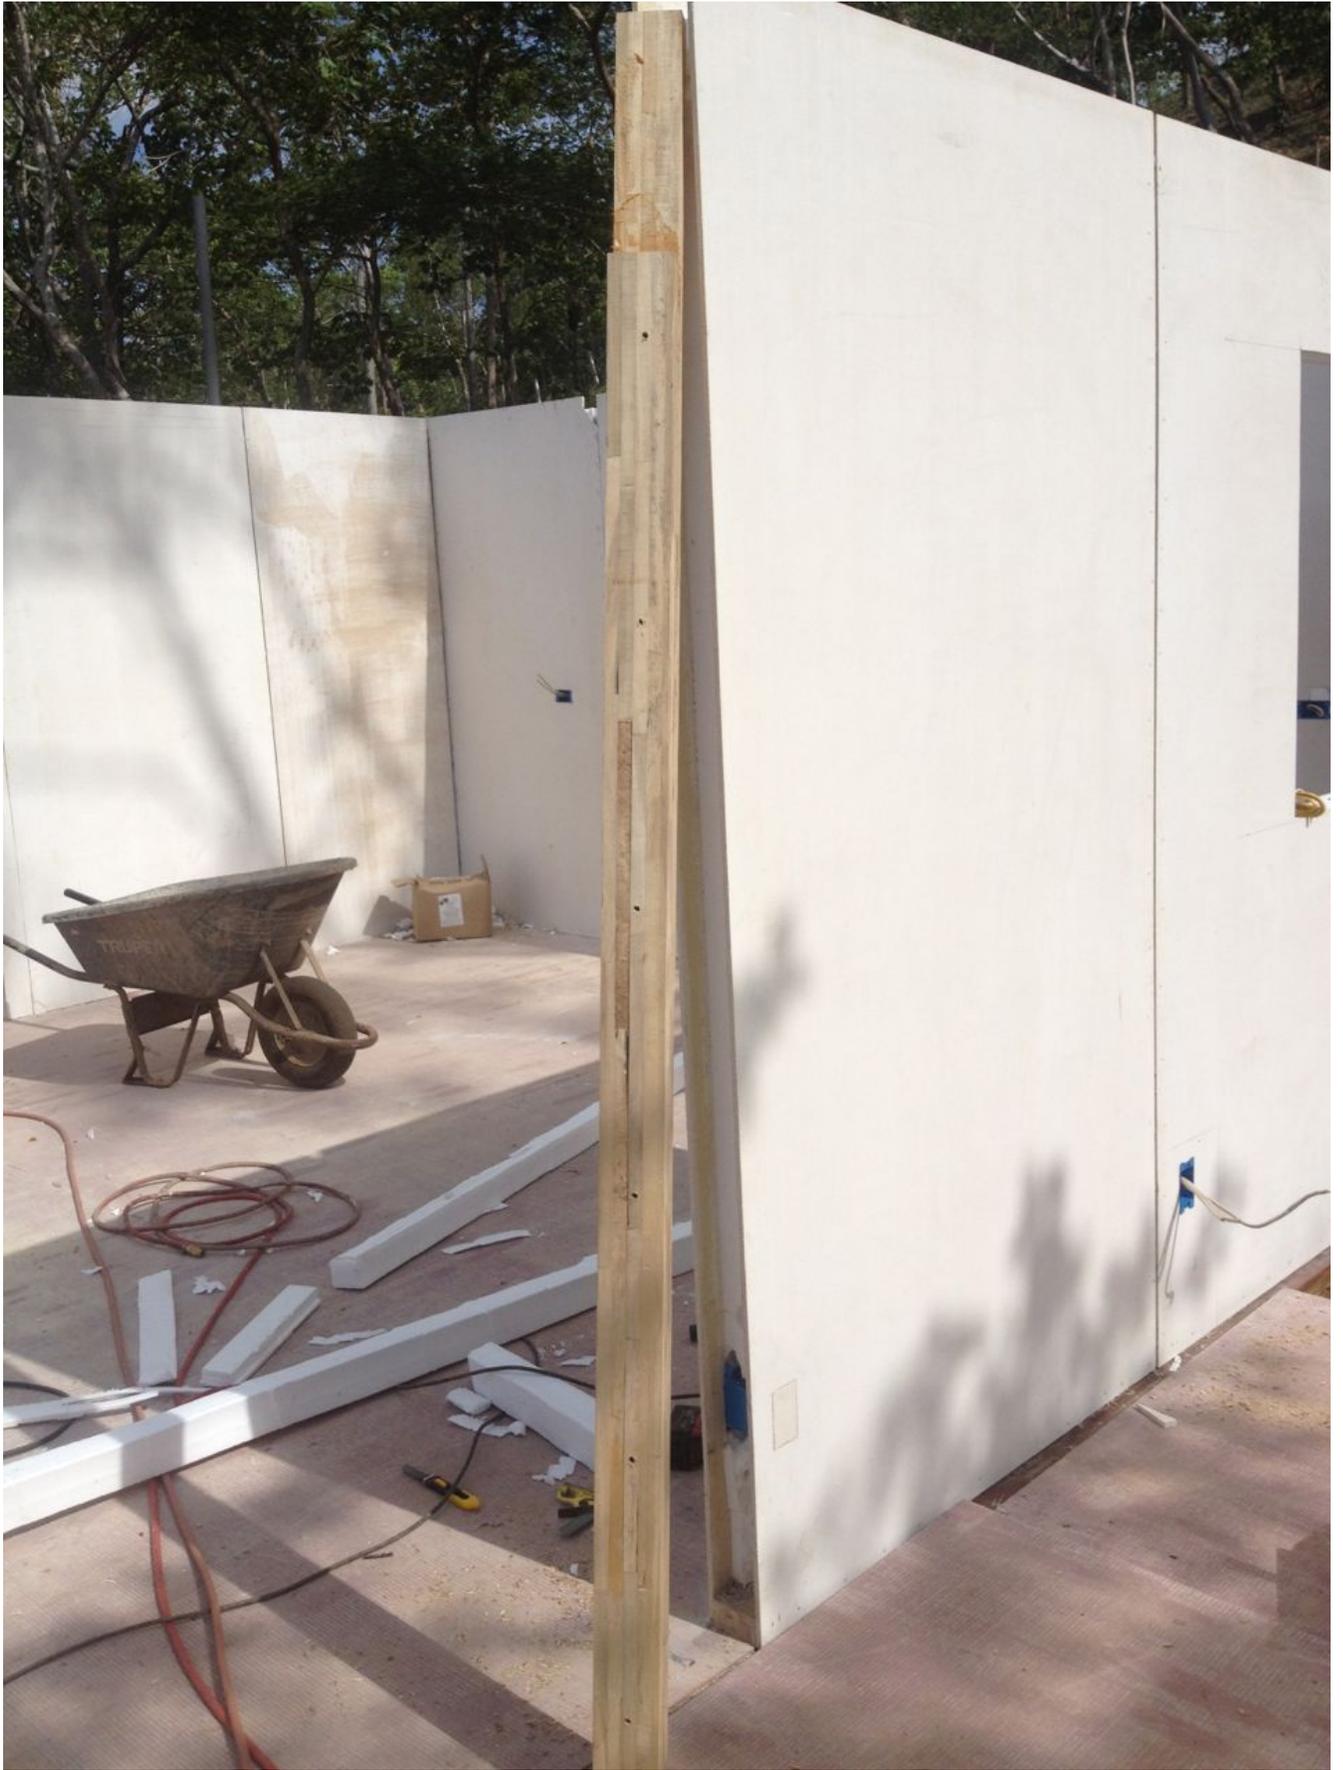
Stud ready to go into the panel edge to create the opening for the 4 meter wide folding door.

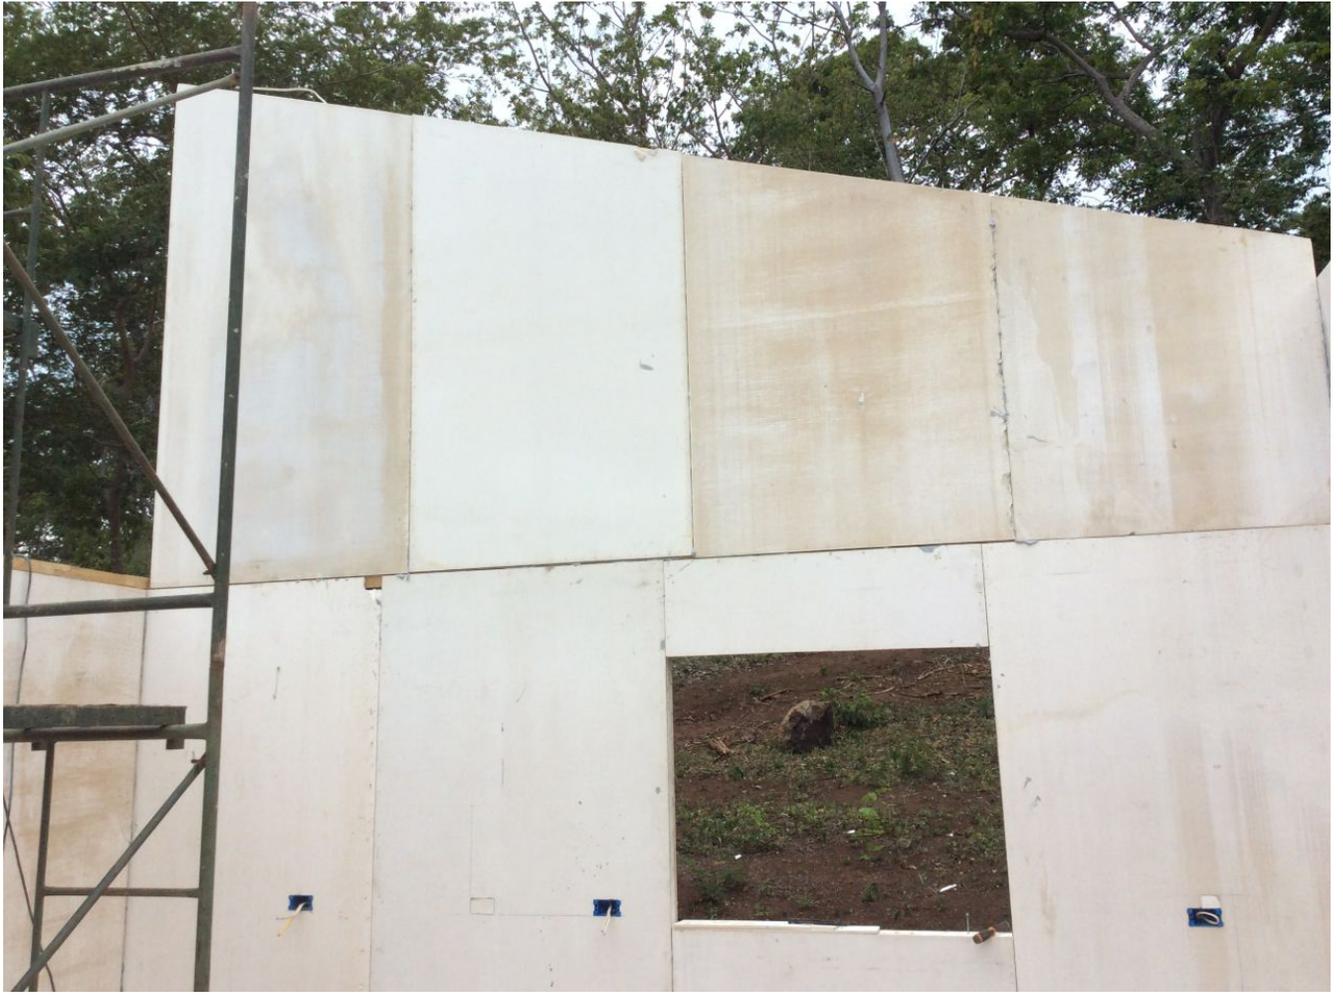
Gables now extended above the kitchen wall creating the 16 (4.4 mtr)foot high ceiling space.

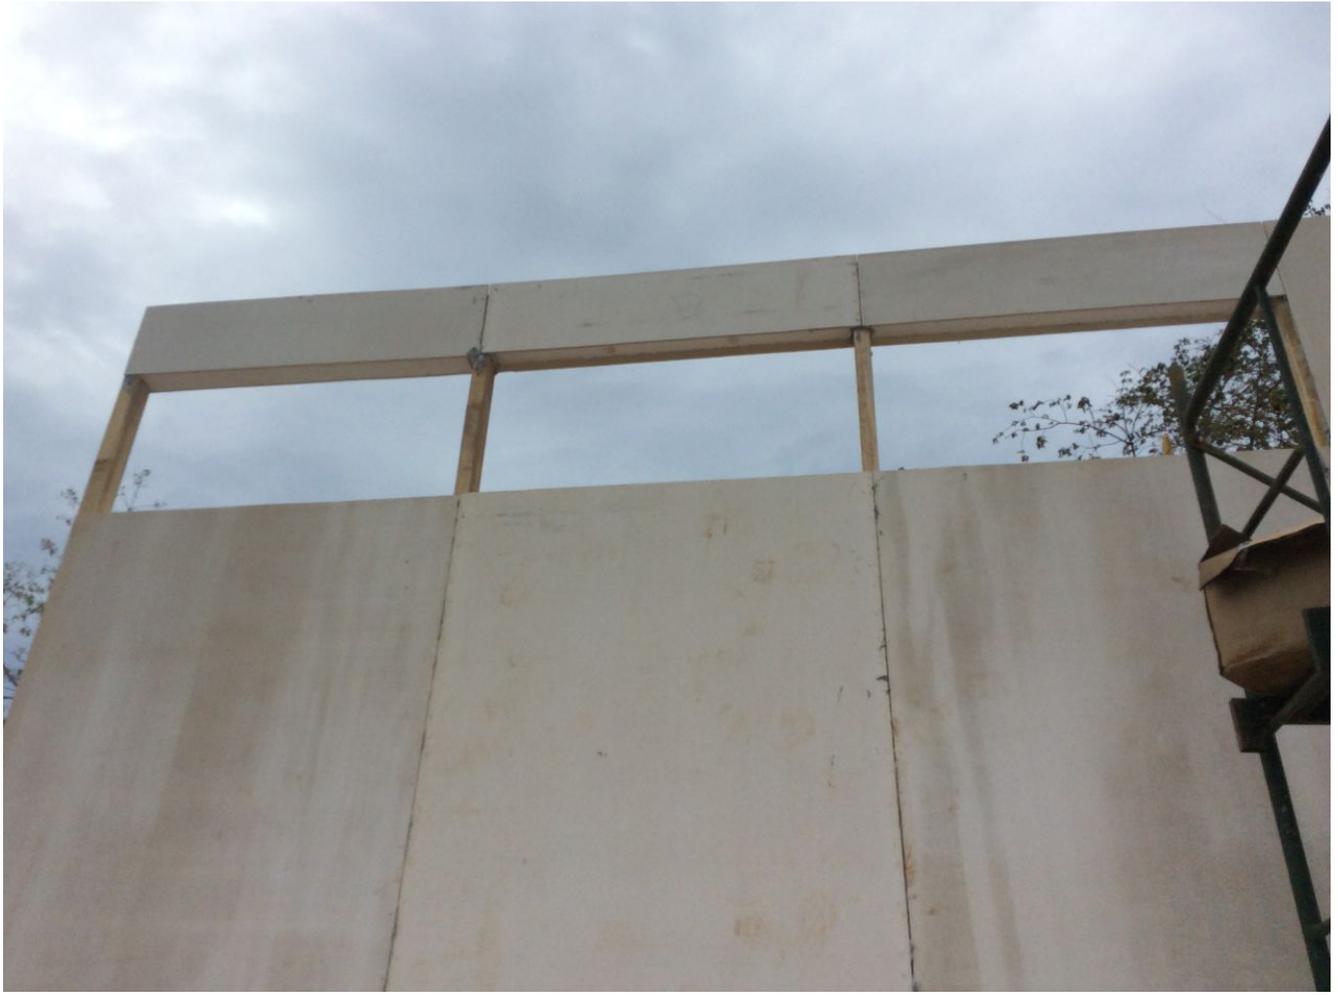
Now making the turn at that corner we see the gables of the center support wall along with the ventilator openings that will allow rising hot air to escape from the home and living space.

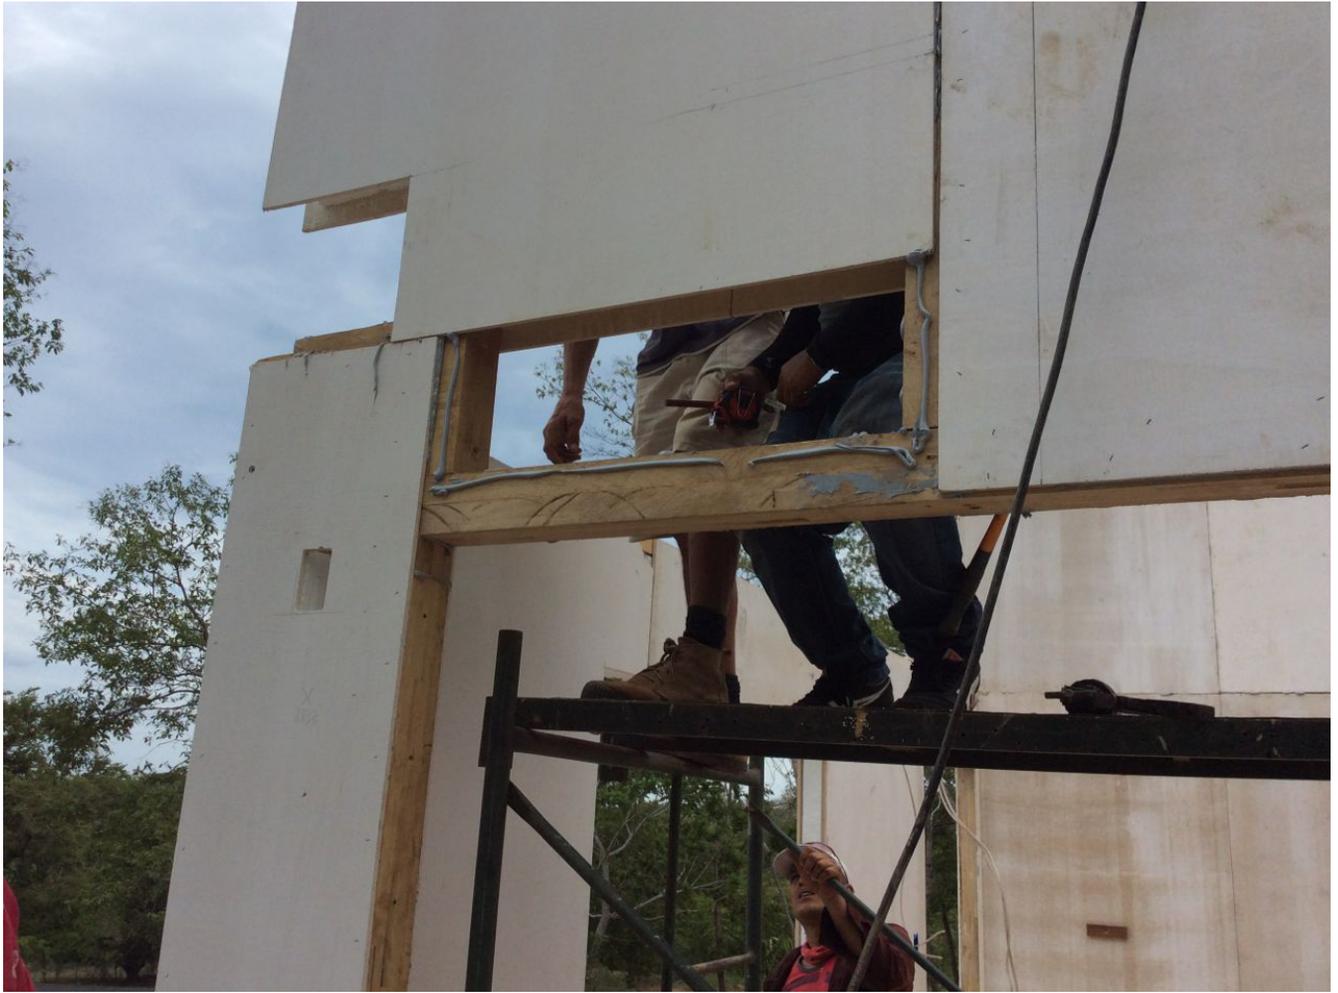
The last panel being fitted into the 4 foot wide (1.2mtr) support beam we have created out of horizontal panels that will carry the roof load over top of the 13 foot (4 meter) wide folding door opening.

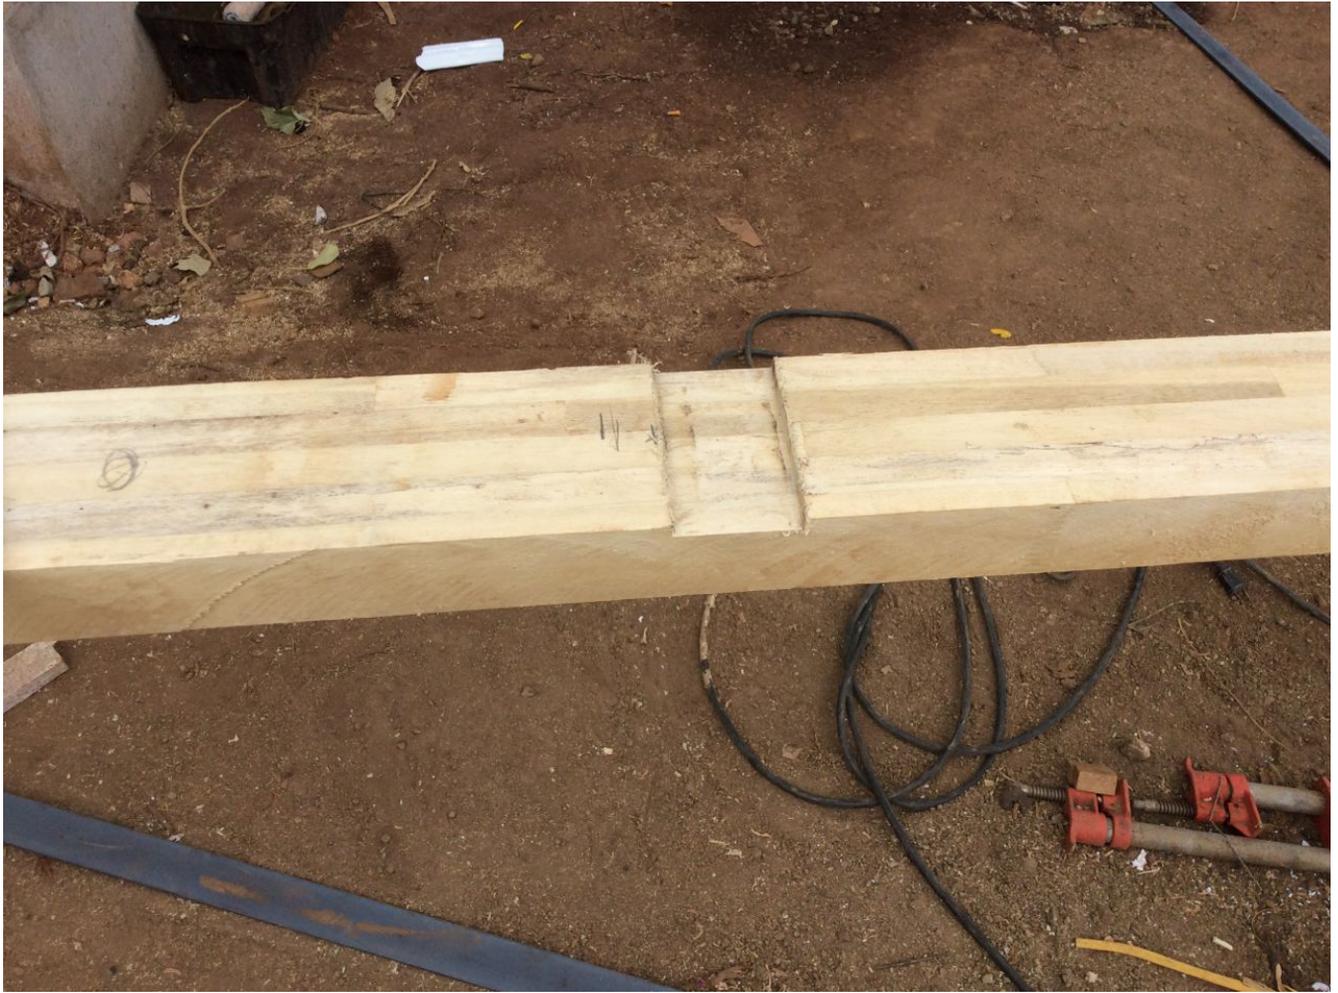
Cutting of a track set into an upper plate creates a socket in which to install a metal tongue that will extend out of the wall to support a awning that will go over the front door and windows.

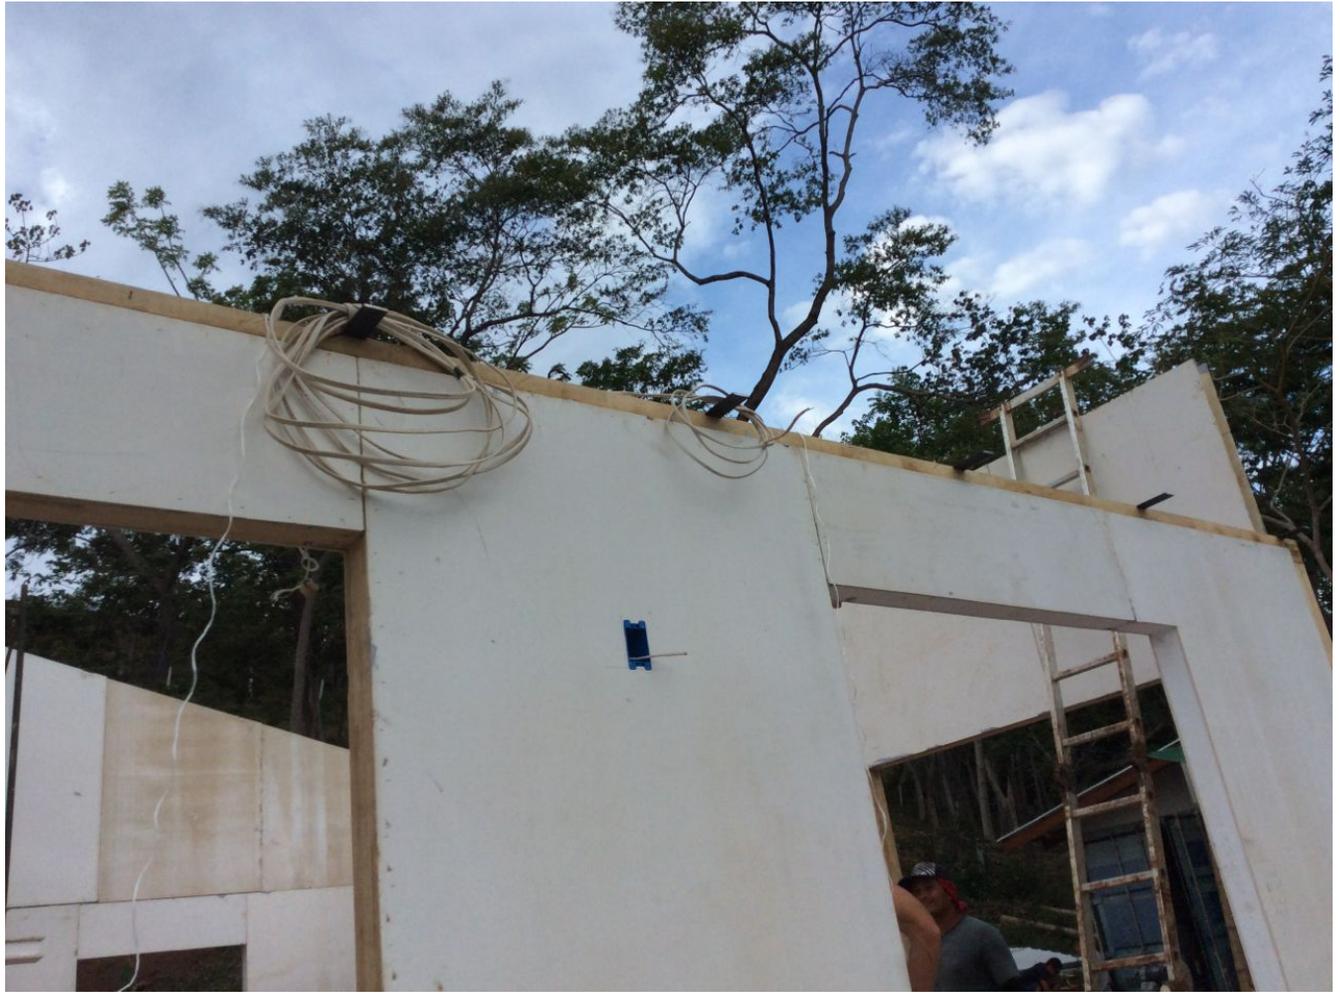
Here you see those tongues protruding from the wall prior to being sandwiched between the two upper plates that make up the union of first level panels to the upper gable panels. Also take note of all the electrical lines run inside the panels that will go up to control ceiling lights and fans.

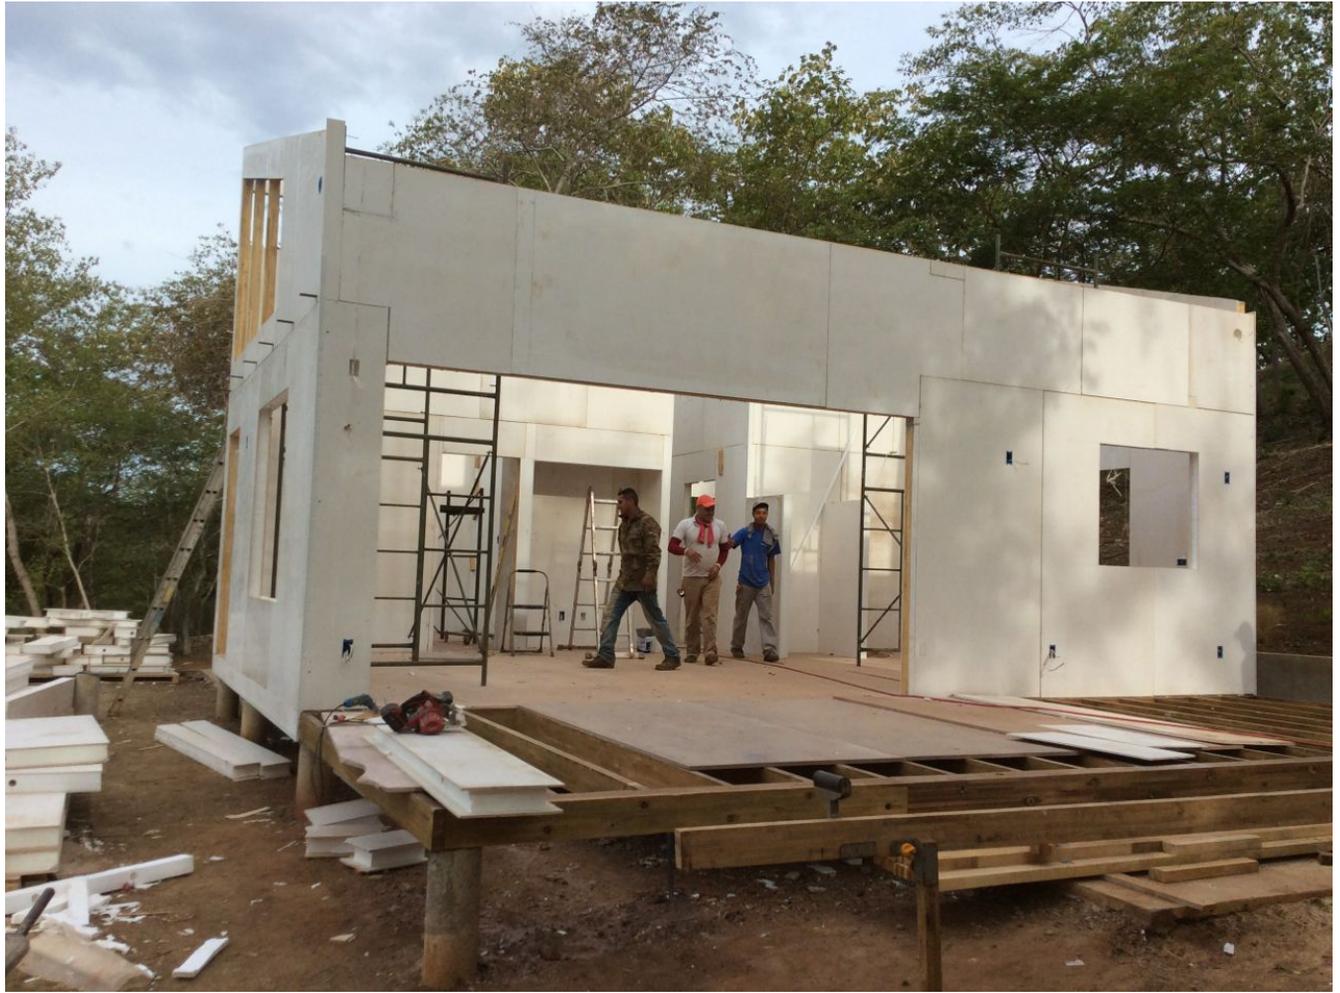
Now all the gable extensions are completed in the main living area as well as the large 4 foot wide beam we have made out of panels to carry the load over the large folding door opening.

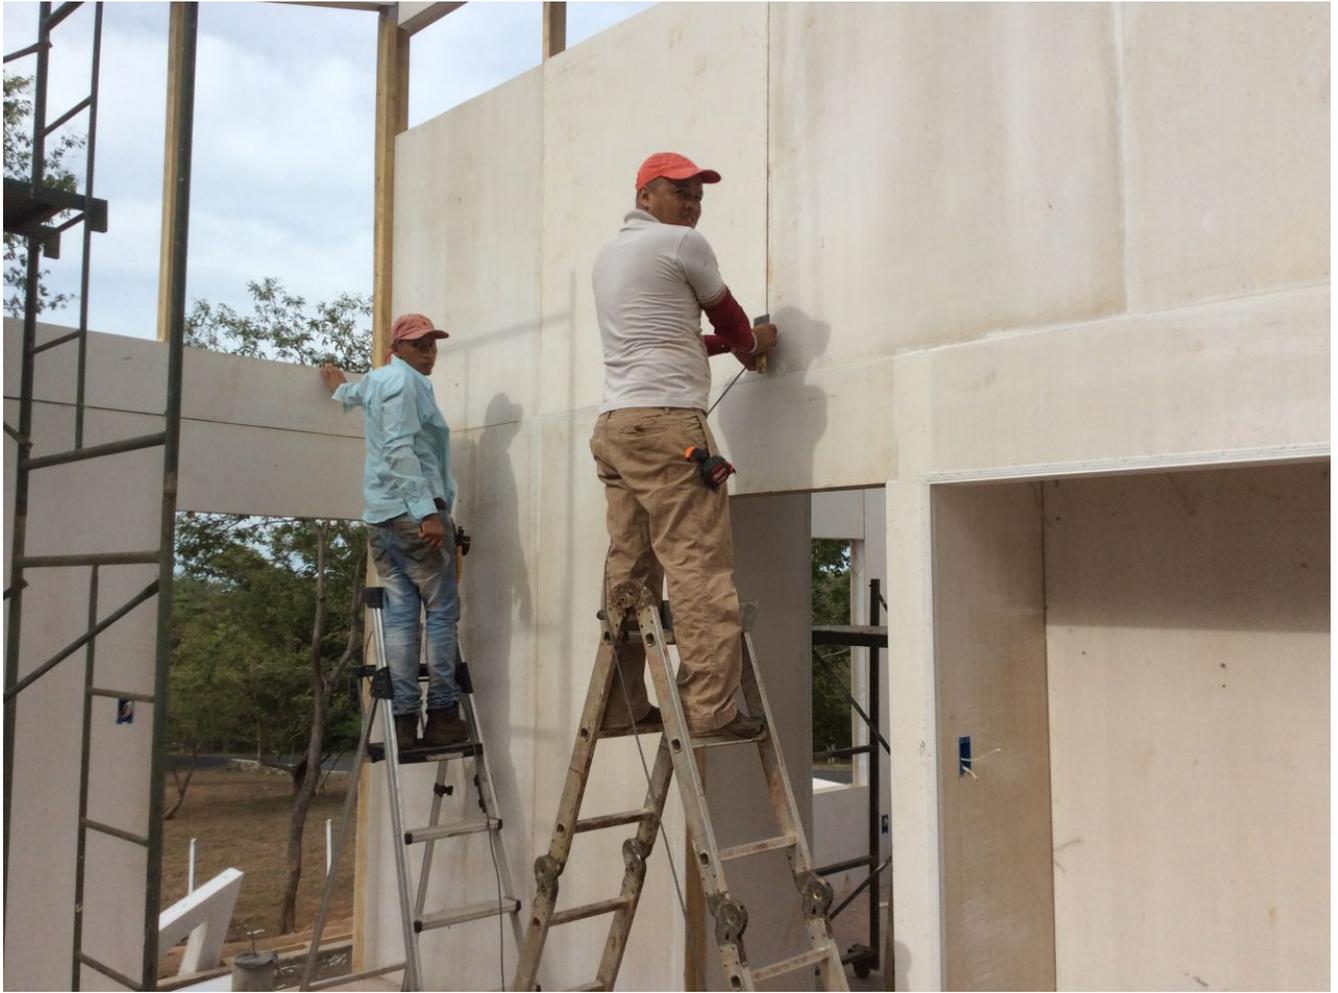
Isac is packing in a foam filler rod here that is stuffed into the panel joints. Later this will have an elastic caulking knifed over the joints sealing them and allowing for flex of ground movements.
