Techos Siglo XXI – Constructing Your Green Home

Home Diary – Playa Grande

Super Home #3 begins with a BIG MOVE!

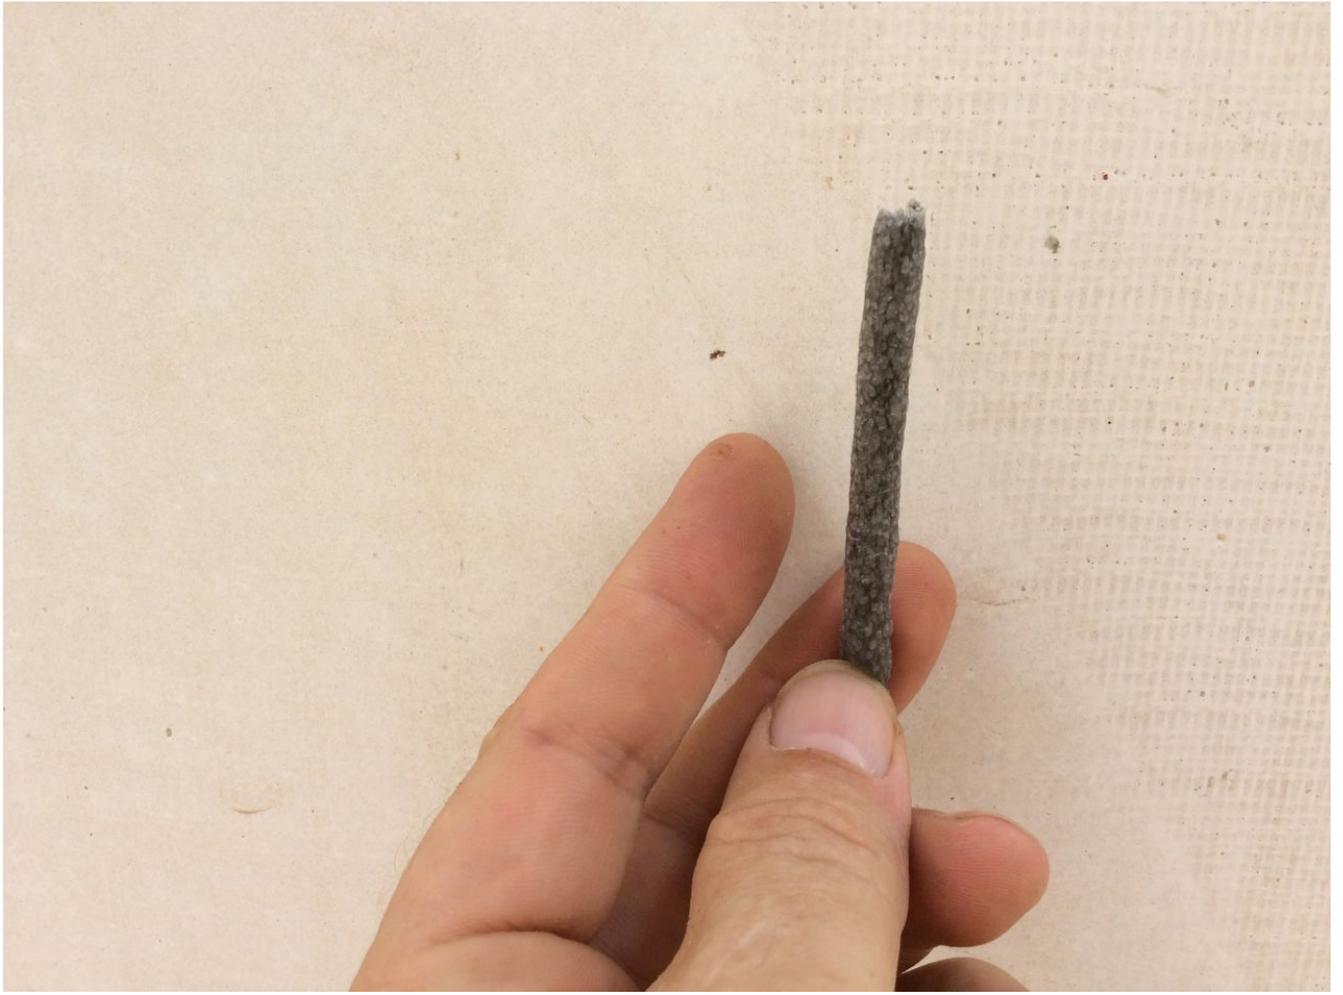
Aa close up of what filler rod looks like.

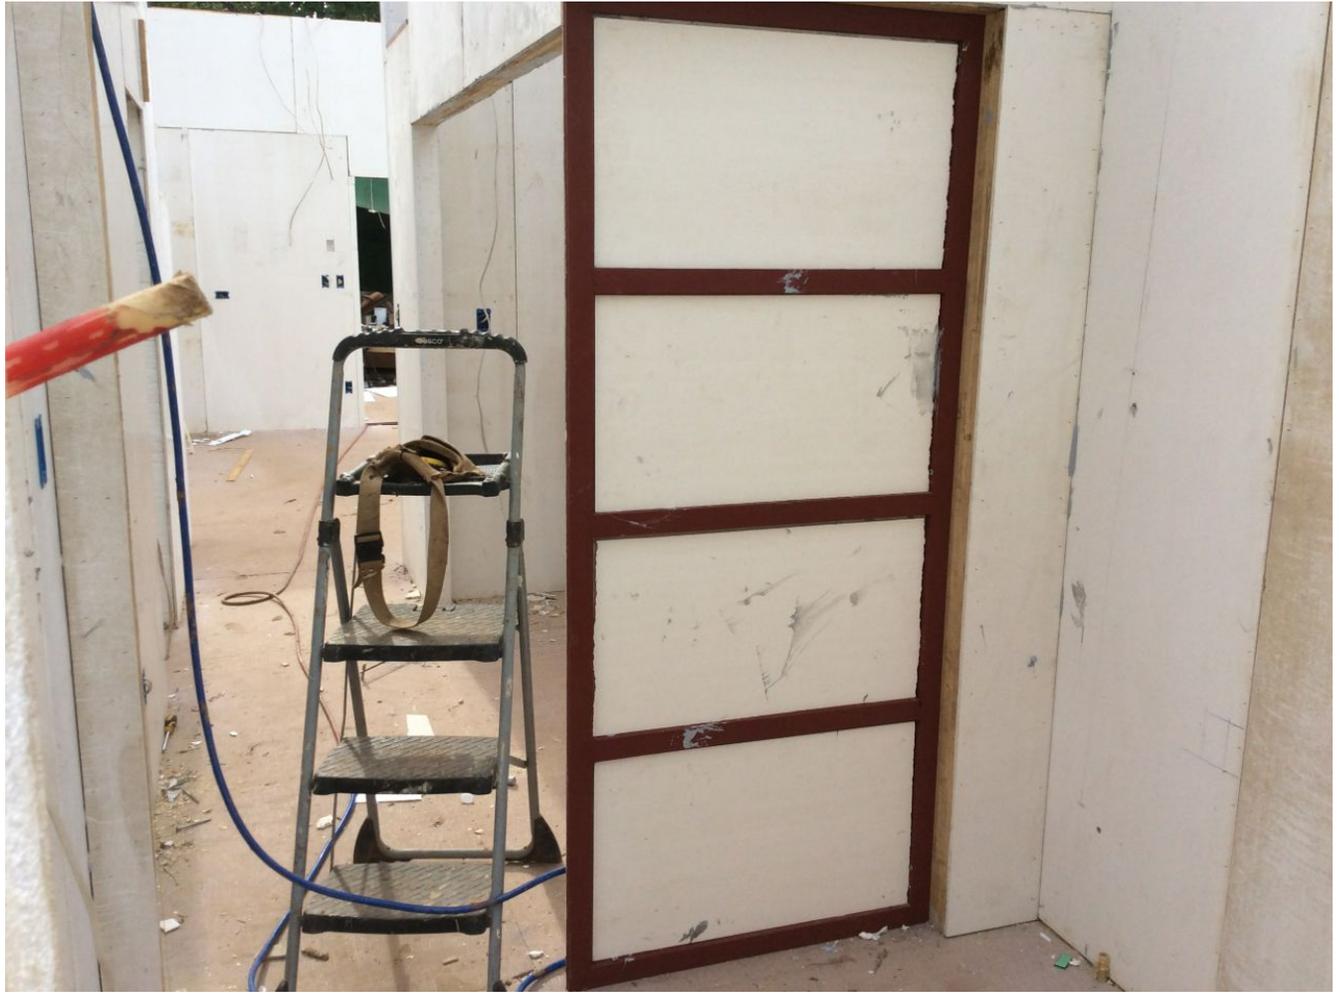
Steel frame was welded up and installed to create one side of a pocket door going into the bathroom.

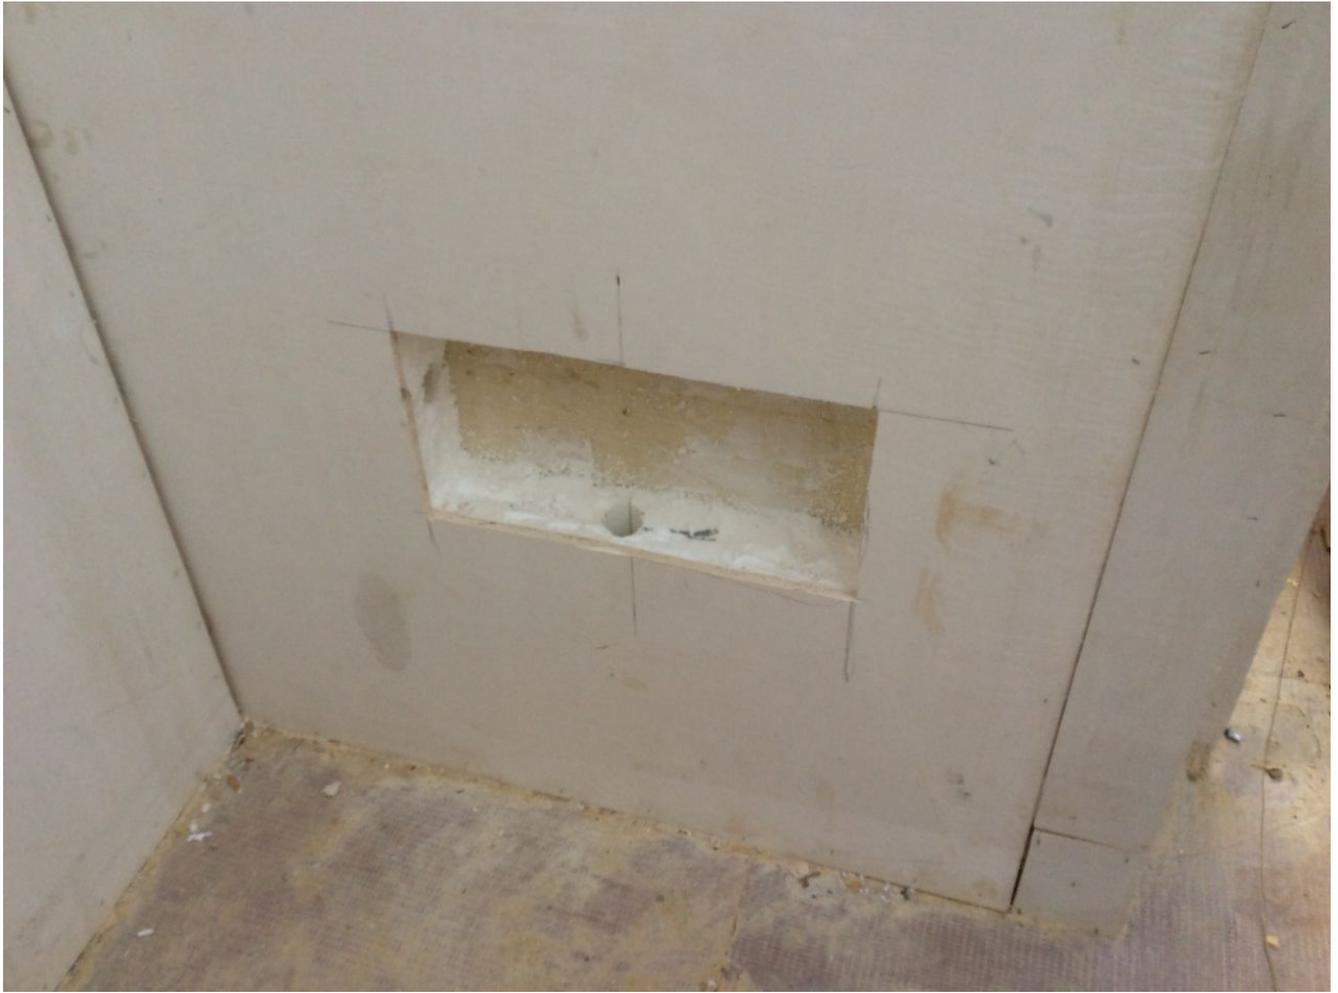
Recesses made into the shower stall to hold bathing accessories and soaps.

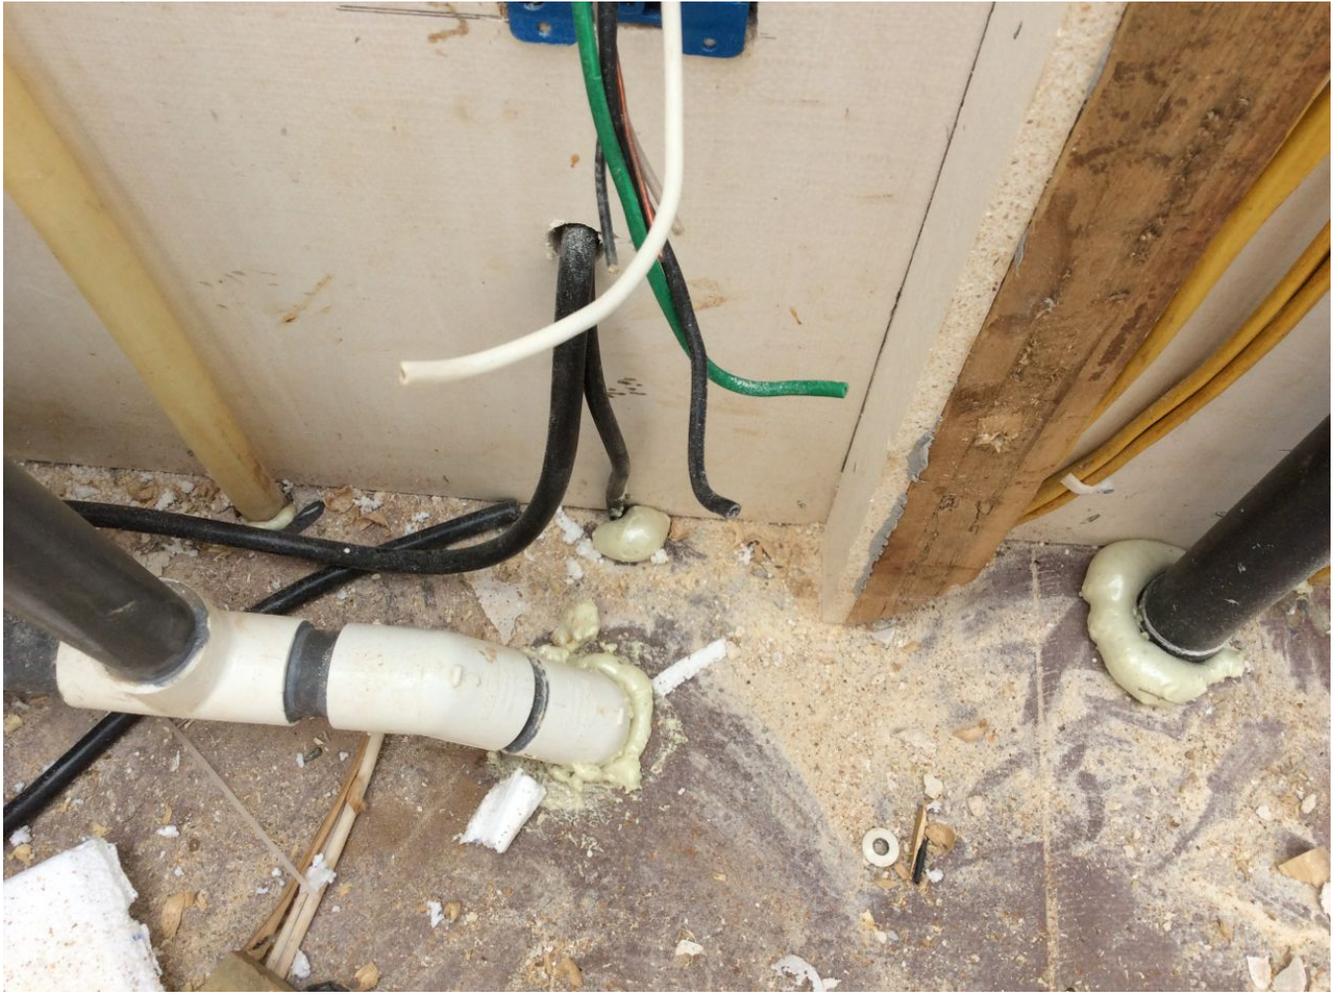
Expanding foam is put in all perforations in the floor to prevent entry of insects.

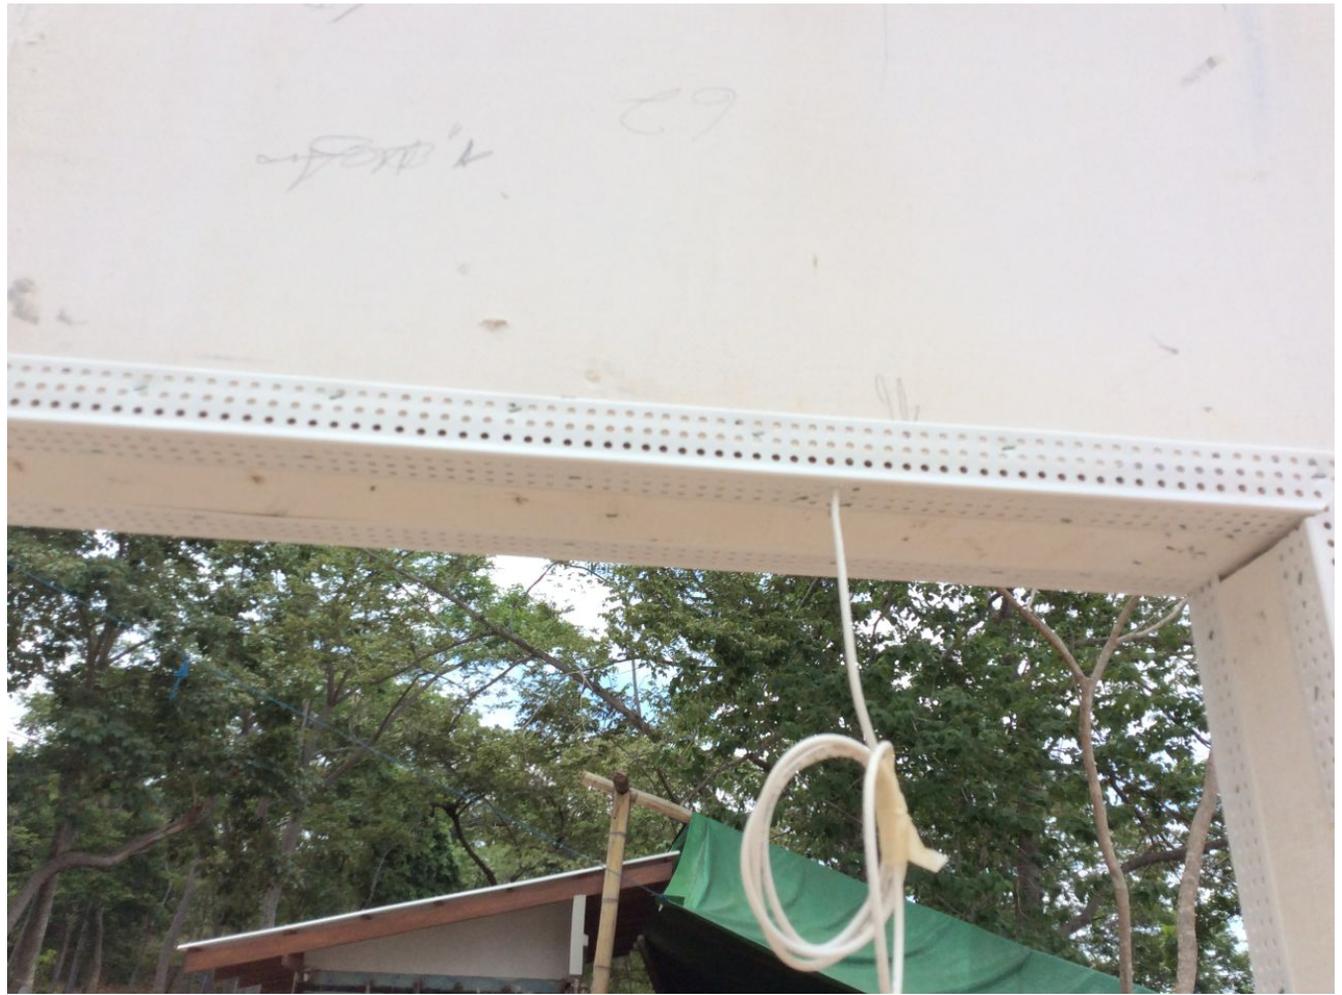
All windows and doors have been wired to accommodate the security system without of course any visible surface wiring.

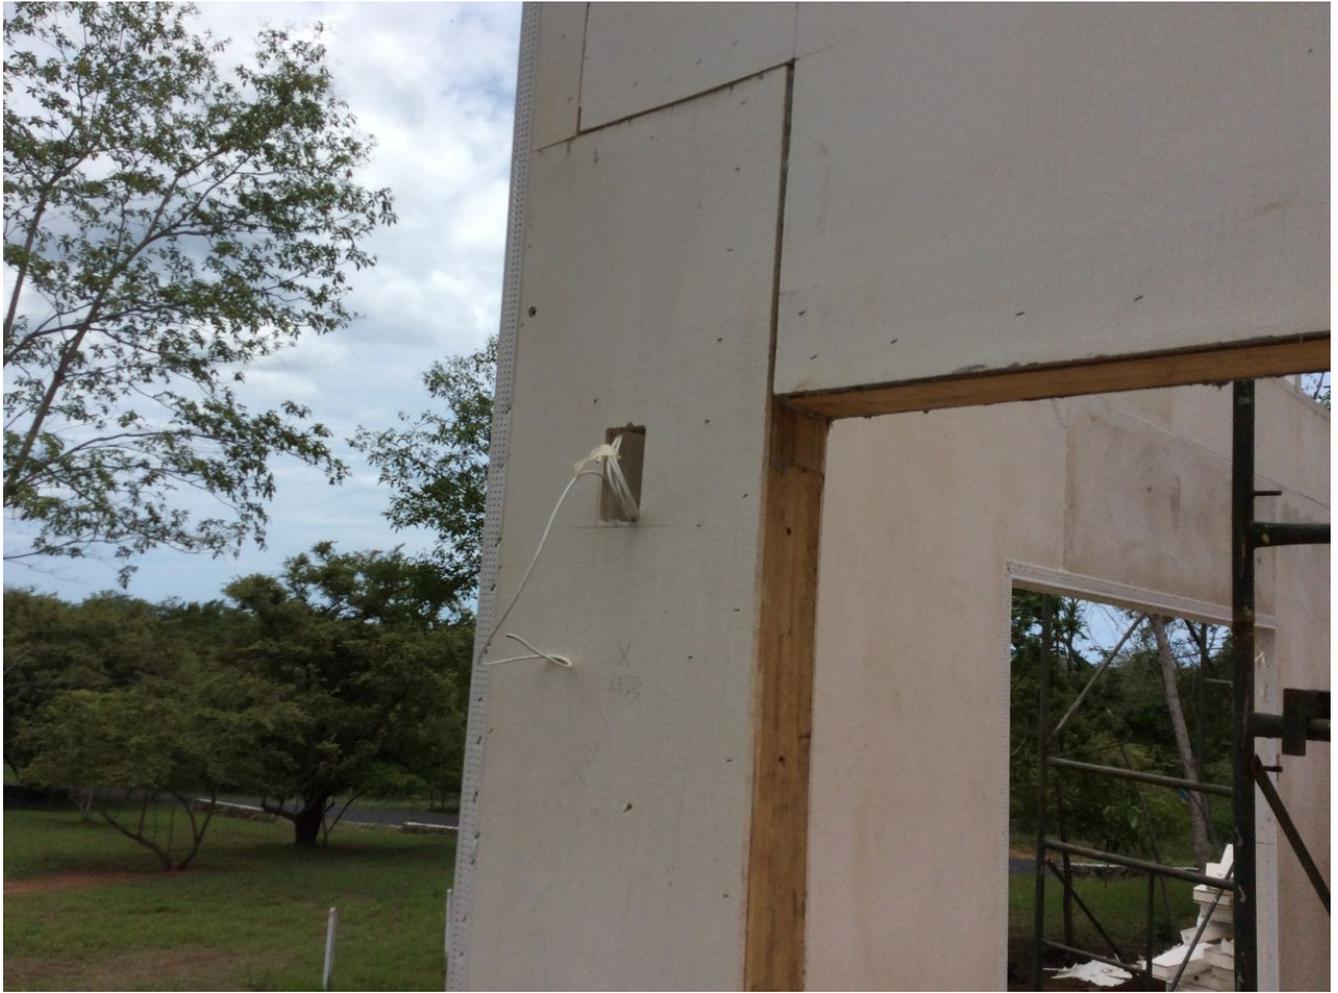
Full surround camera system is also wired into walls.

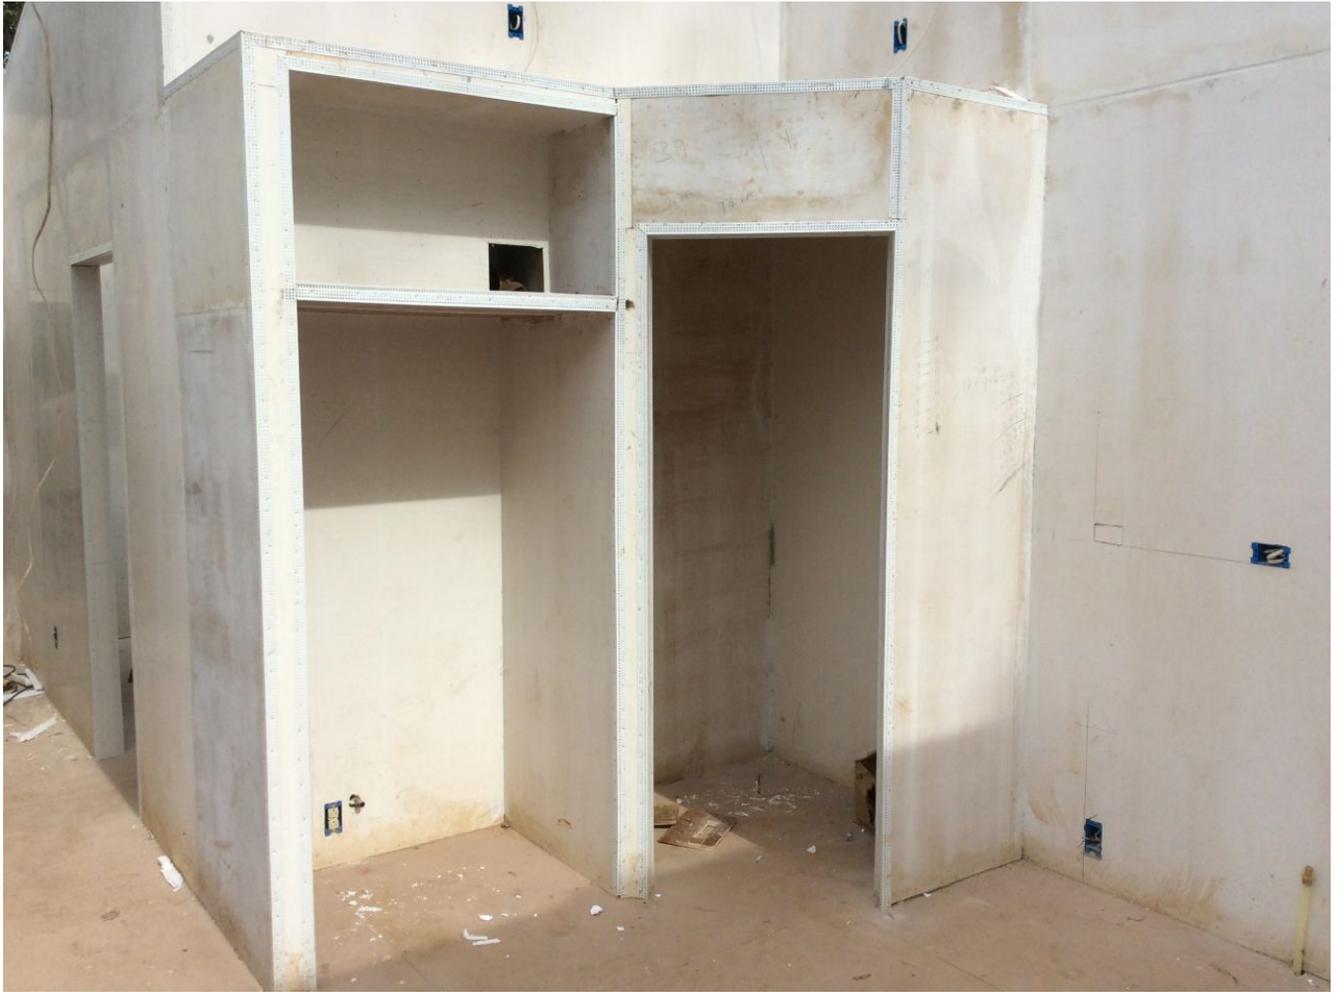
Built ins for fridge and pantry made very easy with panels and incredibly solid.

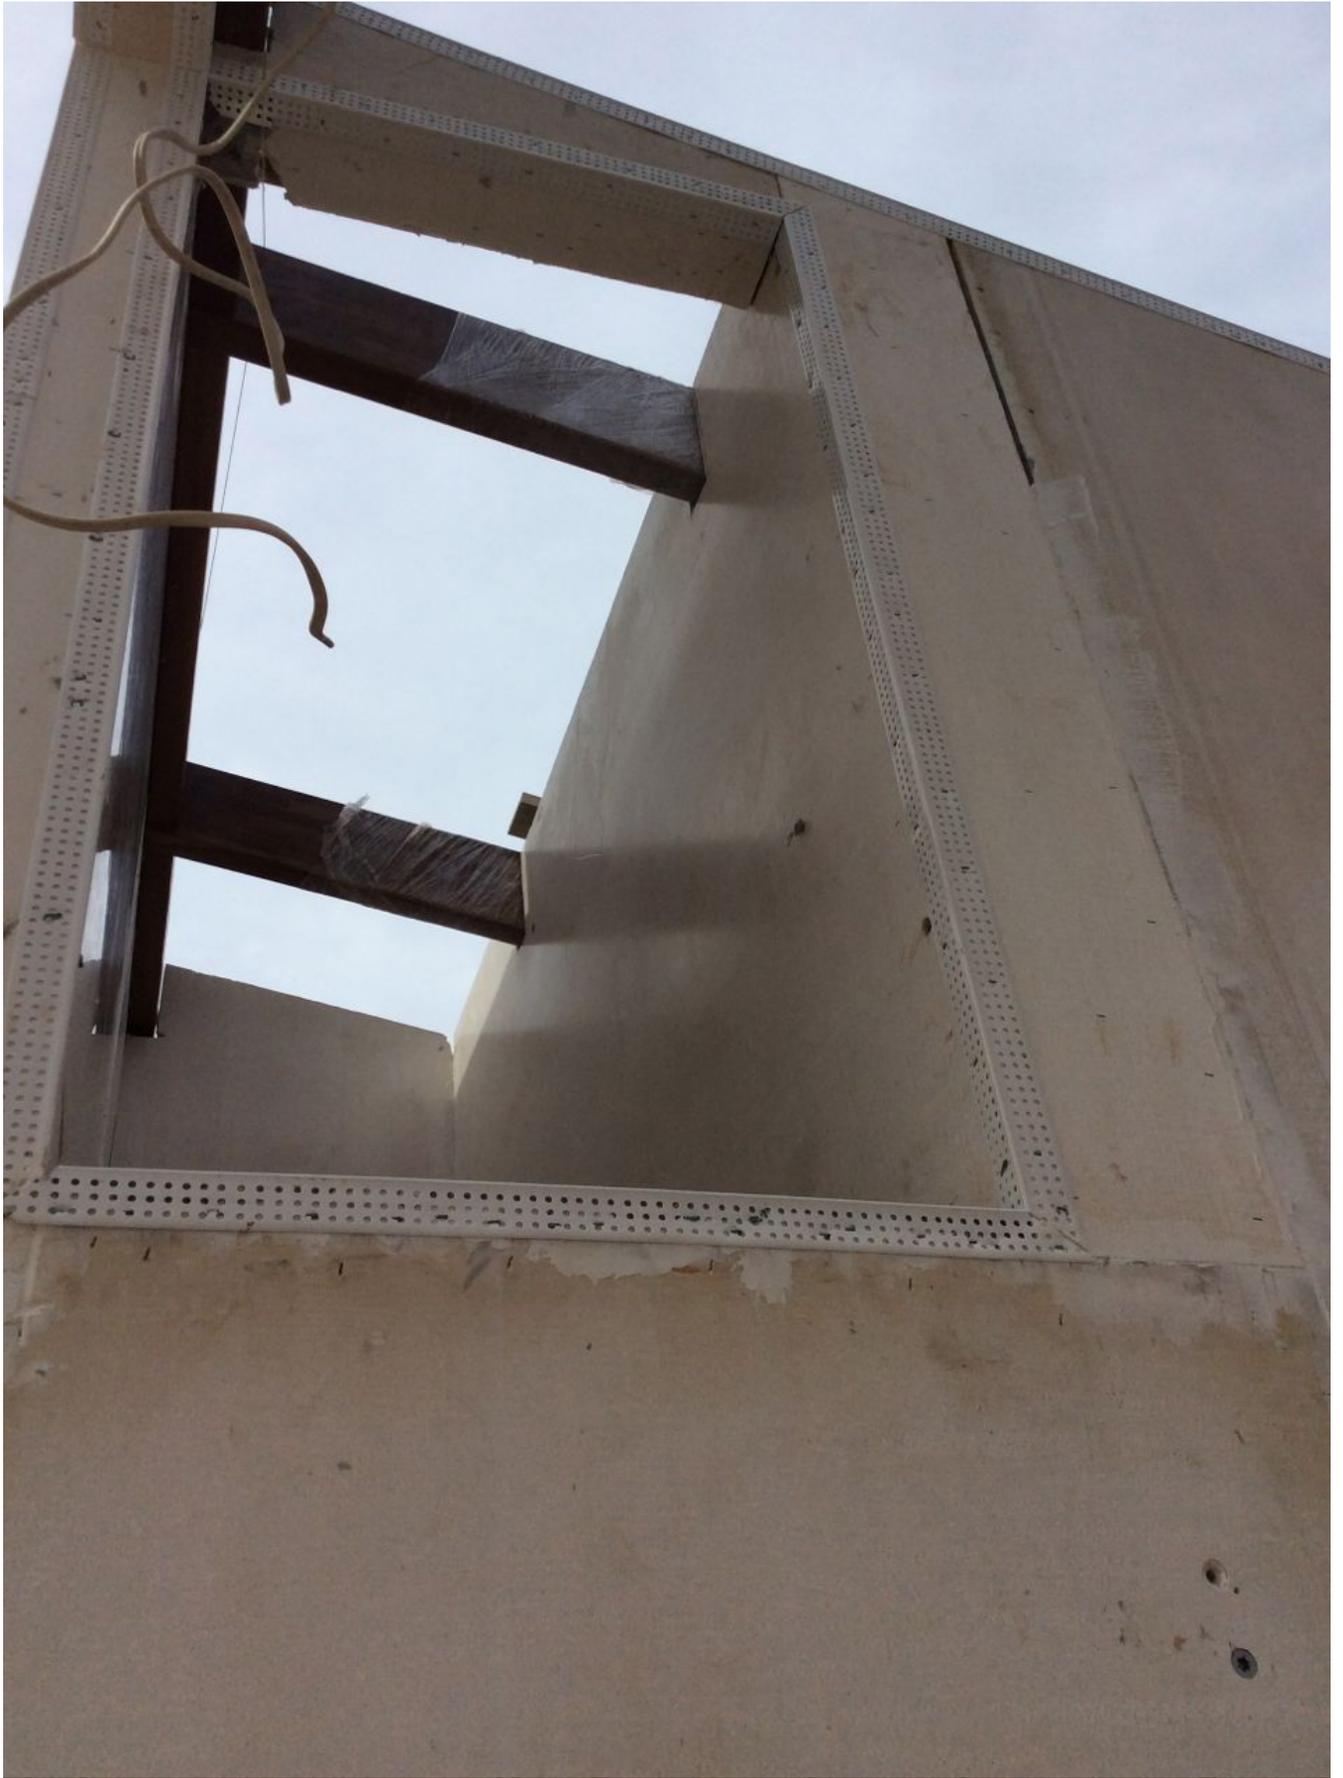
Making use of some of the high ceiling space for extra storage.

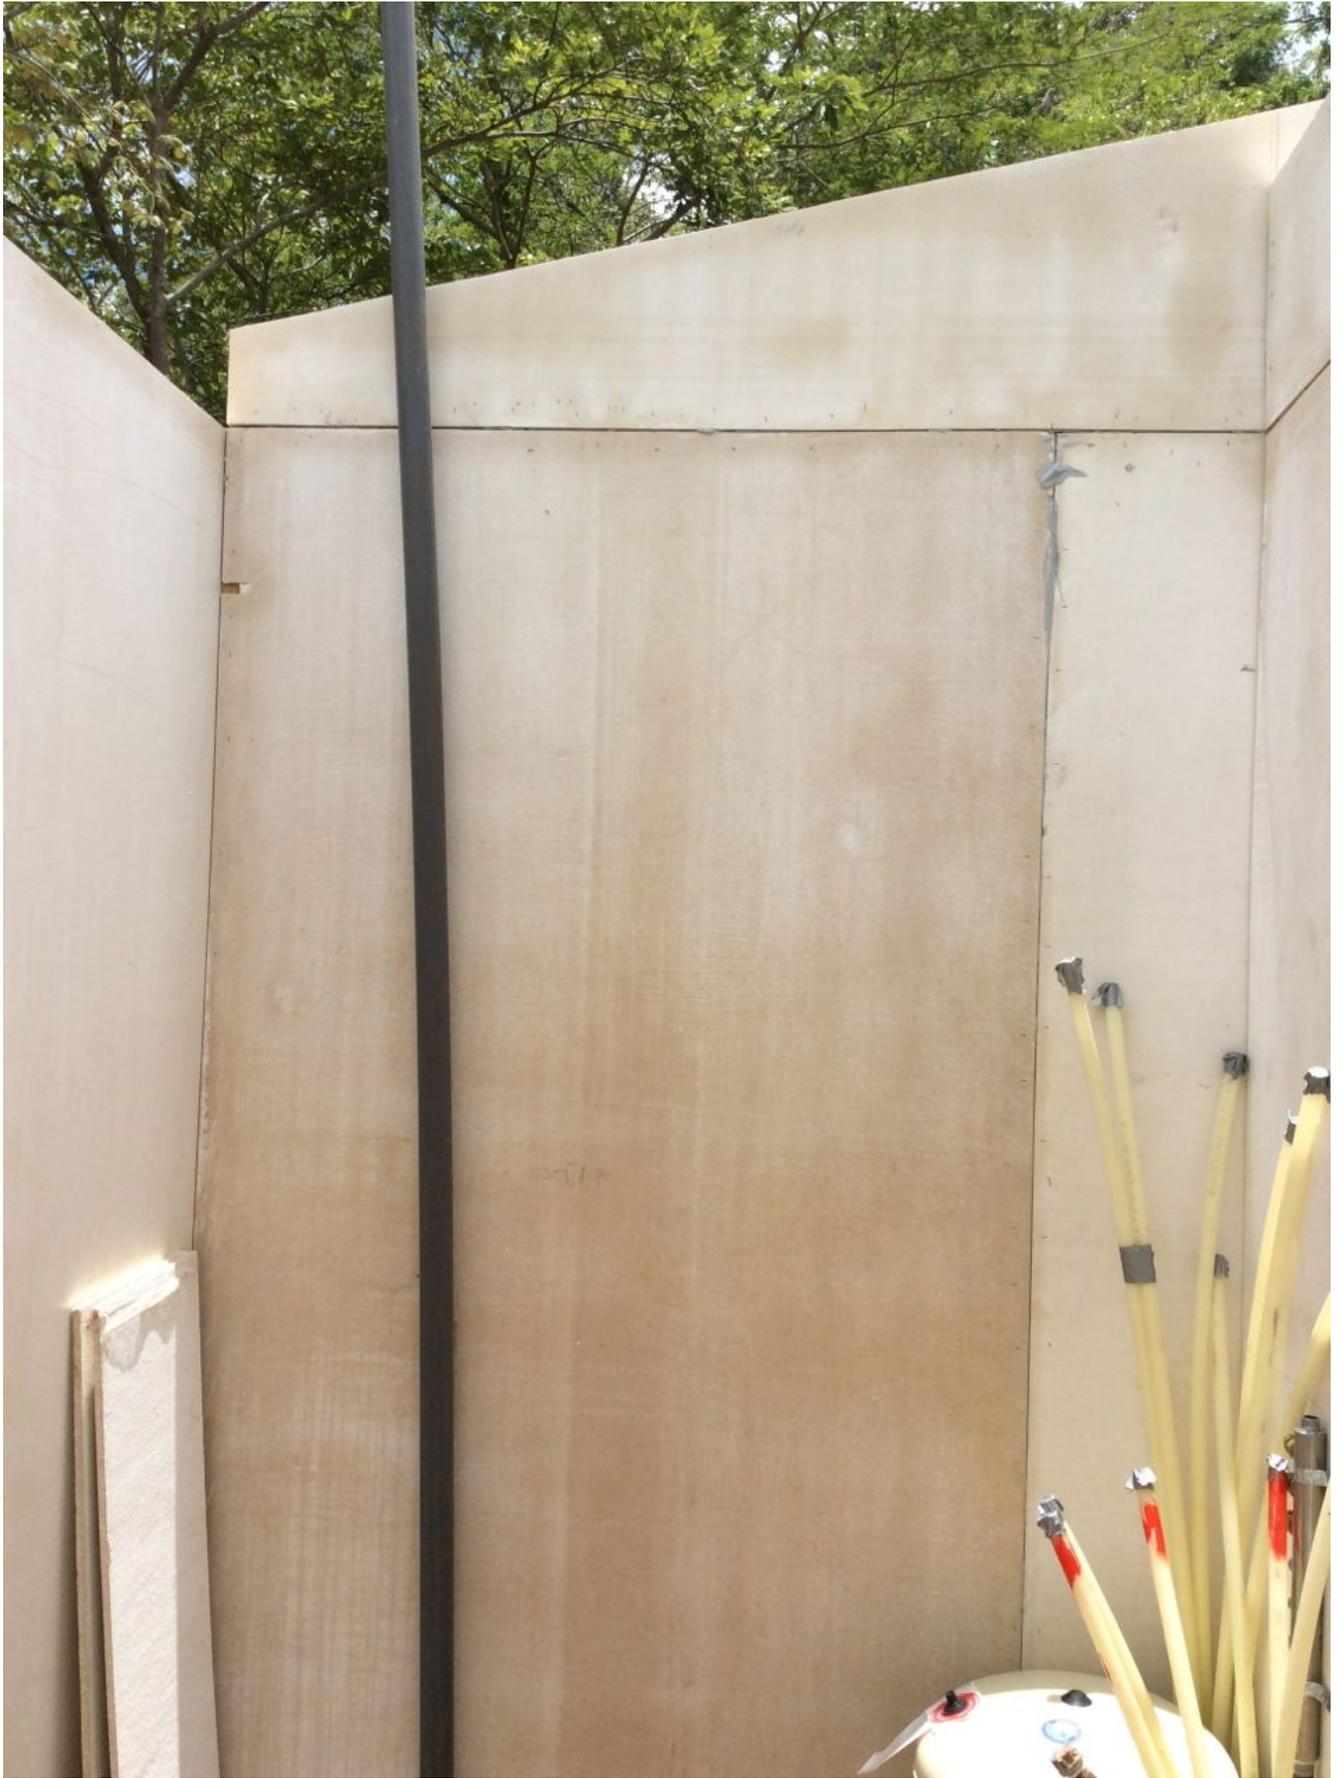
Vent line going up to roof through the storage and mechanical/electrical room.

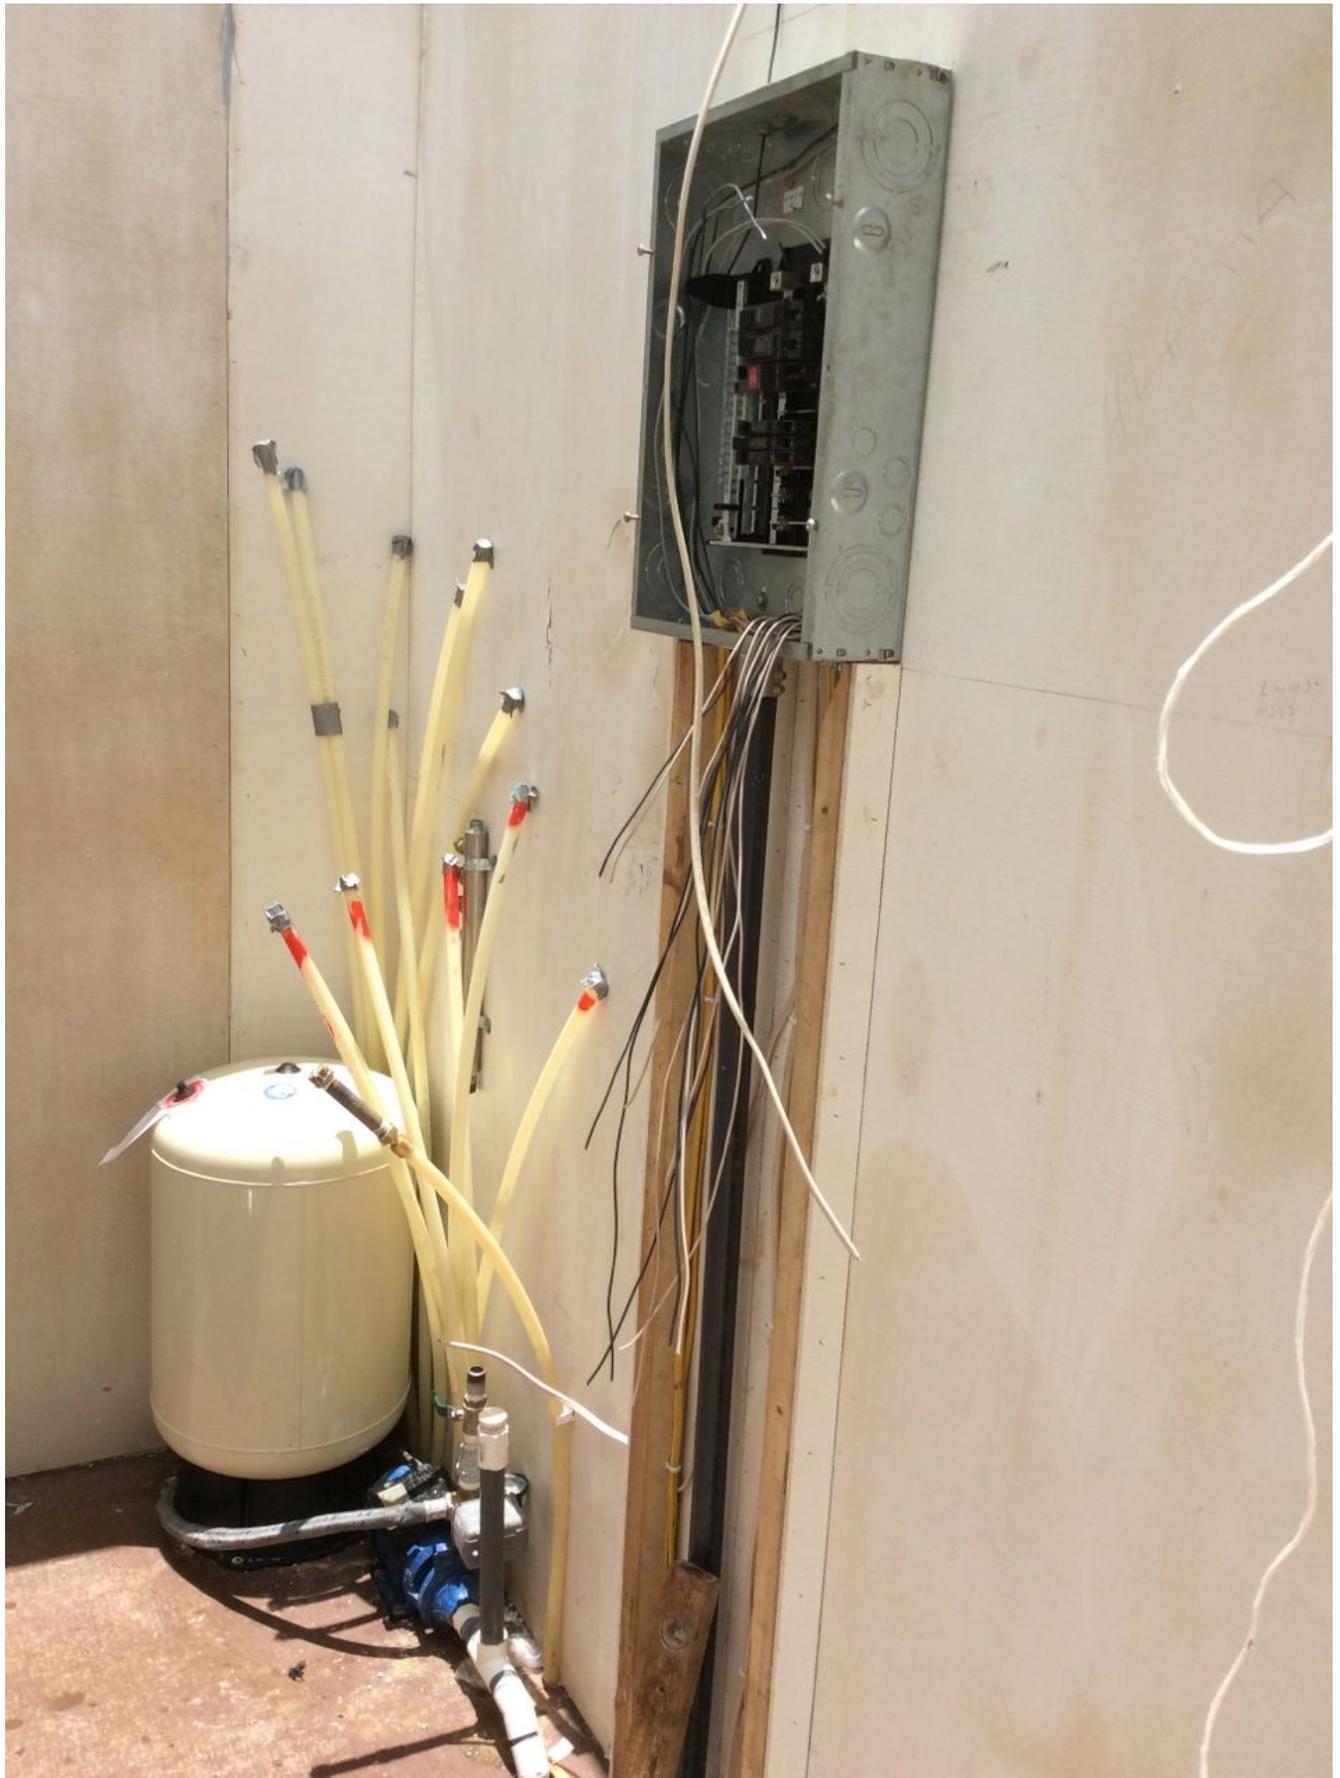
Pressure tank and pump installed for their dual water system that either takes water direct from the project or from their own 5,000 liter holding tank.

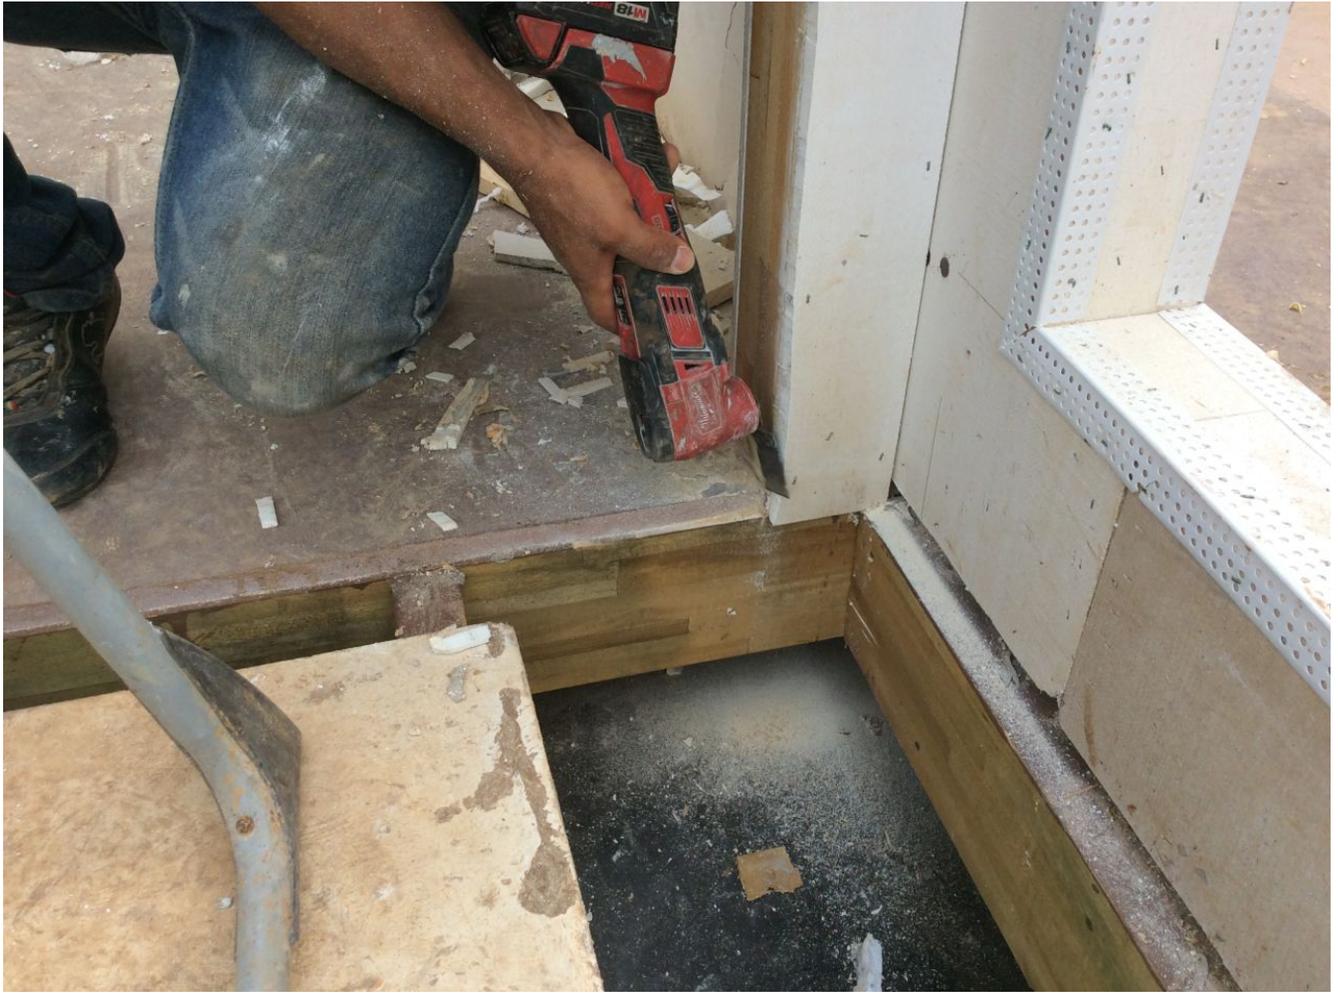
Here we see Michael trimming MgO to allow a cap to be put over the door trimmer. The tool being used is a Milwaukee multi-use tool which we use pretty much every day to speed up and improve our work quality. It was also used to cut all the bird's mouths out of the teak rafters where they meet the top plate. I took this tool in for repairs and the largest repair depot in San Jose had NEVER EVER seen one. I guess it is a bit of a unicorn in Costa Rica yet an indispensable asset in our work for both speed and quality yet few Tico workers have any idea what it is.

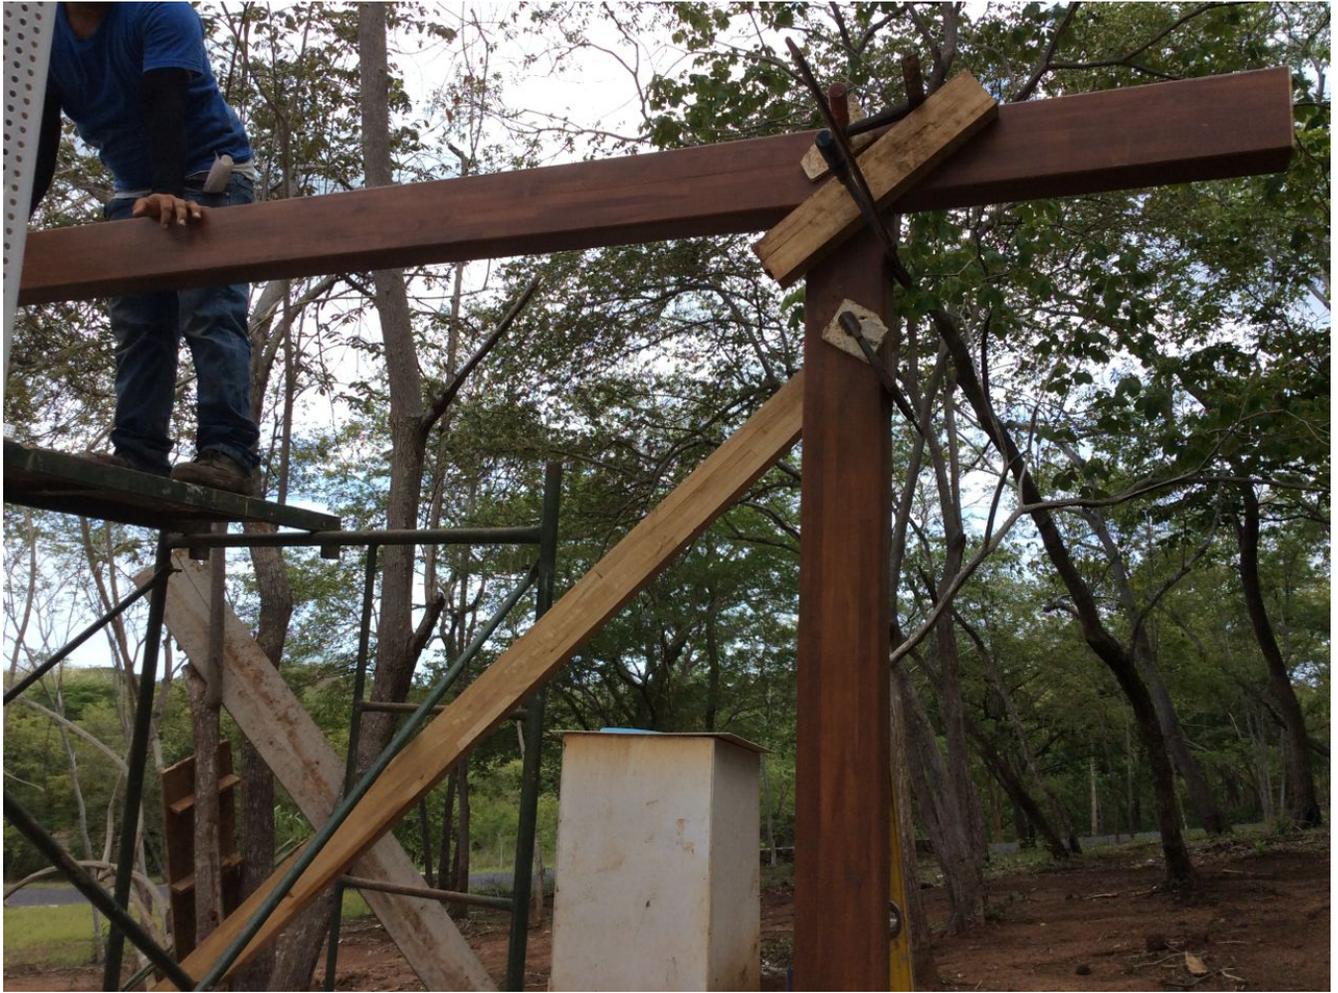
Corner post and support beam to hold the roof over the master deck. This is all glue laminated teak.

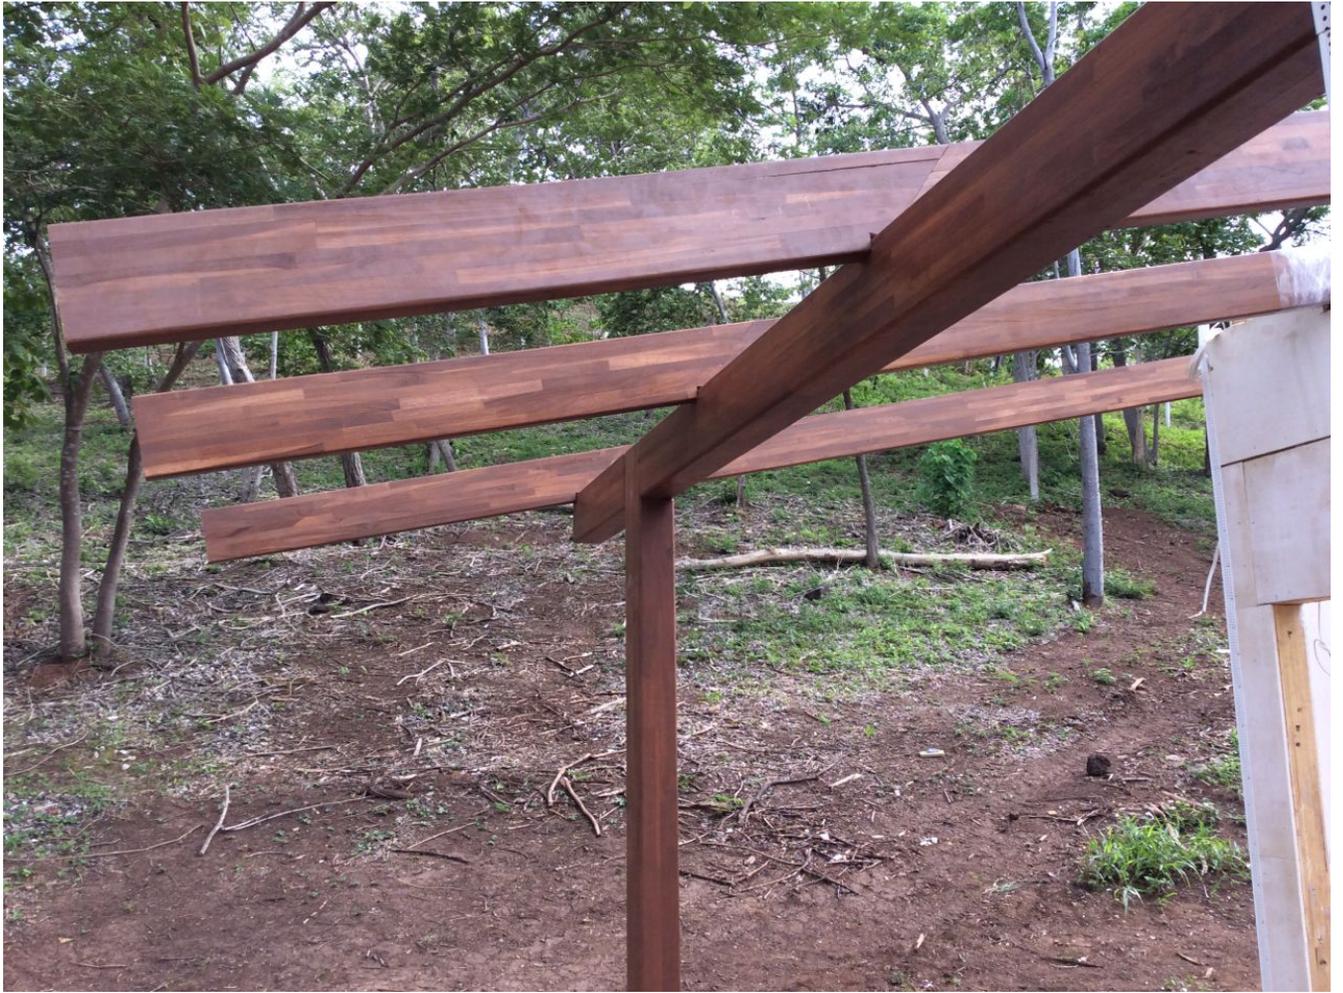
First rafters are going up over the master bedroom and deck.

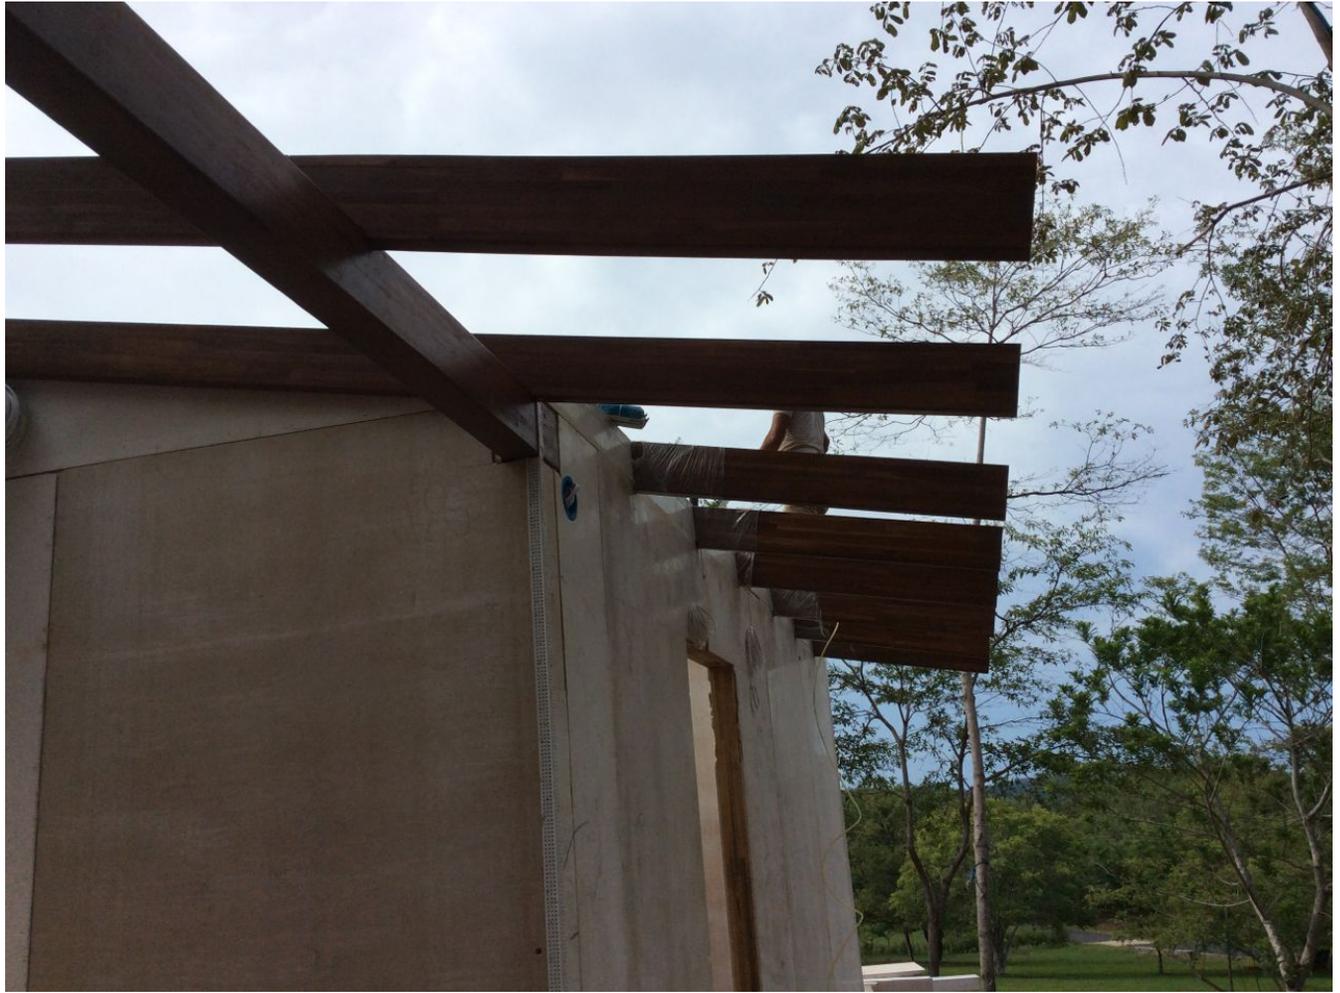
Rafters over the bathroom, bedroom and storage. Note we keep a 1 meter (39") overhang on all homes to shade the home and windows as much as is possible to keep with tropical needs.
