Techos Siglo XXI – Constructing Your Green Home

Home Diary – Playa Grande

Super Home #3 begins with a BIG MOVE!

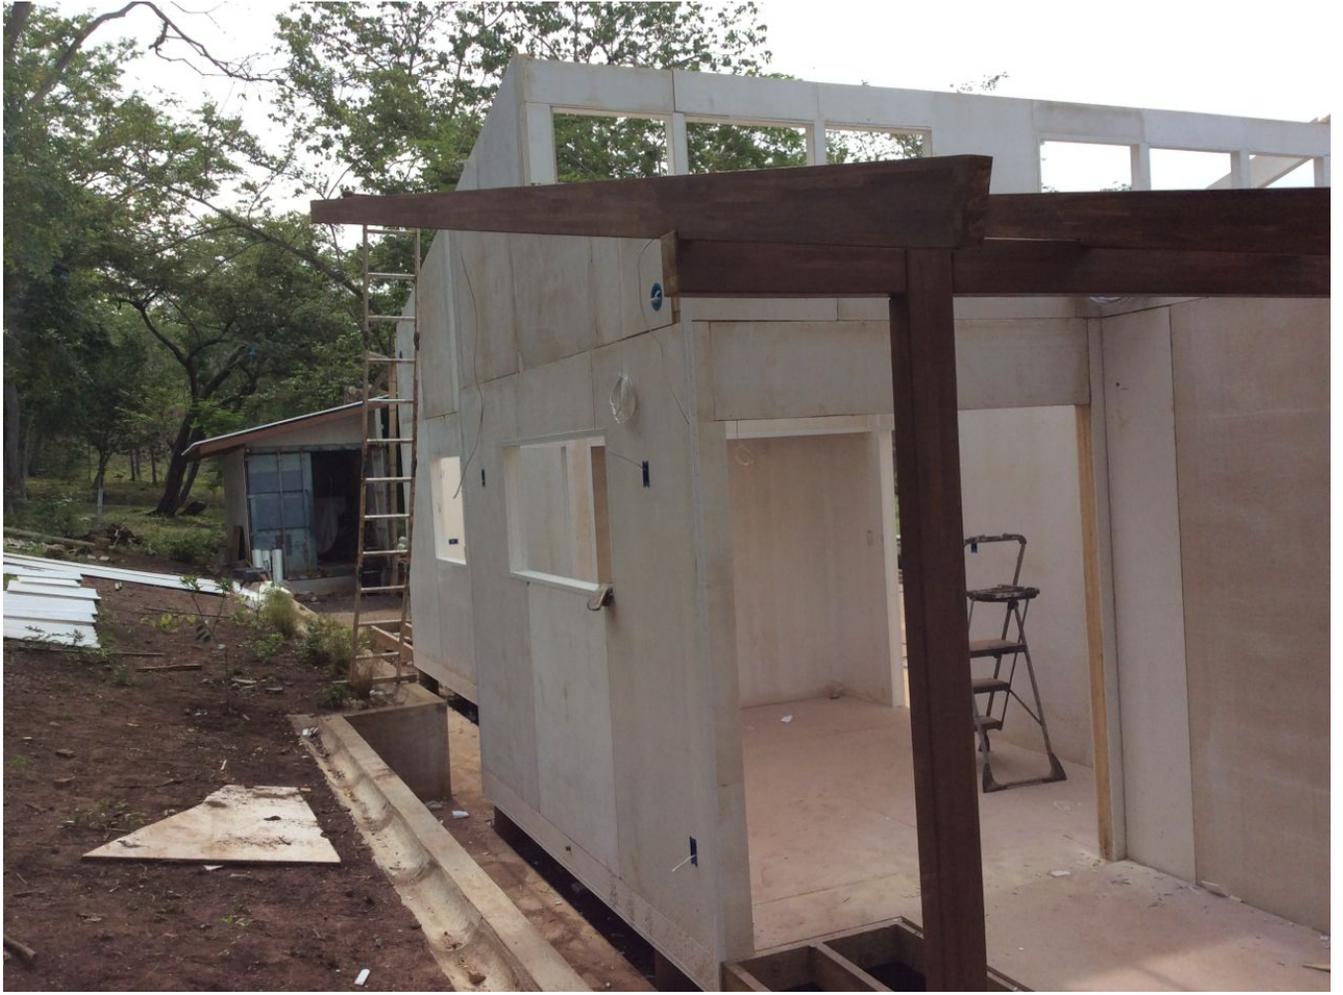
First eve rafter is installed.

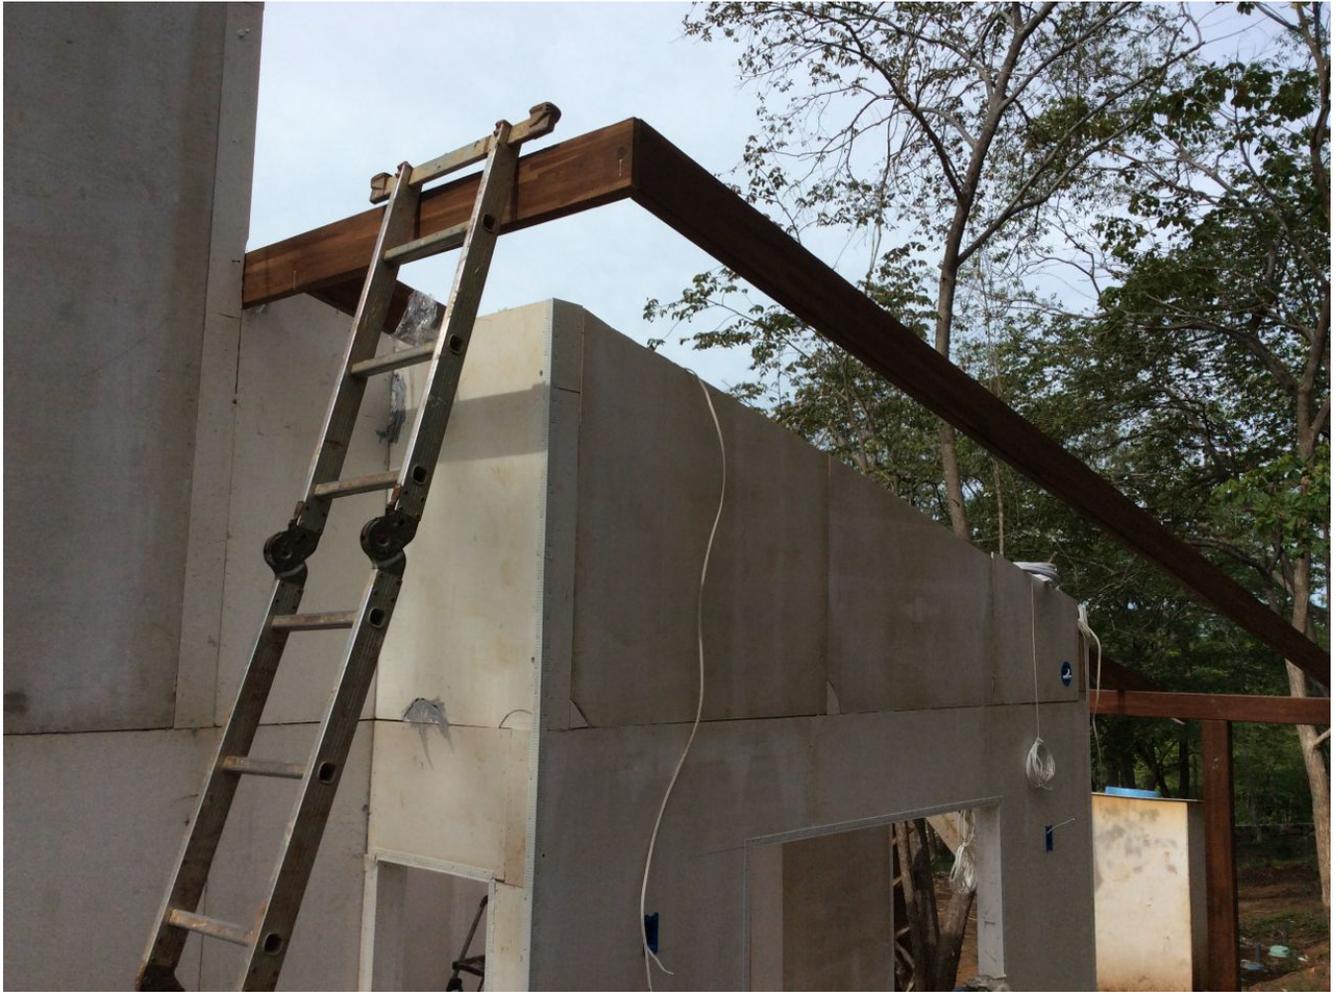
Beam is extended from supporting wall out to hold up the eave or flying rafter.

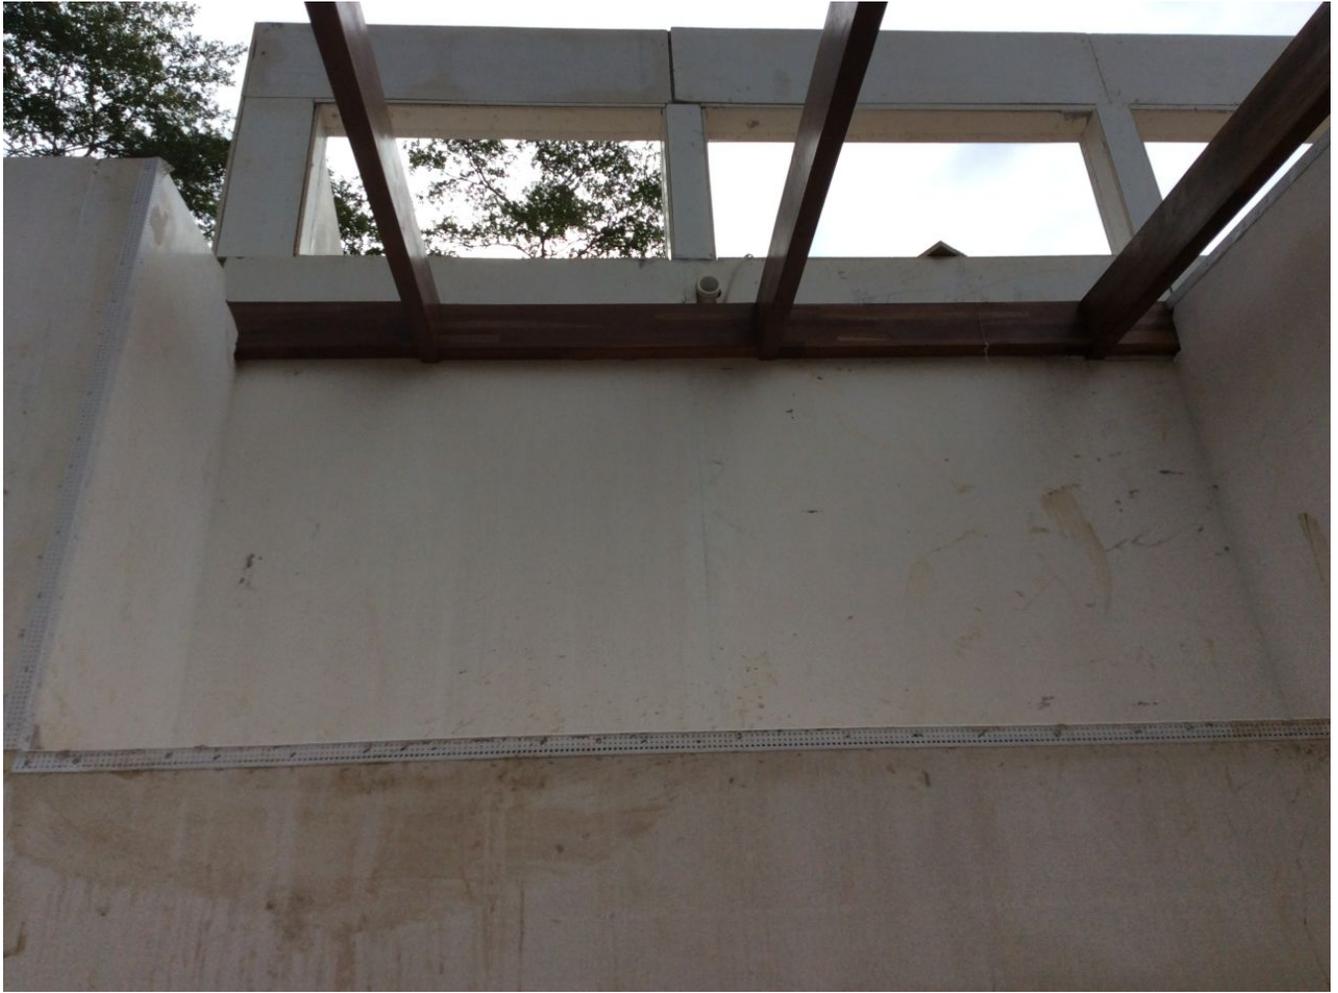
Rafters over the master closet. Rafters go into a pocket cut into the panel for support as well as being glued and screwed to blocking. Note the vent line peaking out of the wall so as to vent between the two roof lines.

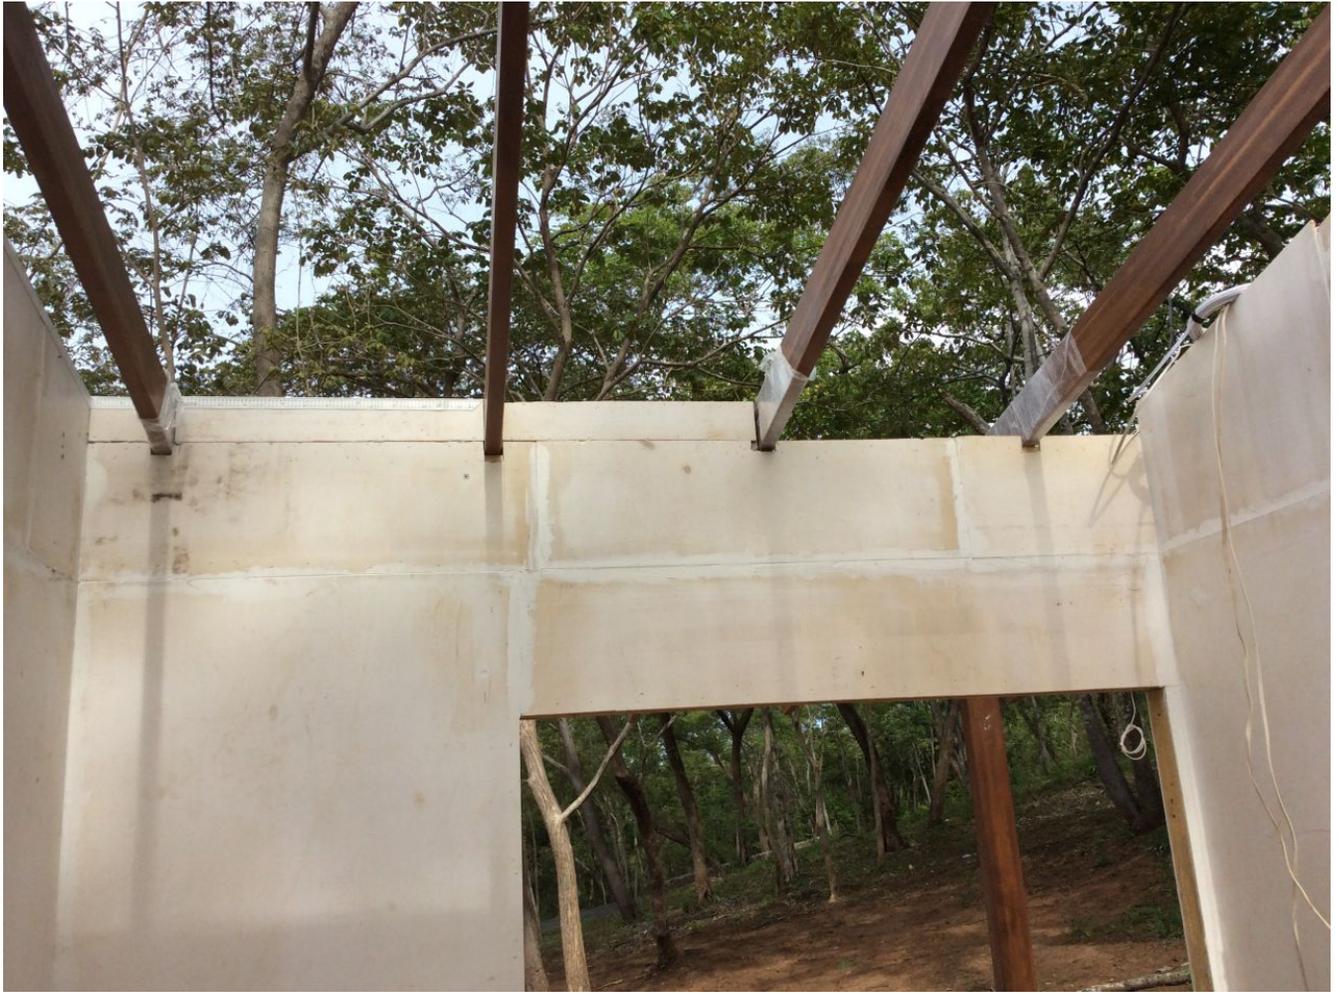
Rafters in place over the master and panel blocks are being added in. All are edged with plastic corners to avoid inevitable cracking from seismic activity.

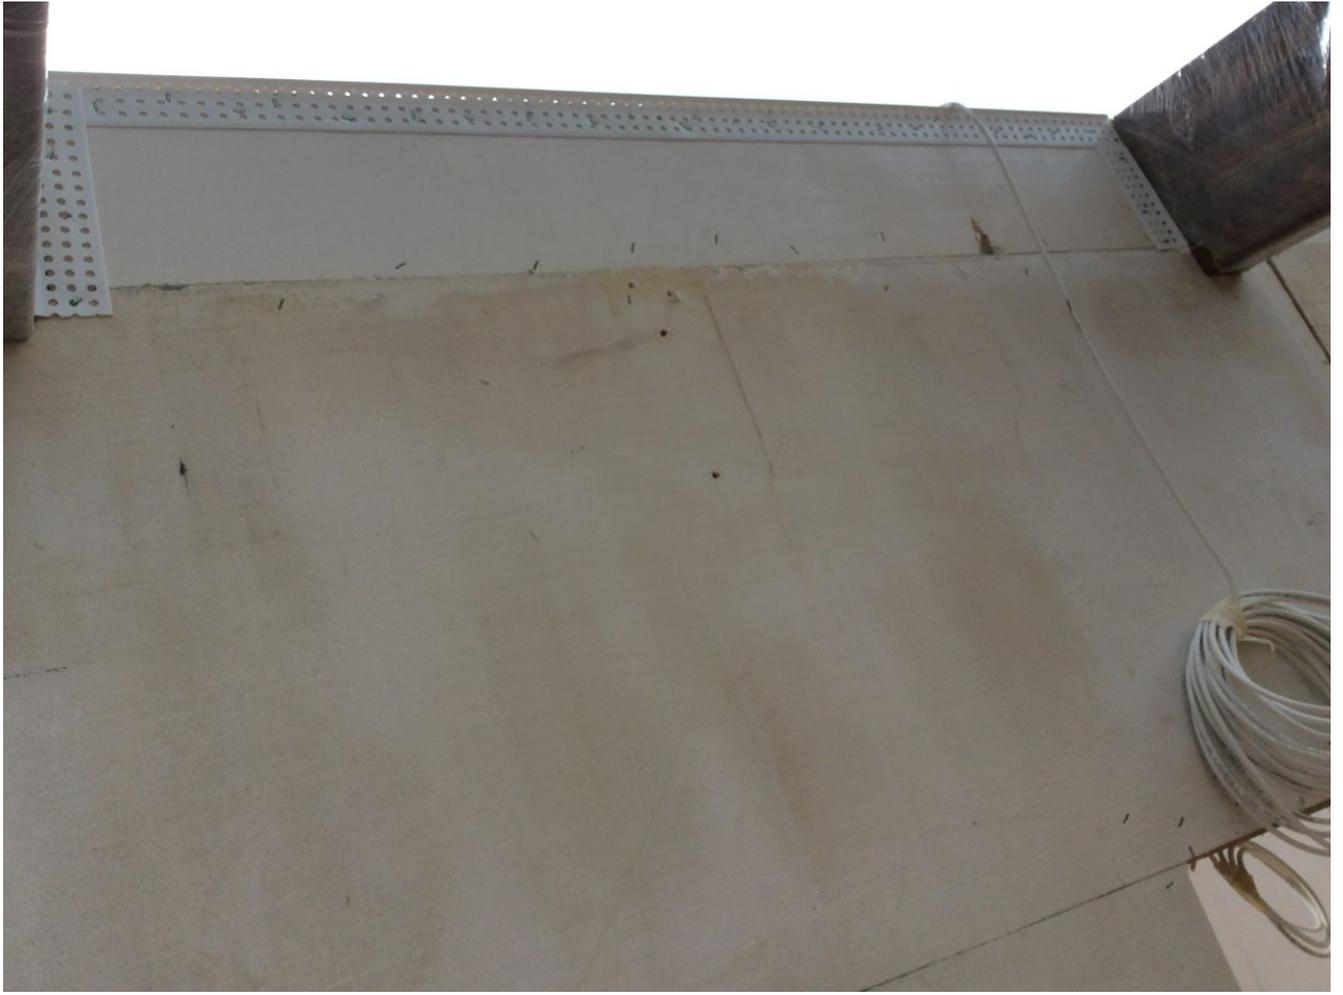
Close up of filling in the gable between rafters.

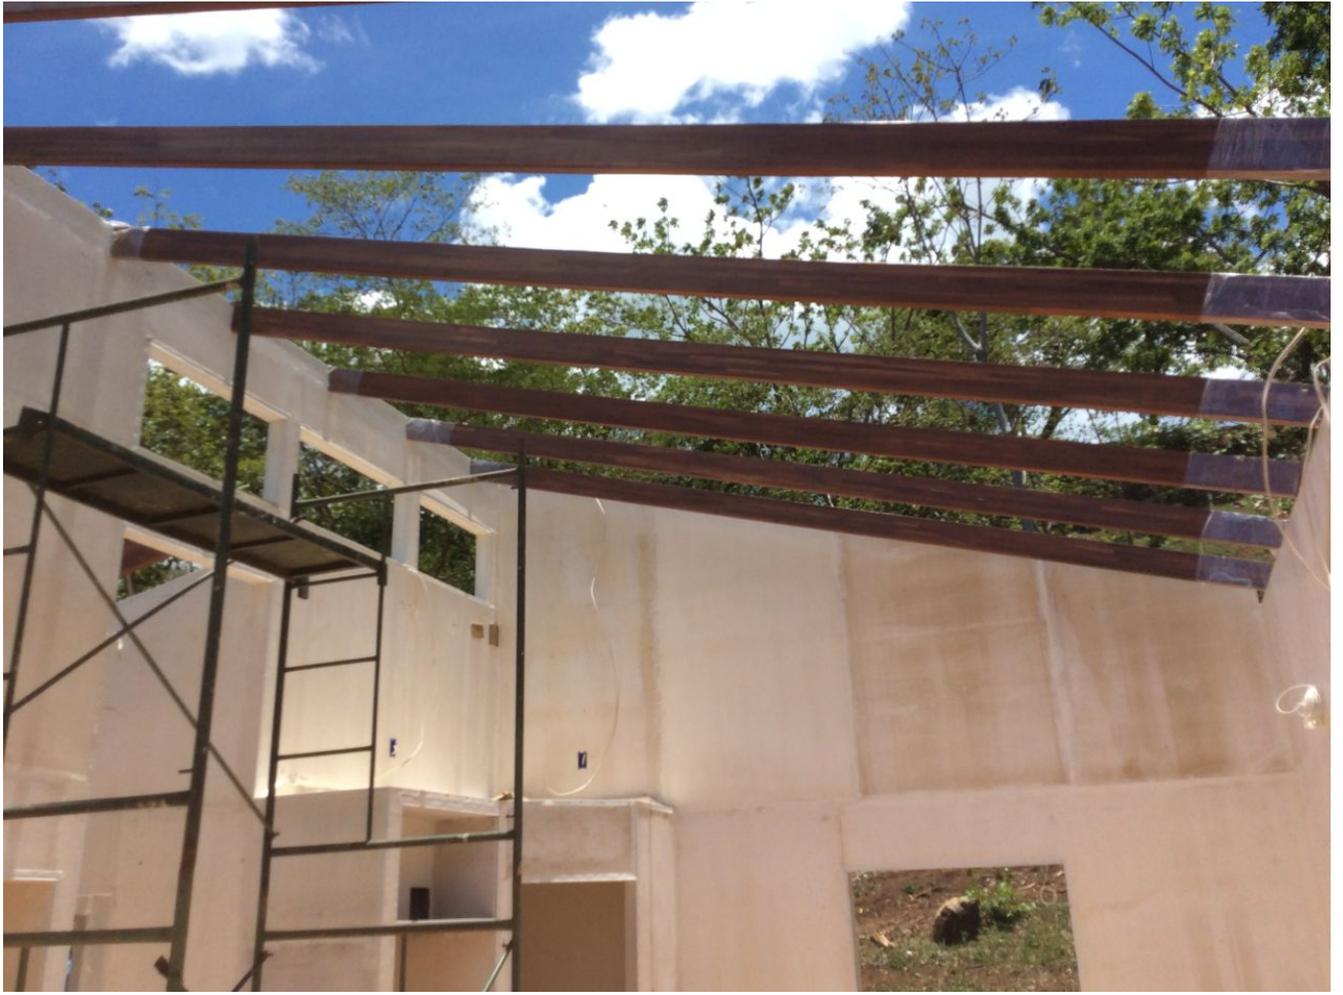
Rafters installed over kitchen.

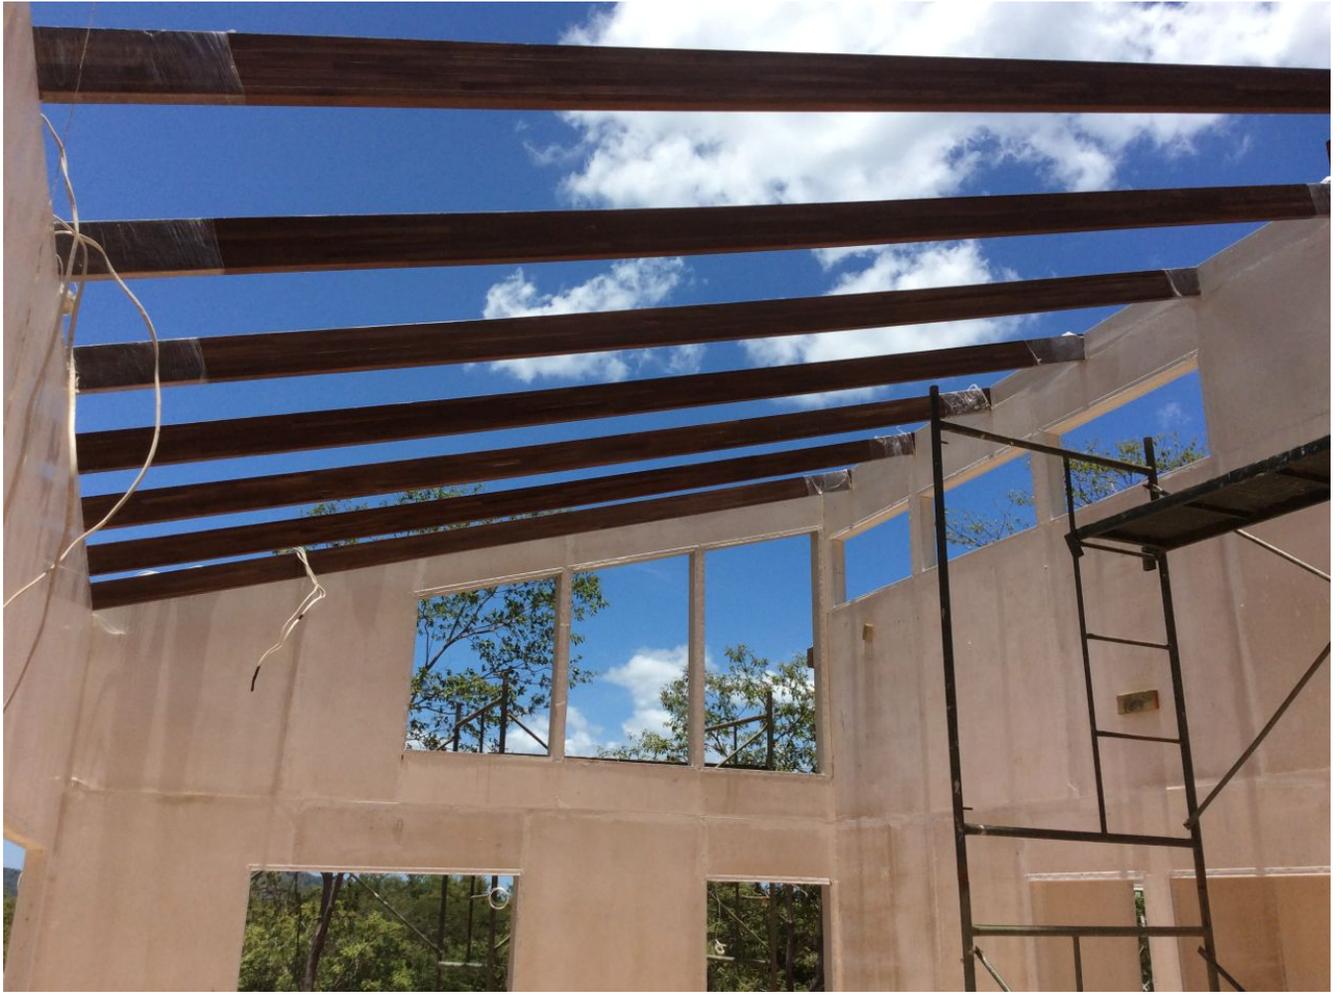
Rafters over front door living room and rake head windows.

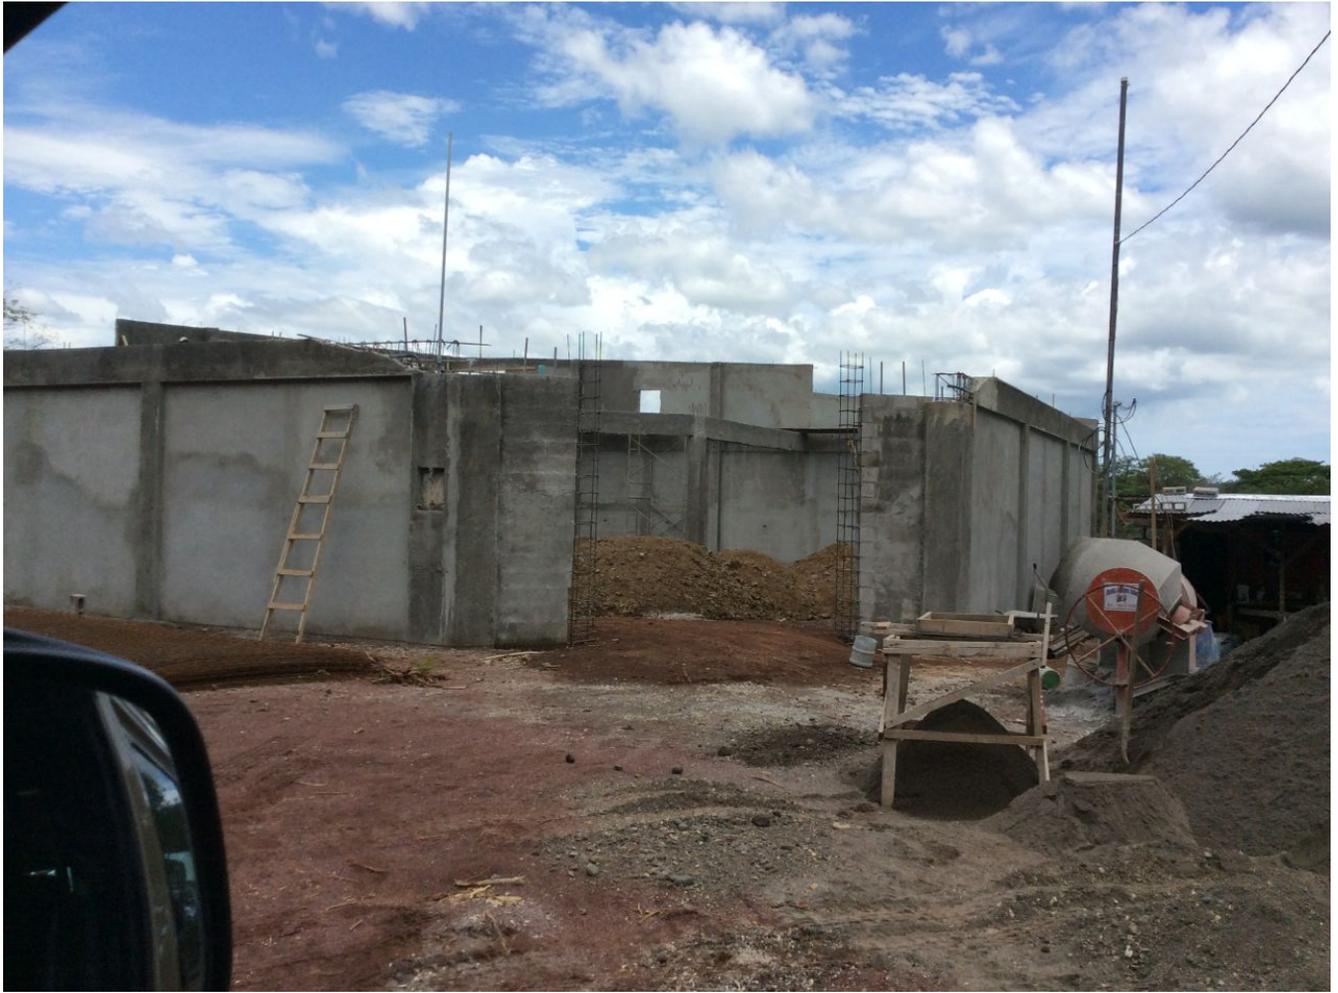
Actually it is a new building going up a couple hundred meters from the build site. Hence I observe it from the street every day with shall I say a degree of amusement. There is a huge structural error here. Can you spot it? No doubt this constructor if I dare call him that has spent his life building with concrete yet this picture indicates he knows less than nothing about what he does. The other big question is who the hell is the technical director on this job? Why is he/she not screaming blue murder and warning the smuck paying the bills just how incredibly bad this construction is. Certainly proves why there is supposed to be someone watching out for the technical requirements on any job site.

This is standard post and beam concrete structural system however this beam over the main entrance is absolute junk and could well collapse in any earthquake. You CANNOT CANNOT make a cold joint in concrete and have any structural integrity. This beam to be stopped in any pour must be joined at a bulkhead in the center of a supporting post. In this case at the 45 degree corner to the front entrance where also the steel need to be carried through the bulkhead to tie the two sections together. Whereas what have the IDIOTS DONE? They let the concrete just flow down from the last pour in a taper so now when they fill this in to complete the beam you have what is called a cold joint where new concrete will not, does not and cannot adhere to the old concrete even if done the next day let alone a couple of months later. I would not recommend standing in this doorway in the middle of an earthquake.

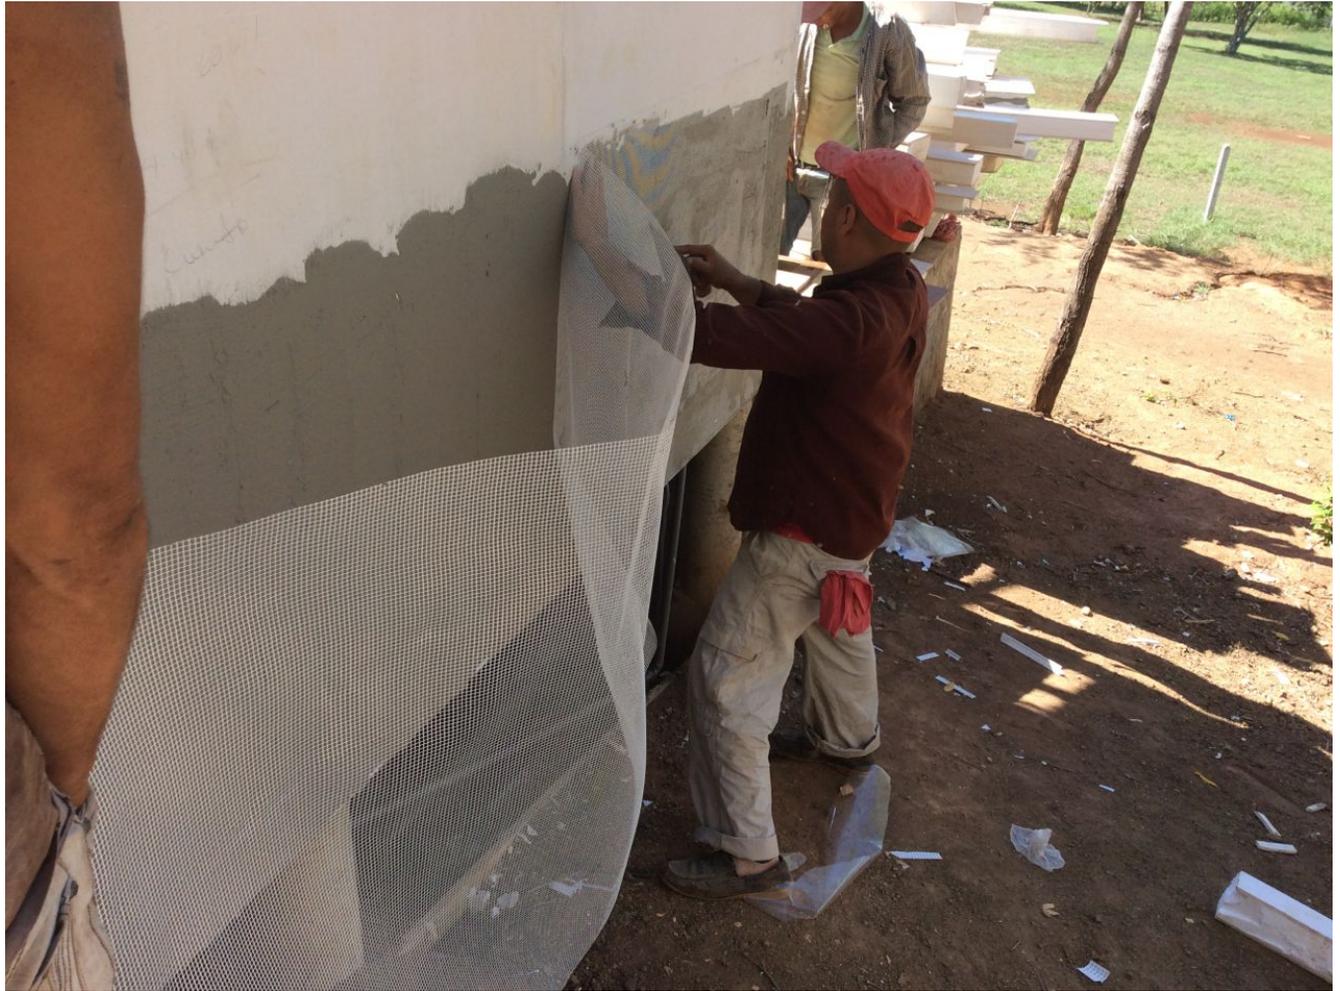
Yes we have a very solid base with the MgO skins of our panels but now we want to add an impermeable continuous skin to all of those by tying it all together in one sold membrane to give the home a water tight and insect tight covering. So here we start with the first section of stucco being added to our panels beside the storage area. Note a base of very sticky stucco from SUR is troweled onto the wall then a heavy fiberglass mesh in meter wide rolls is embedded into the base stucco.

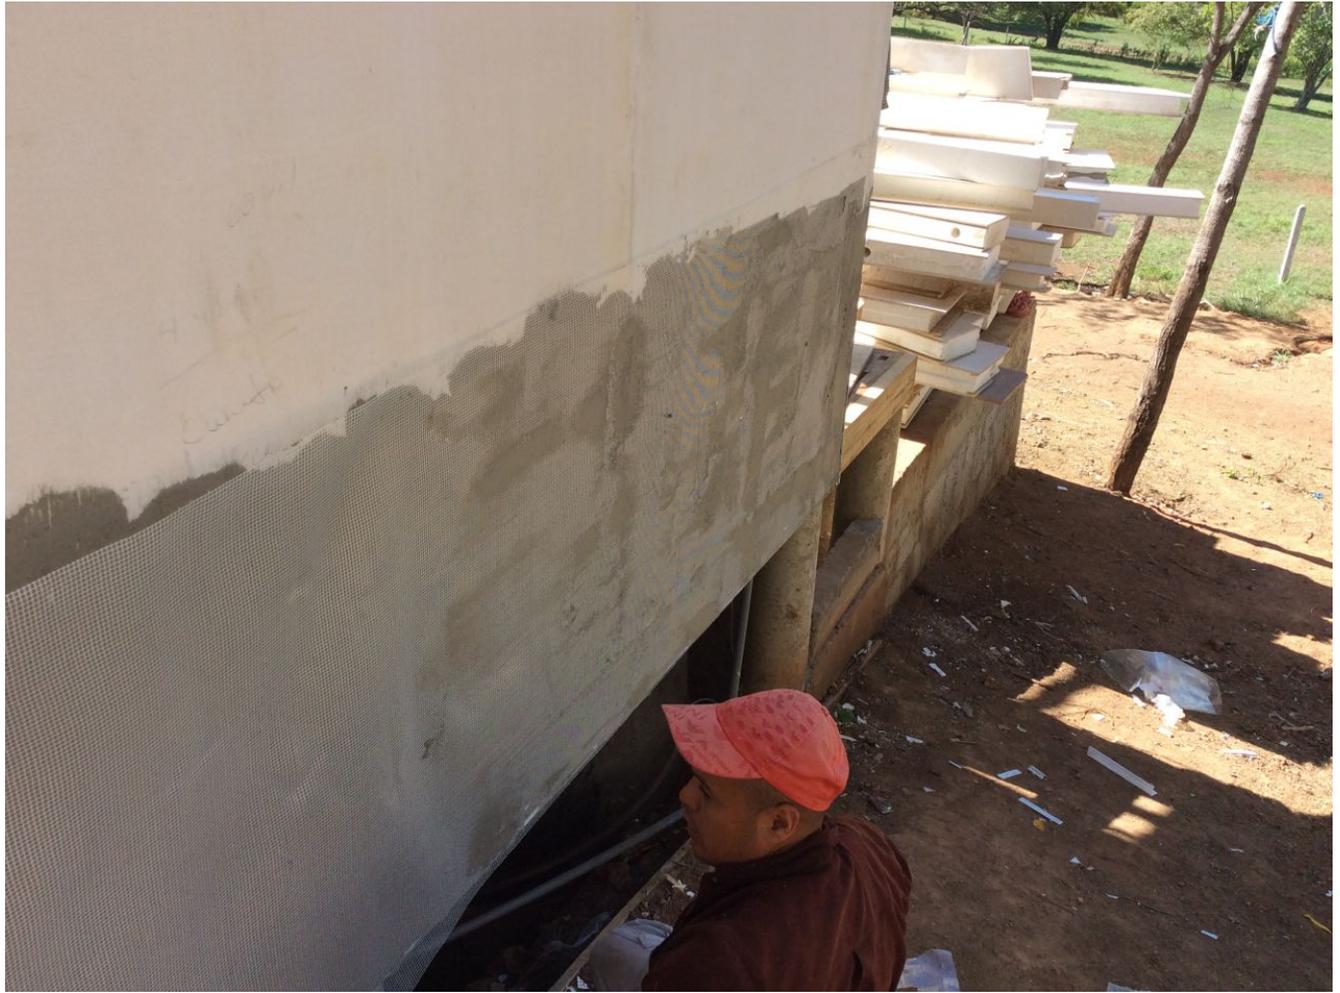
A second coat is now added over the mesh.

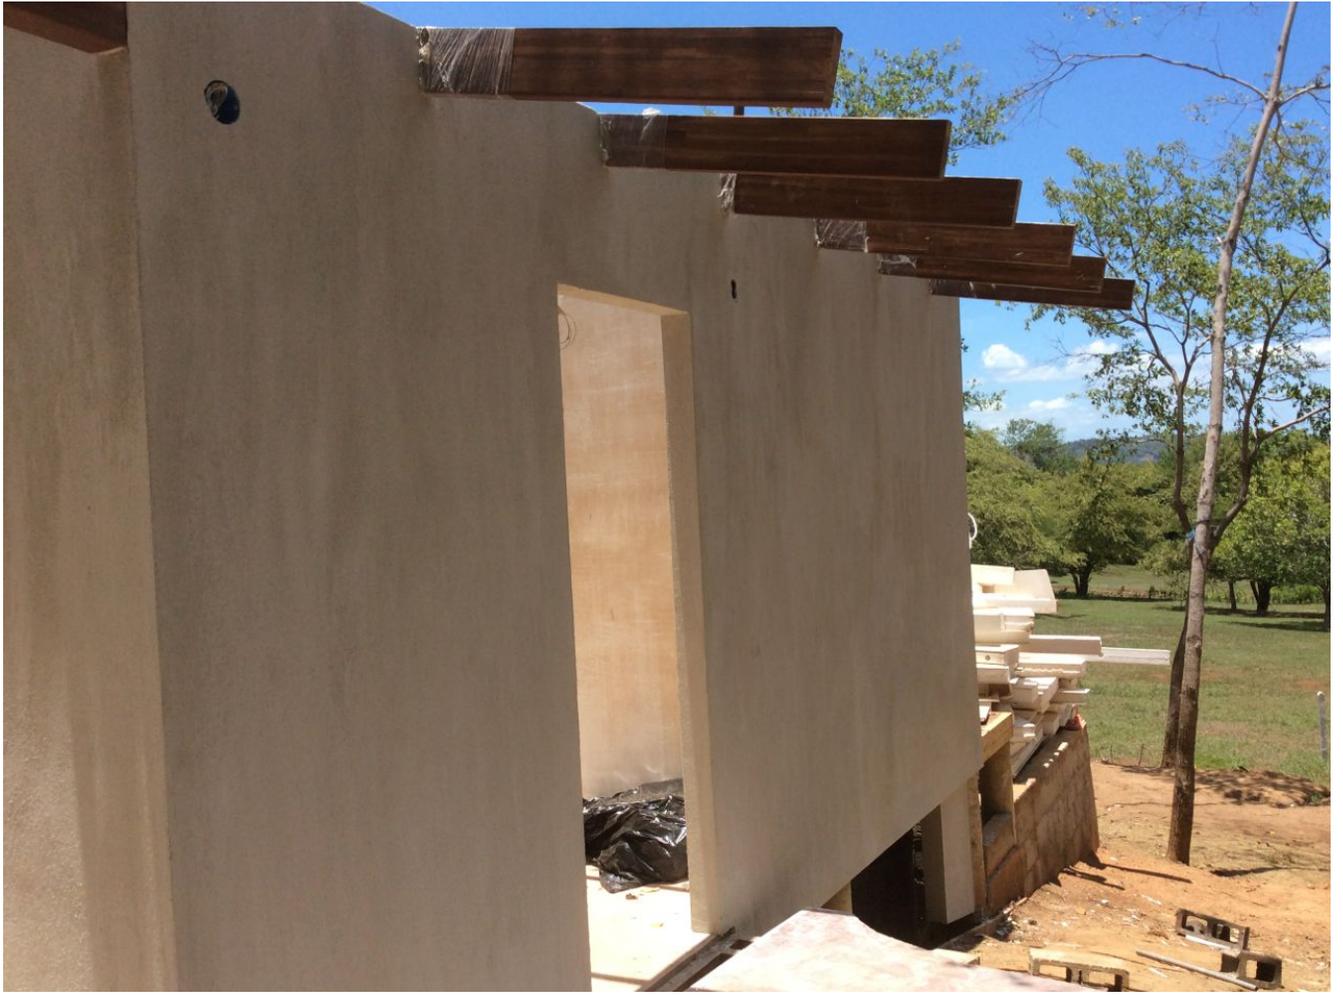
West wall now has its first two coats complete.

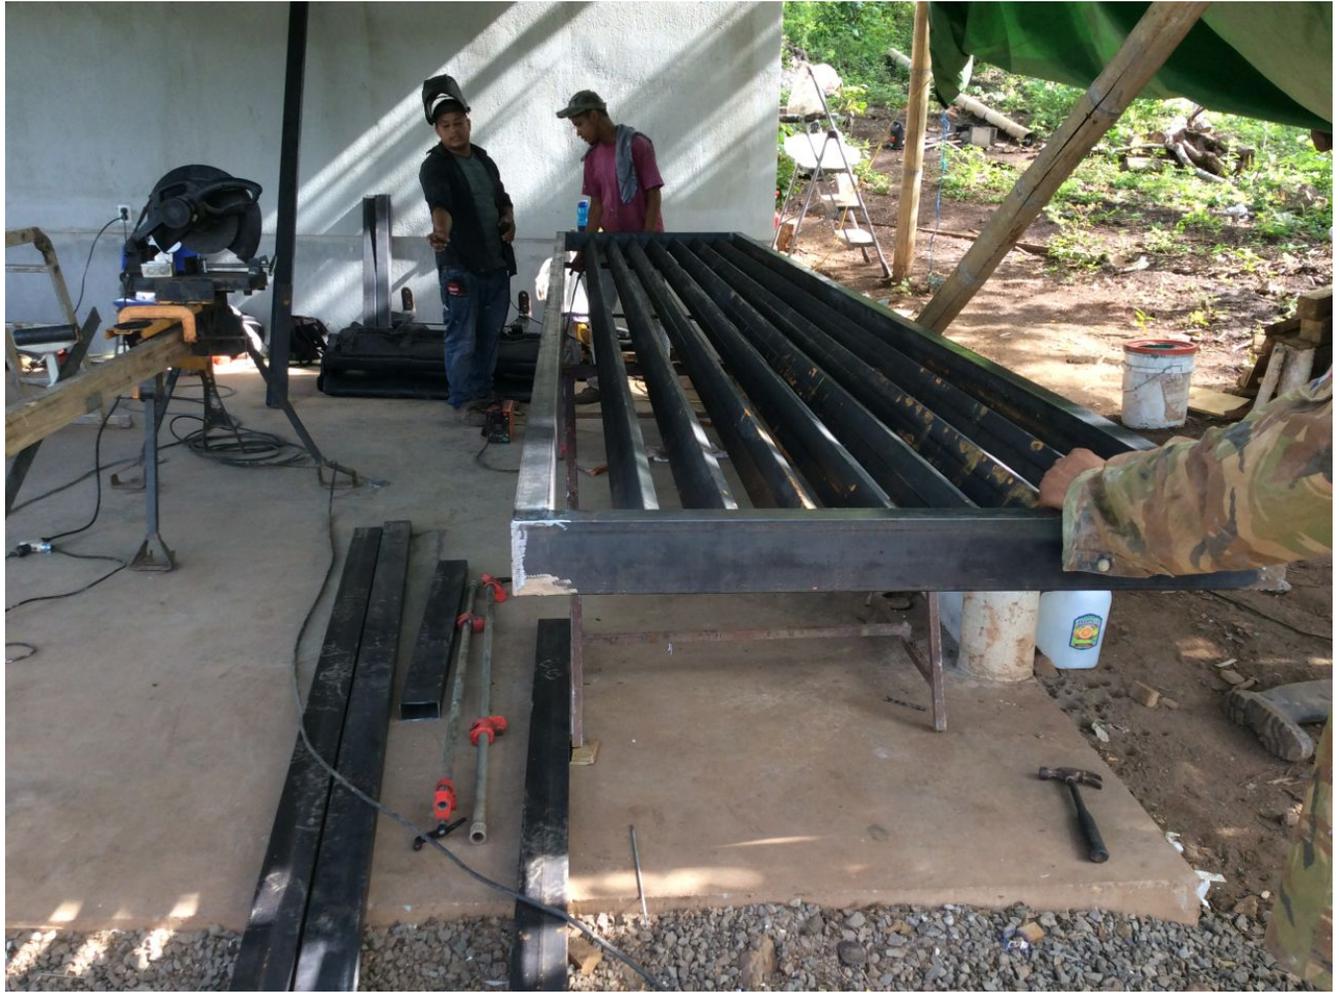
Here we have turned the carport into the metal fabrication shop where we are making the custom window louvers and a trellis for the front of the home using 2 x4 steel tube as well as 1 x 3.

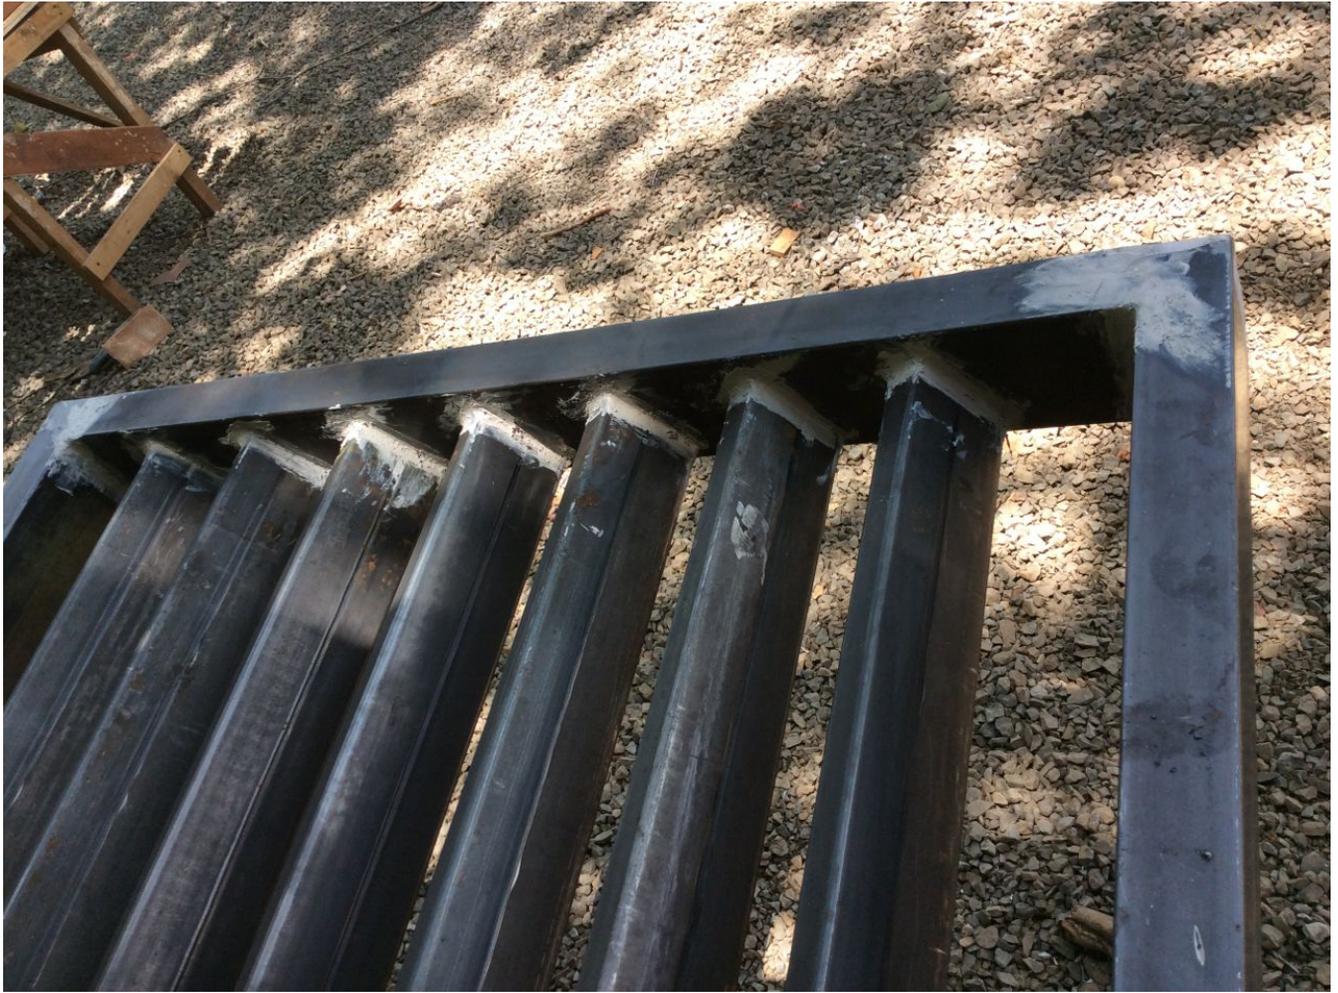
Here you see we have put filler in to not leave any openings for water to enter the metal and start oxidizing at the joints.

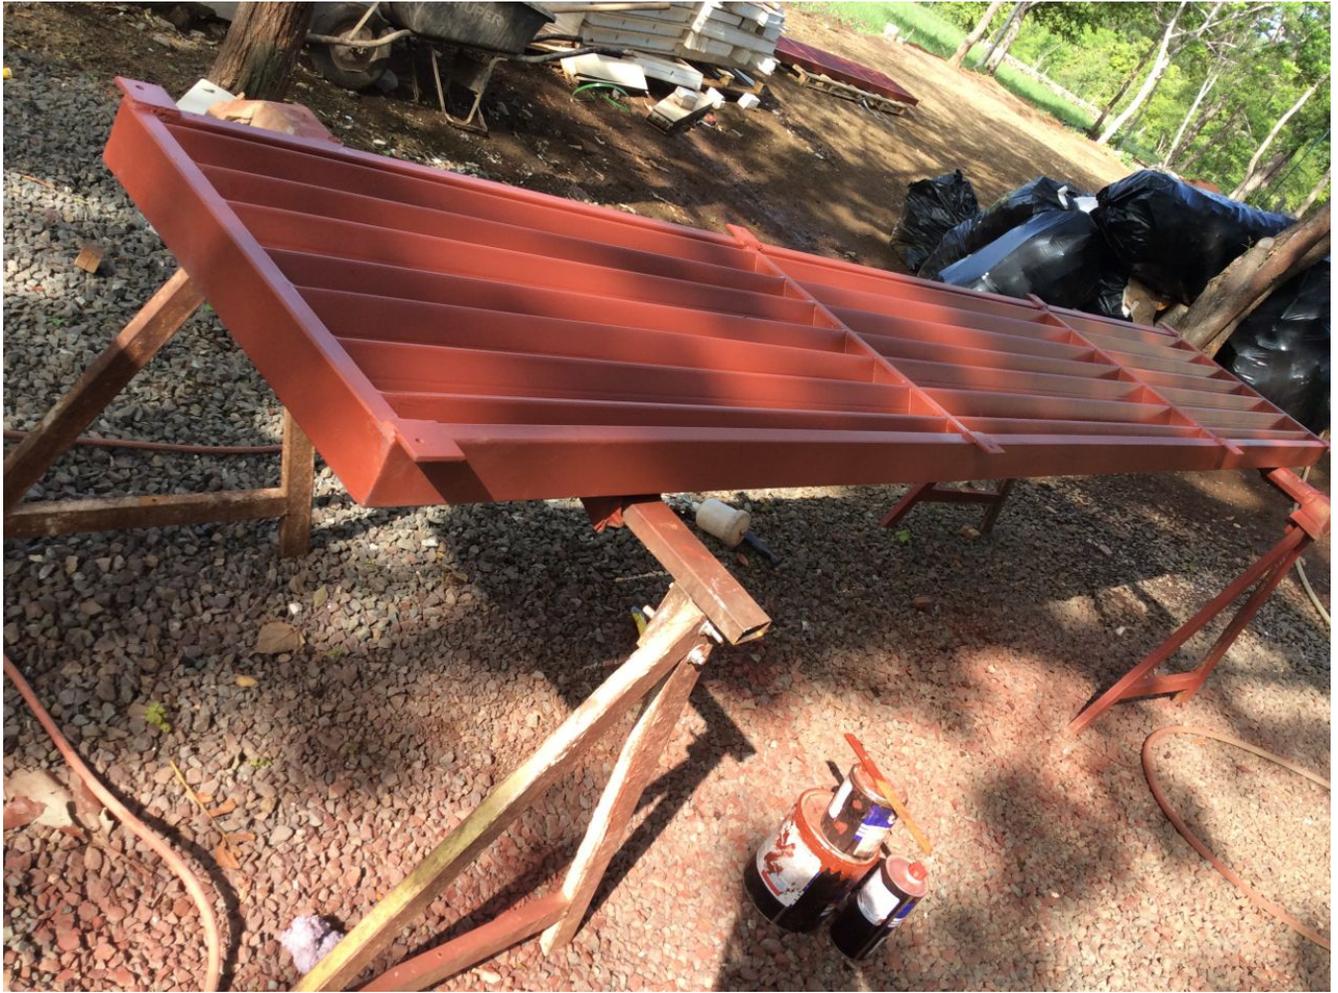
First coat of primer is now added. Lets remember we are within 2 kms of a significant surf that will be sending lots of salt onto these finishes. This requires one to spend smart money versus stupid money. Normal paint has around a 5 year life under such conditions. Let's stop and consider what it will be like to try to re-coat all this metal once it is installed on the home. How difficult it is to apply such paint and what kind of finish a typical brush applied paint will leave.

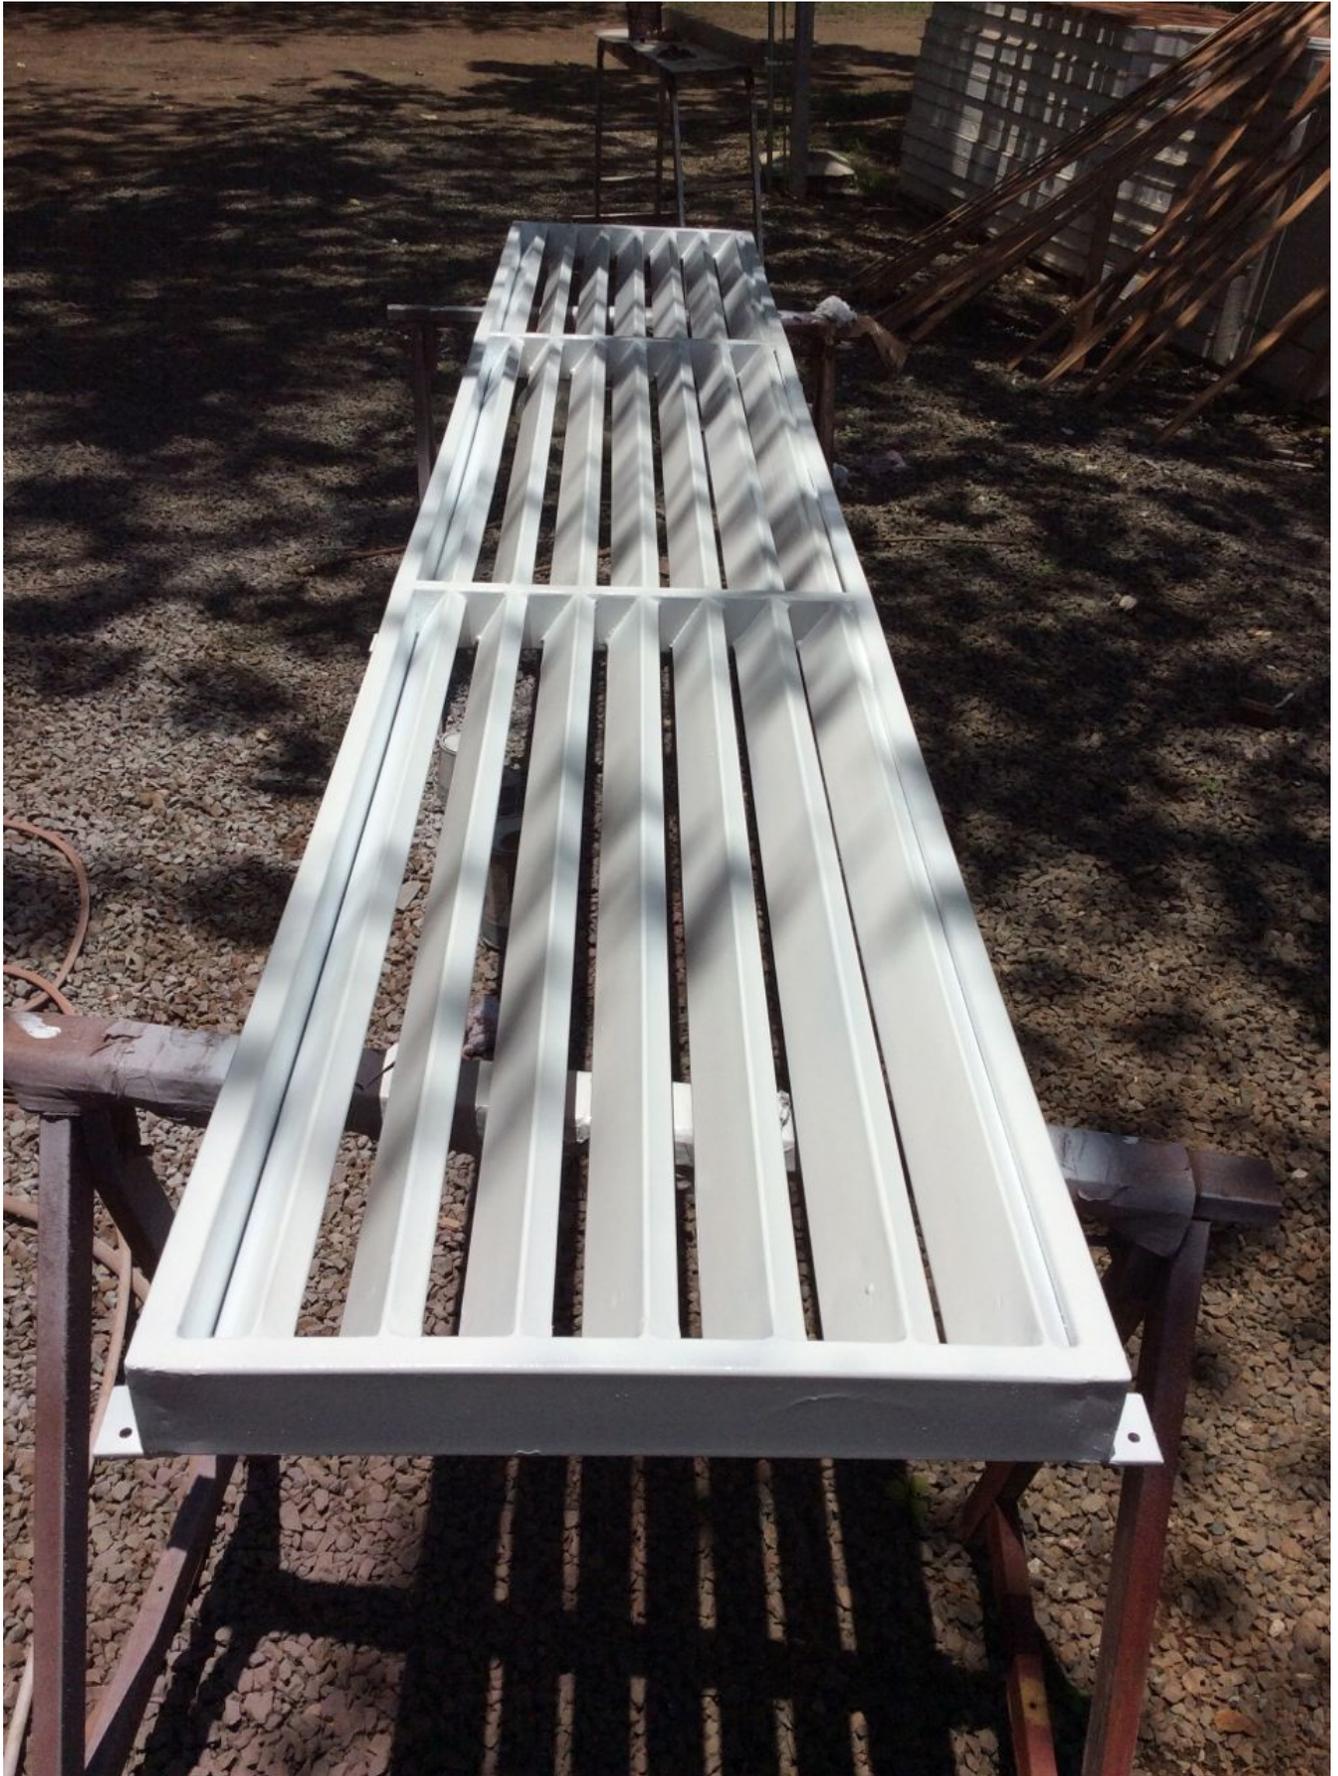
Finish coat of white has been applied to the ventilator louvers. All this paint is a product made under license of a Dutch company by SUR paints here. The catalyzed polyurethane is designed specifically for a marine environment for piers and boats. It is EXPENSIVE meaning it is twice the price of typical anti-

corrosion paints. However its life expectancy should be more in the range of 20 years hence over the life of the finish it is actually cheaper. I drive by construction sites and regularly see someone out there brushing on a paint on metal. That makes for such a crappy finish with such a short life in these environments hence why I call this spending smart money or stupid money. I leave it up to the reader to decide which is which but at the very least to understand the difference and what makes it so.
