Techos Siglo XXI – Constructing Your Green Home

Home Diary – Playa Grande

Super Home #3 begins with a BIG MOVE!

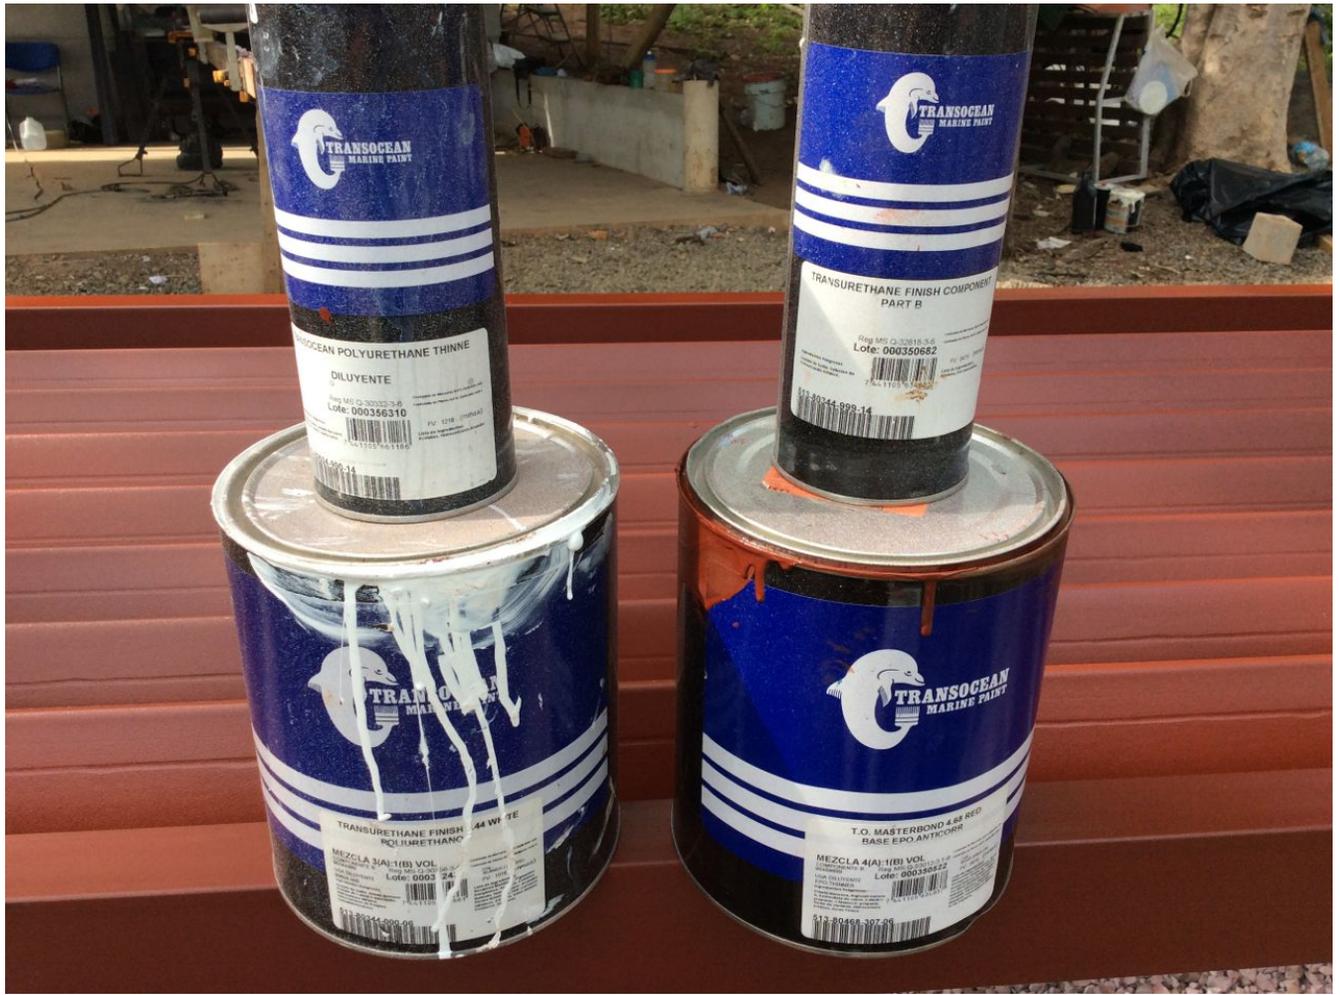
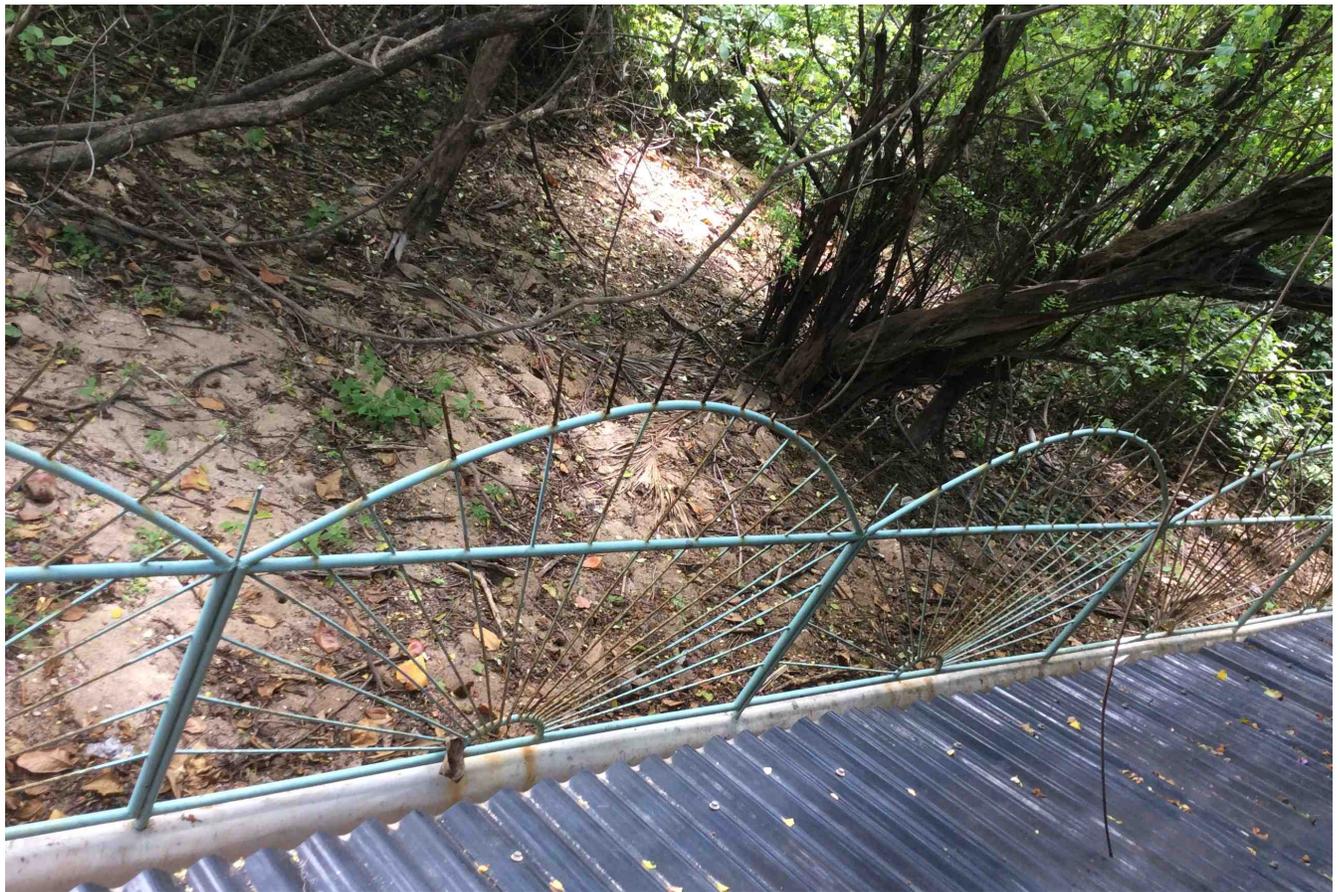
Here is a perfect example from Playa Grande as to what you get in the long run when you put cheap paint on a fence in a beach zone.

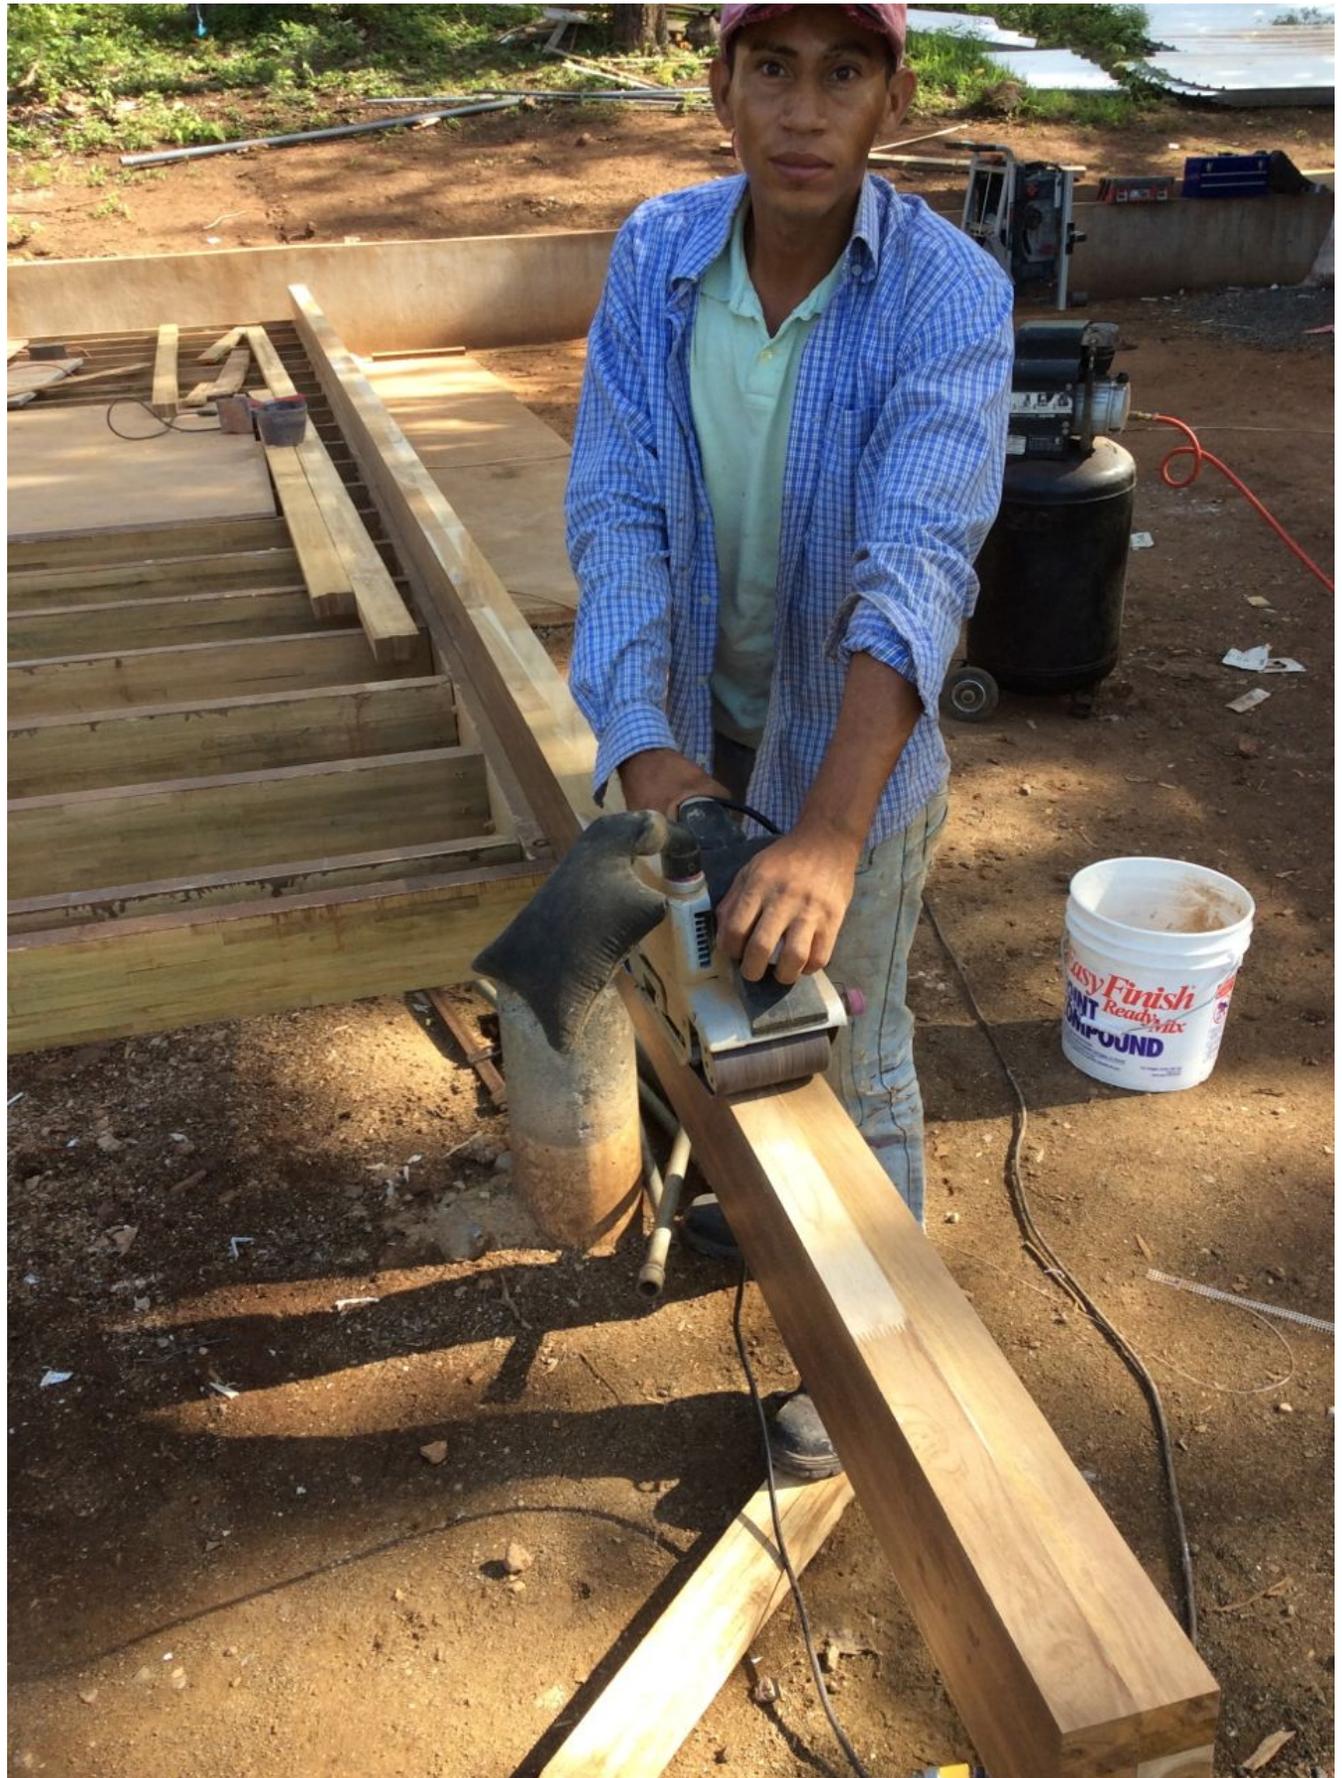
Danile here sanding up the looong beam we laminated that will support the roof over the deck area. This beam is 10 mtrs or 33' long and had to be made on site due to its size and the fact that the big press is limited to 6 mtr long lengths.

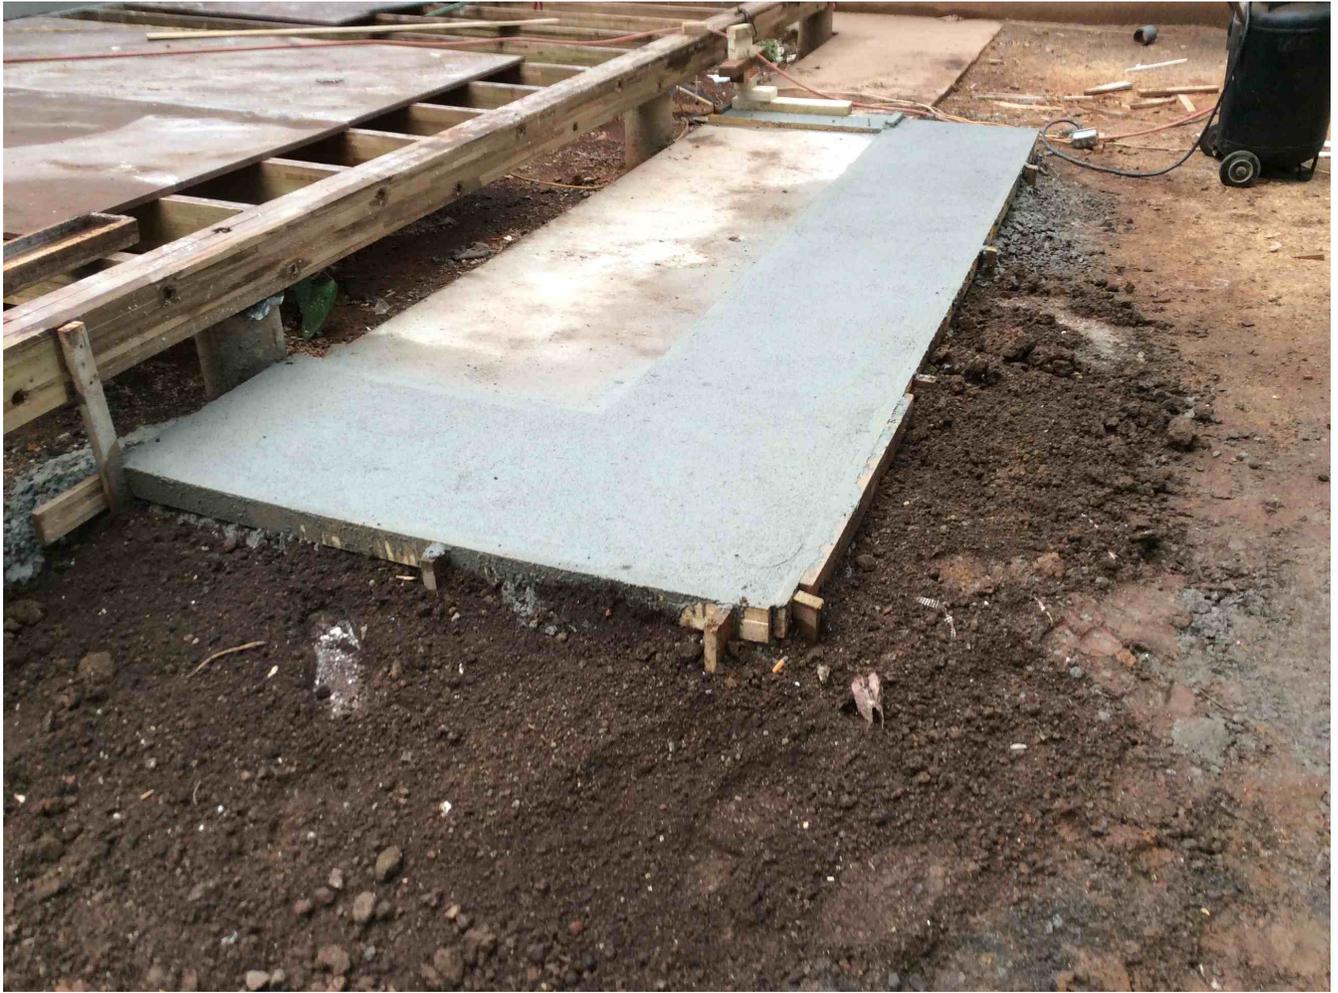
We started to work on the accesses to the home by building up 4 sets of steps to access our elevated home. Here we have started by expanding the sidewalk into a base platform in which to build from.

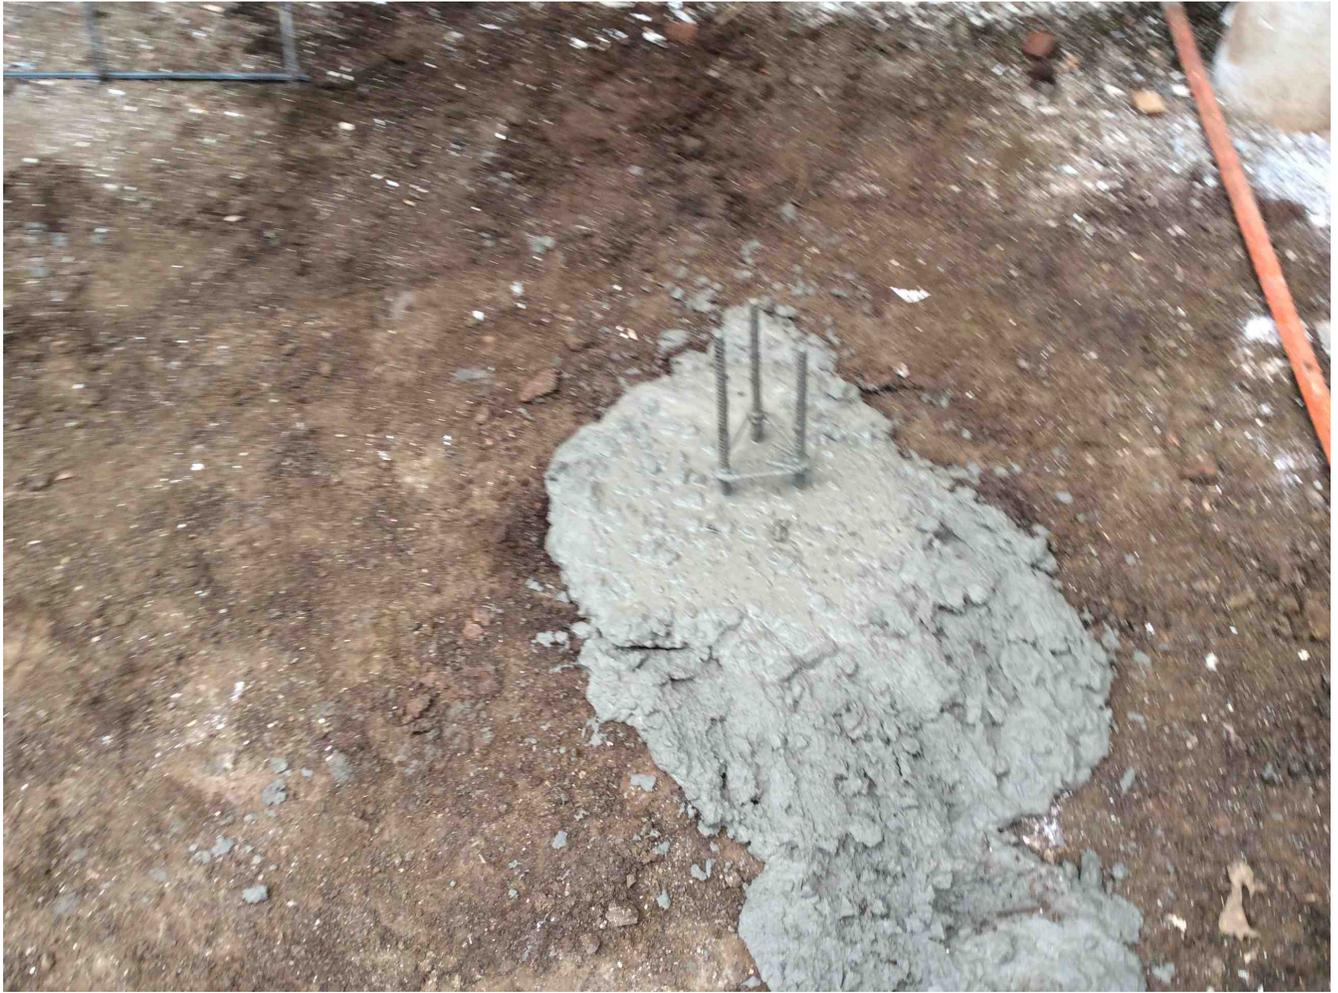
This also required adding two pilings for both of the front steps with the new plan for the design of such. These steps are sitting on top of over four feet of fill we placed in this area which means over time this fill will compact hence settle. Without pilings going down to virgin soil this settling would cause the these two steps to crack and settle as well. With this protection the dirt will still settle but that means just adding in more fill with zero damage to any of the structure.

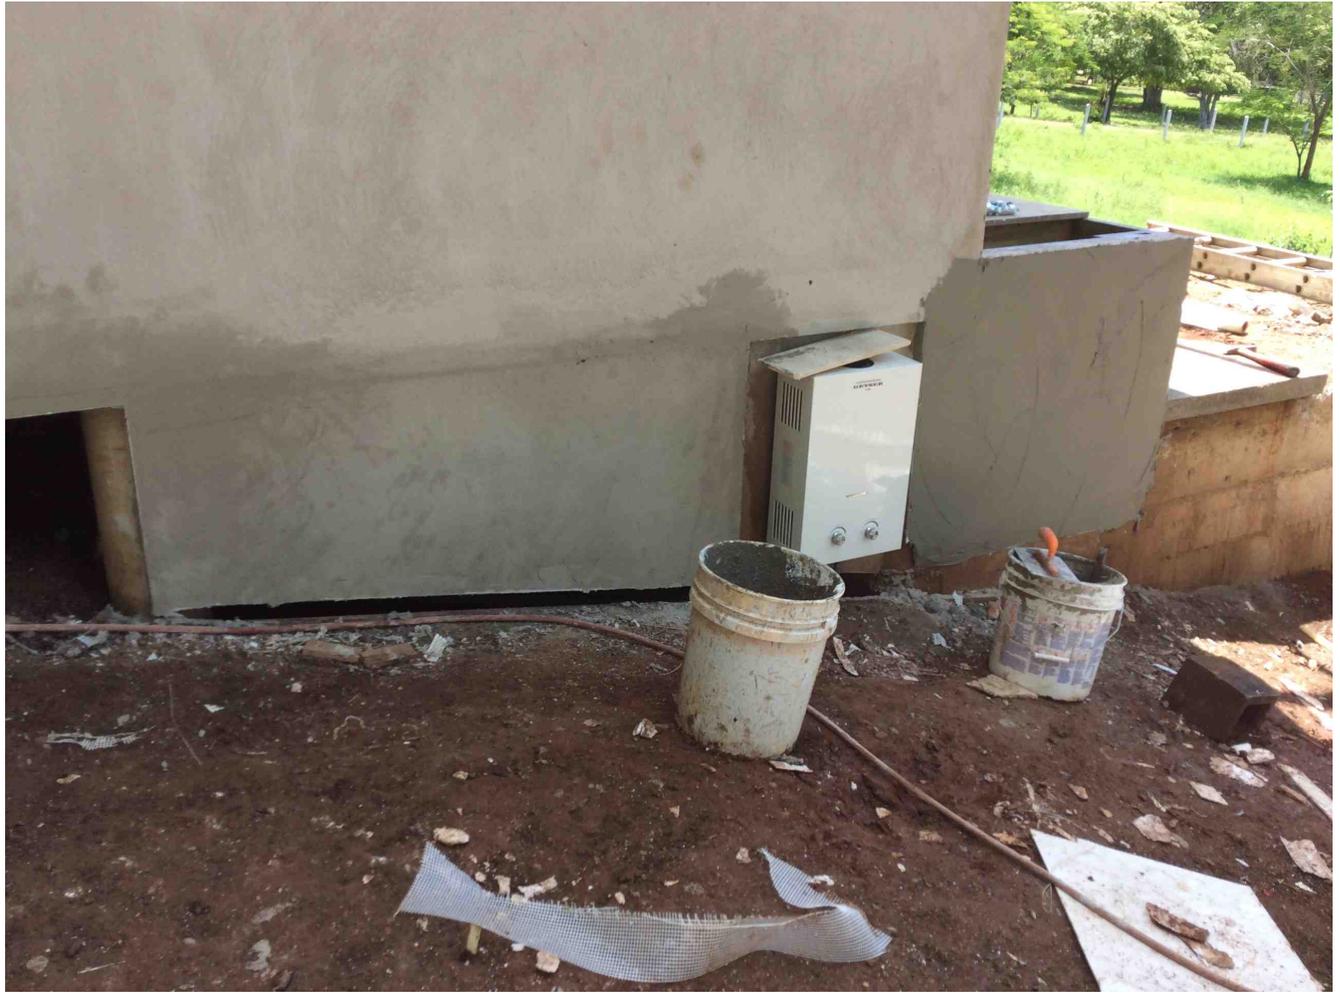
In order to complete the look of this corner of the home we have used up some of our junk panels in carrying the wall down to the ground to close in the water tank hole and to provide a base for the gas water heater.

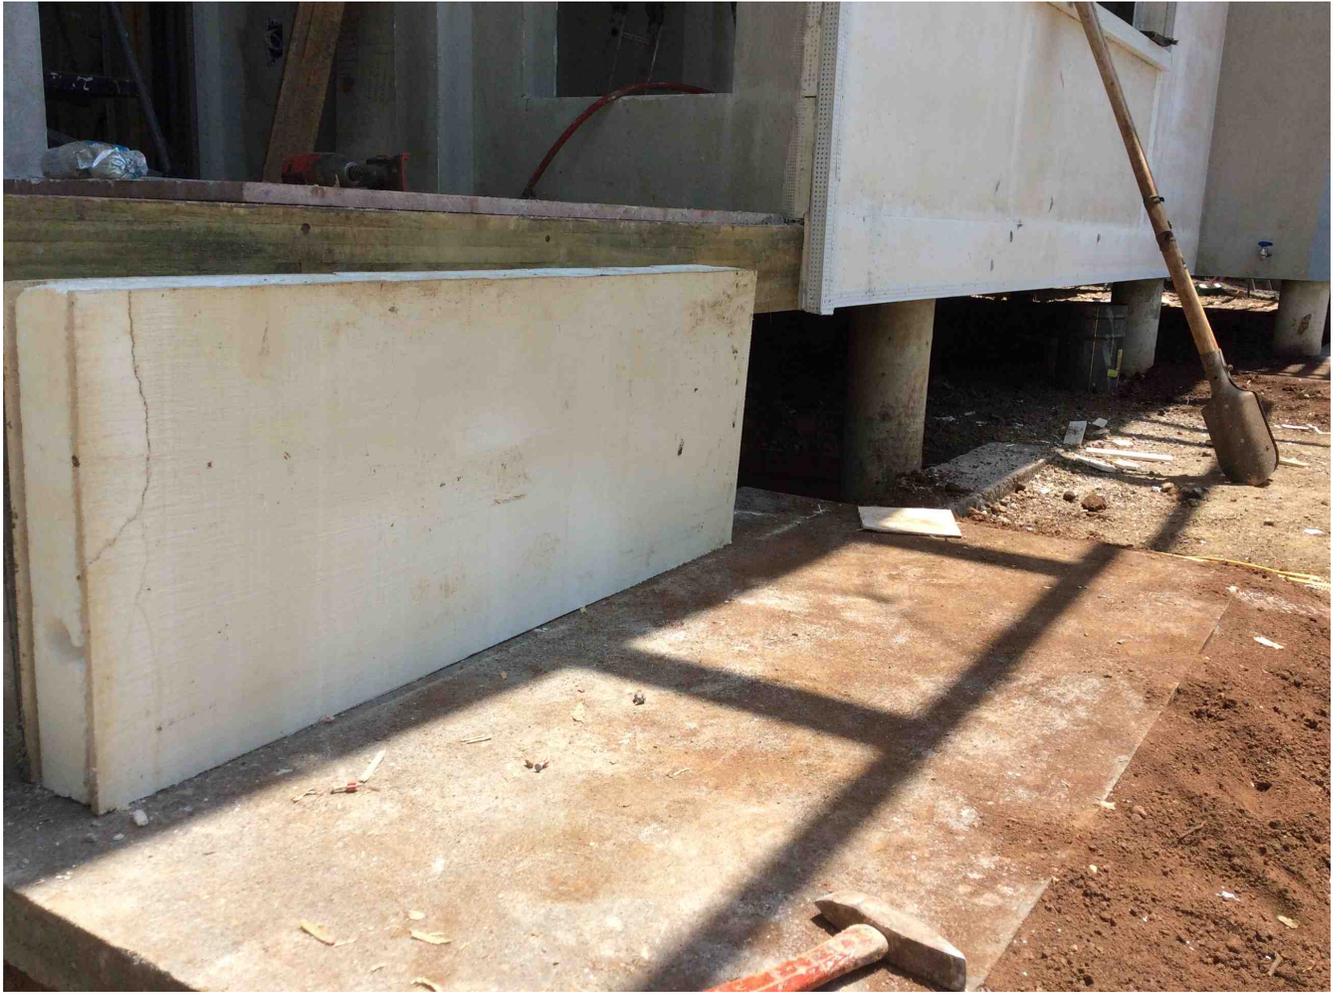
More panel scraps used to provide a backer to sustain the base of the steps.

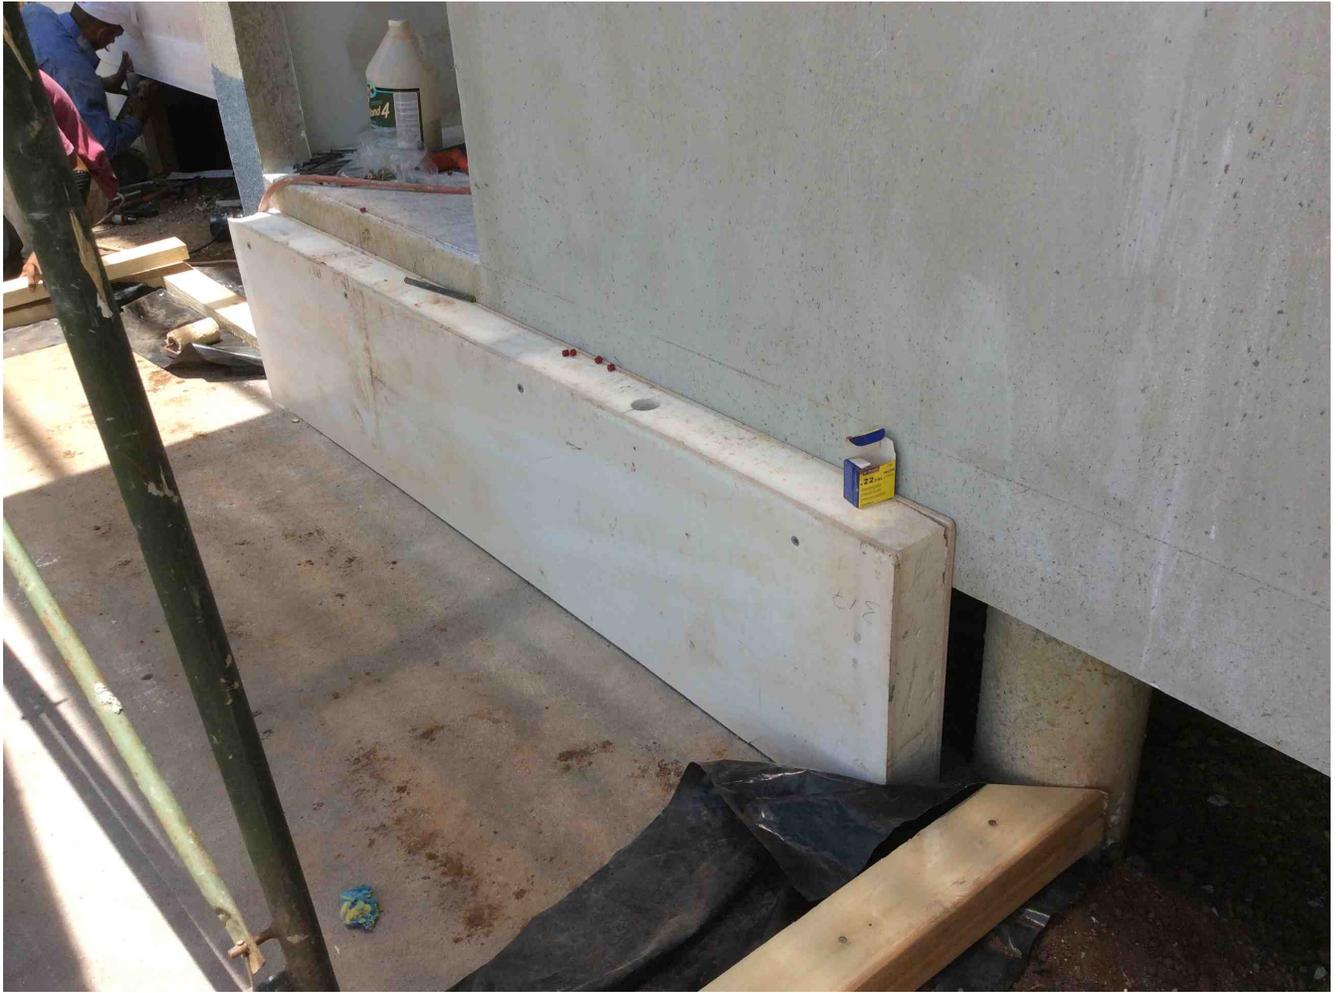
Base for front step completed with panel used as a back again and first two tiers of wood nailed down to create the risers of the step. Here we are using a Melina 2 x 4 to create the risers and structure of the steps.

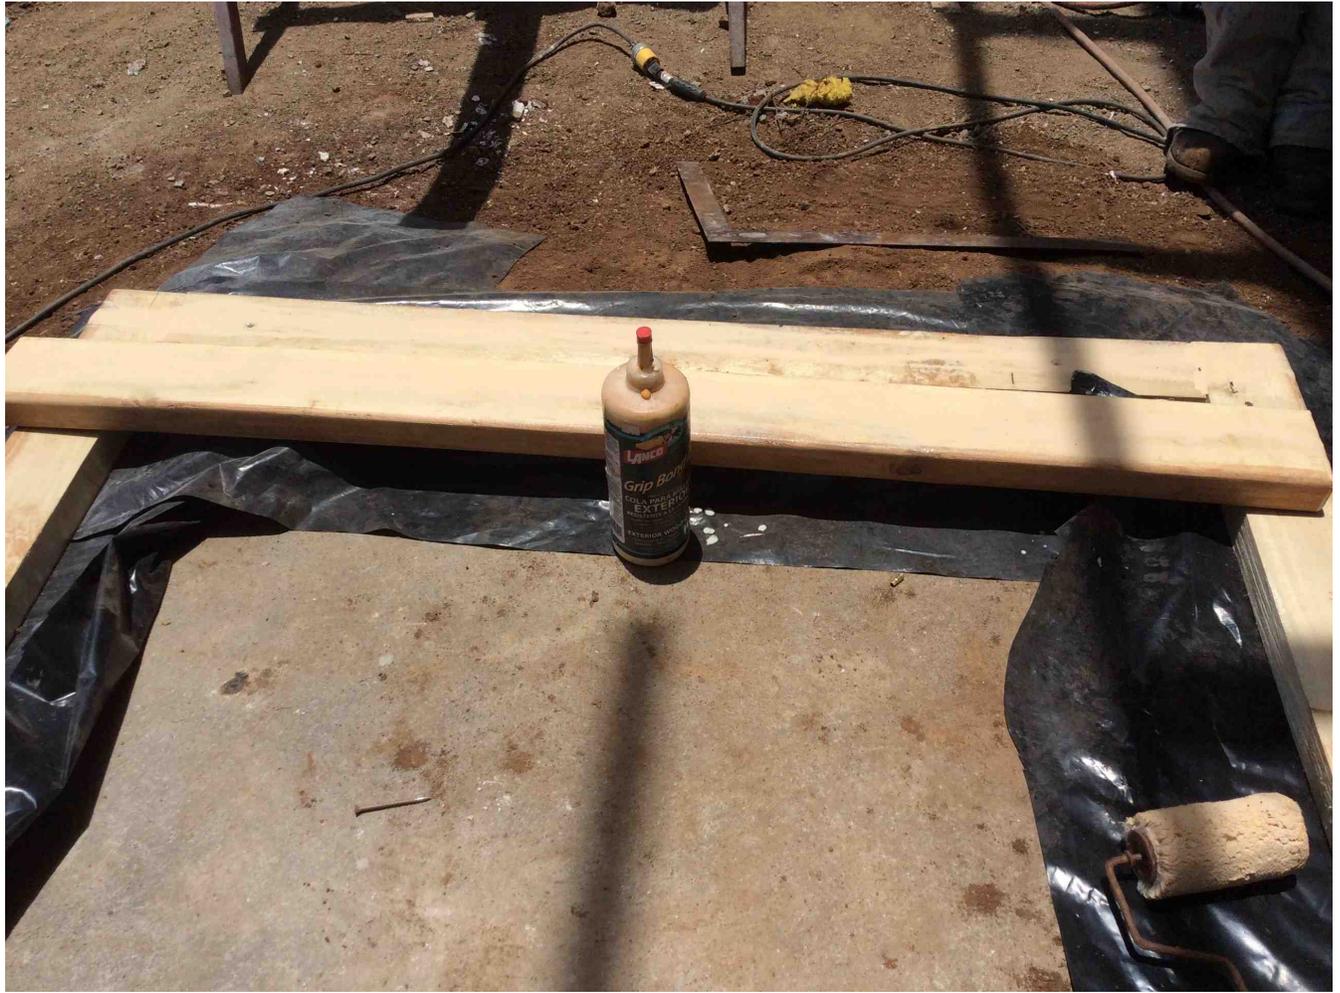
Here is an example of how you could well call us the glue crew as we glue everything we do. In this case Lanco's Grip Bond #4 which is an exterior glue not affected by normal moisture levels. This prevents entry of any creepy crawlies and it also stops any of the components from warping and twisting after the fact. In essence it is a flu-lam step very similar to all the rest of the structure just done on site as is required in this case.

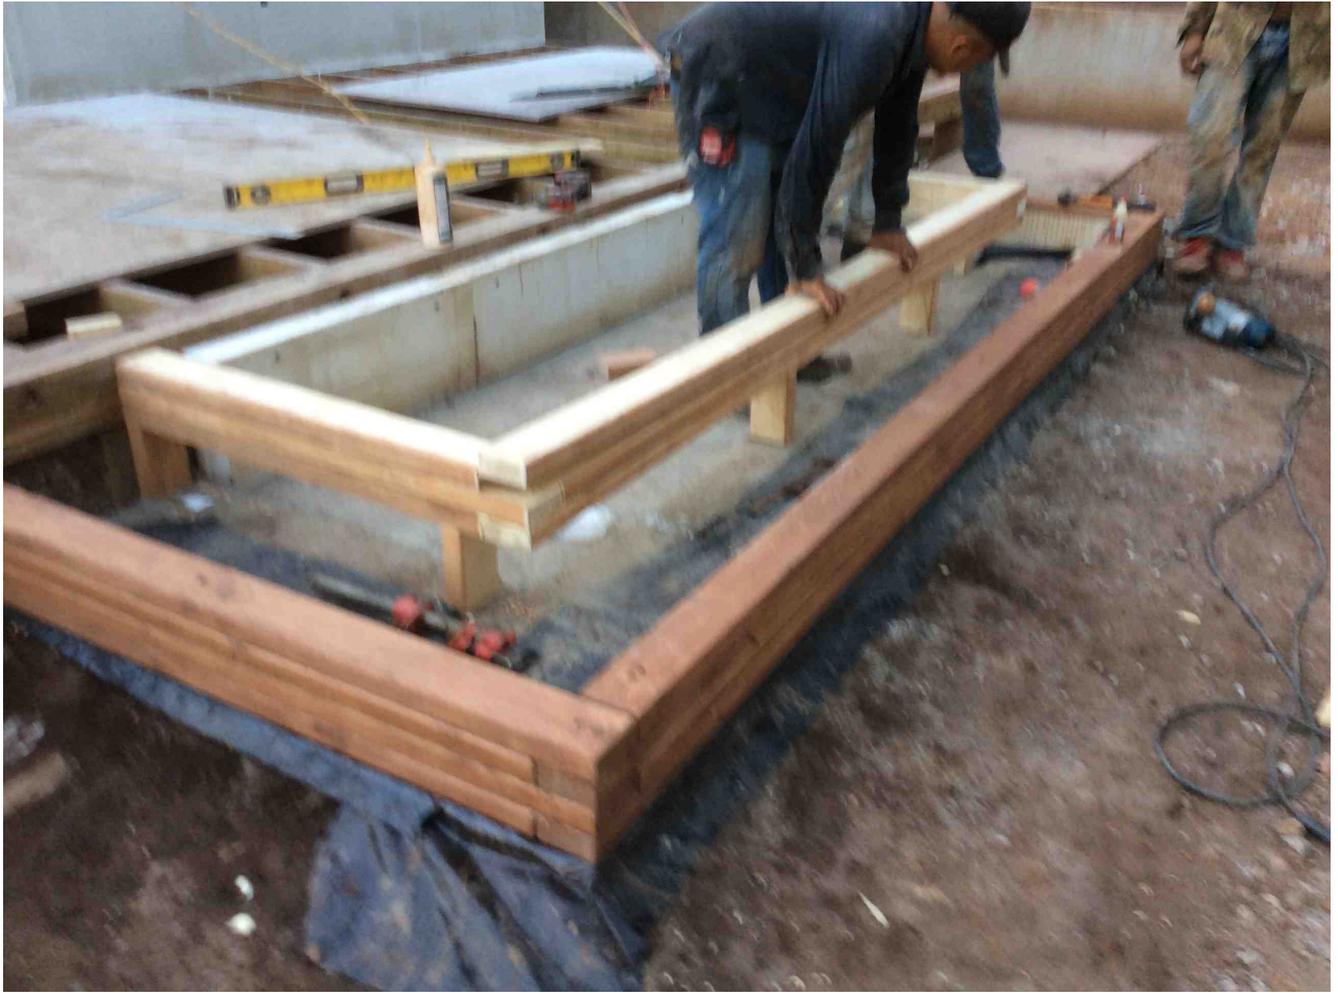
Here we are assembling the second riser that creates the large platform for the entry into the deck area. Note the black plastic protecting the wood from the moisture of the concrete base, always the greatest area of risk since these two do not play well together at all.

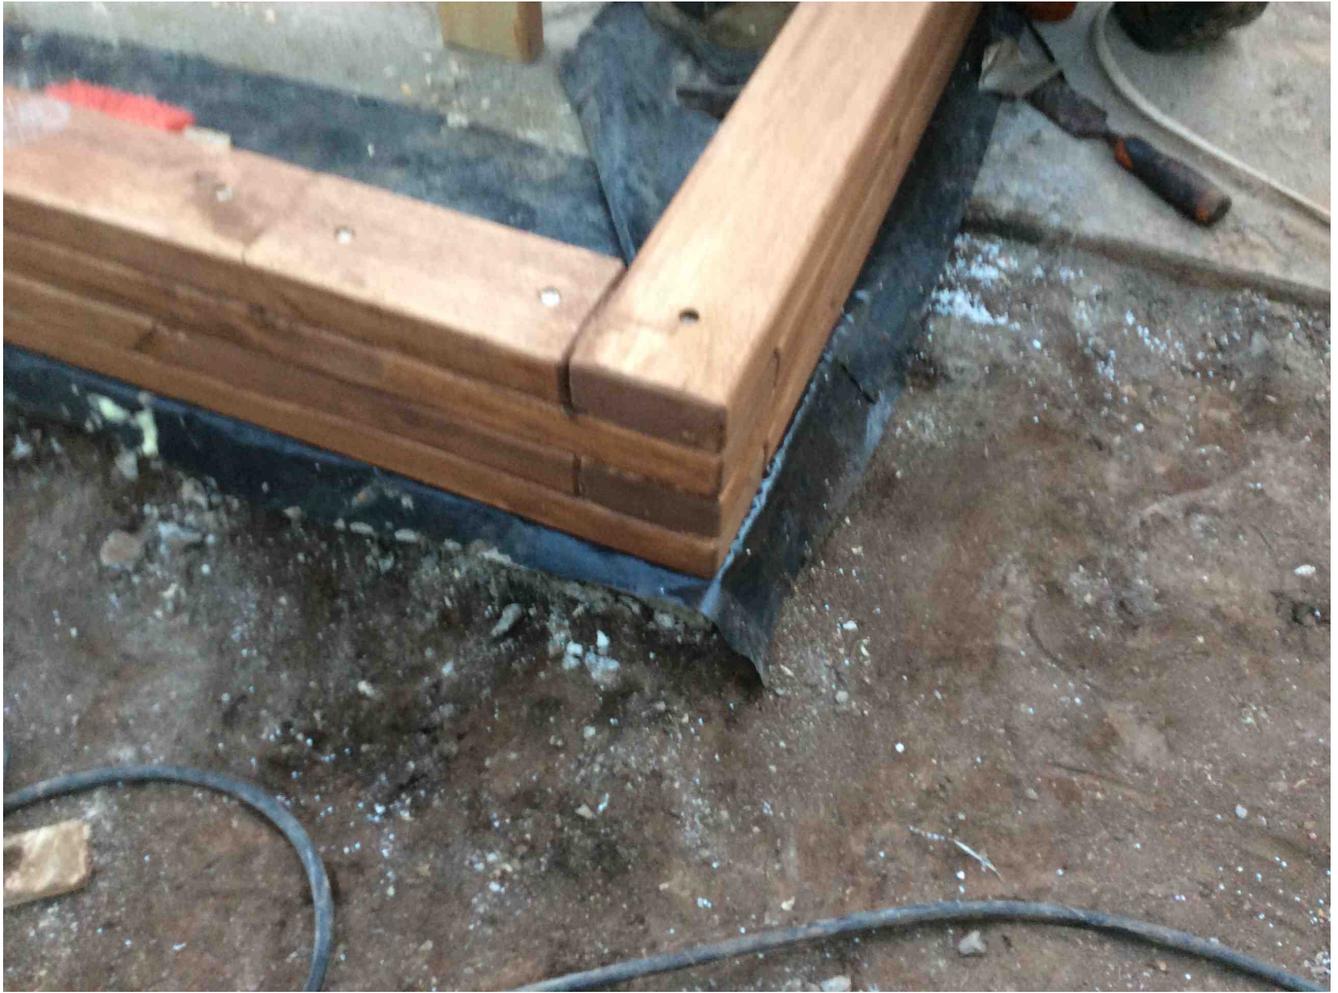
Each layer of the riser is interlocked together creating a very strong connection.

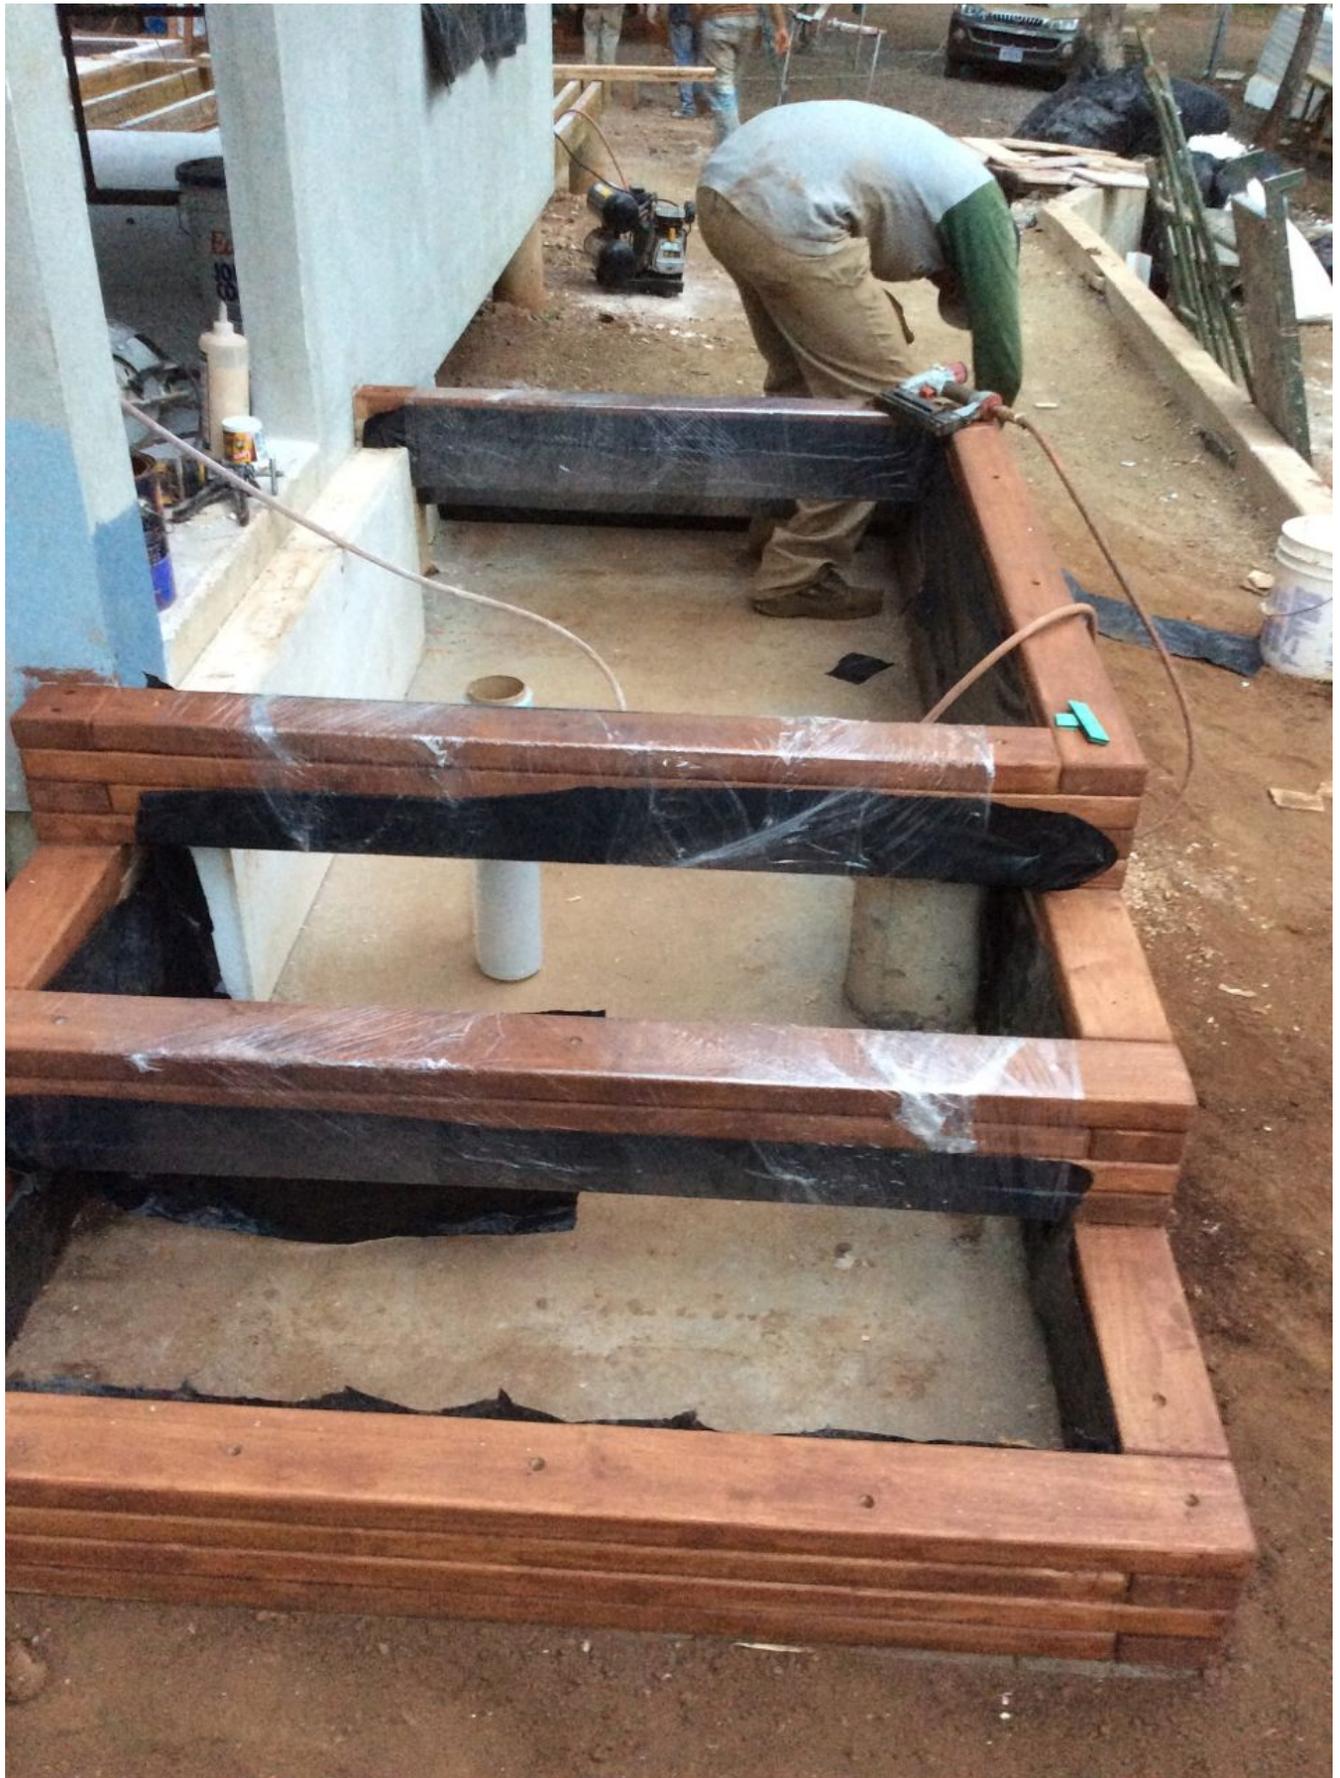
Front step structure is now completed ready for being filled with fine rock to create the base while reducing the use of concrete to a minimum.

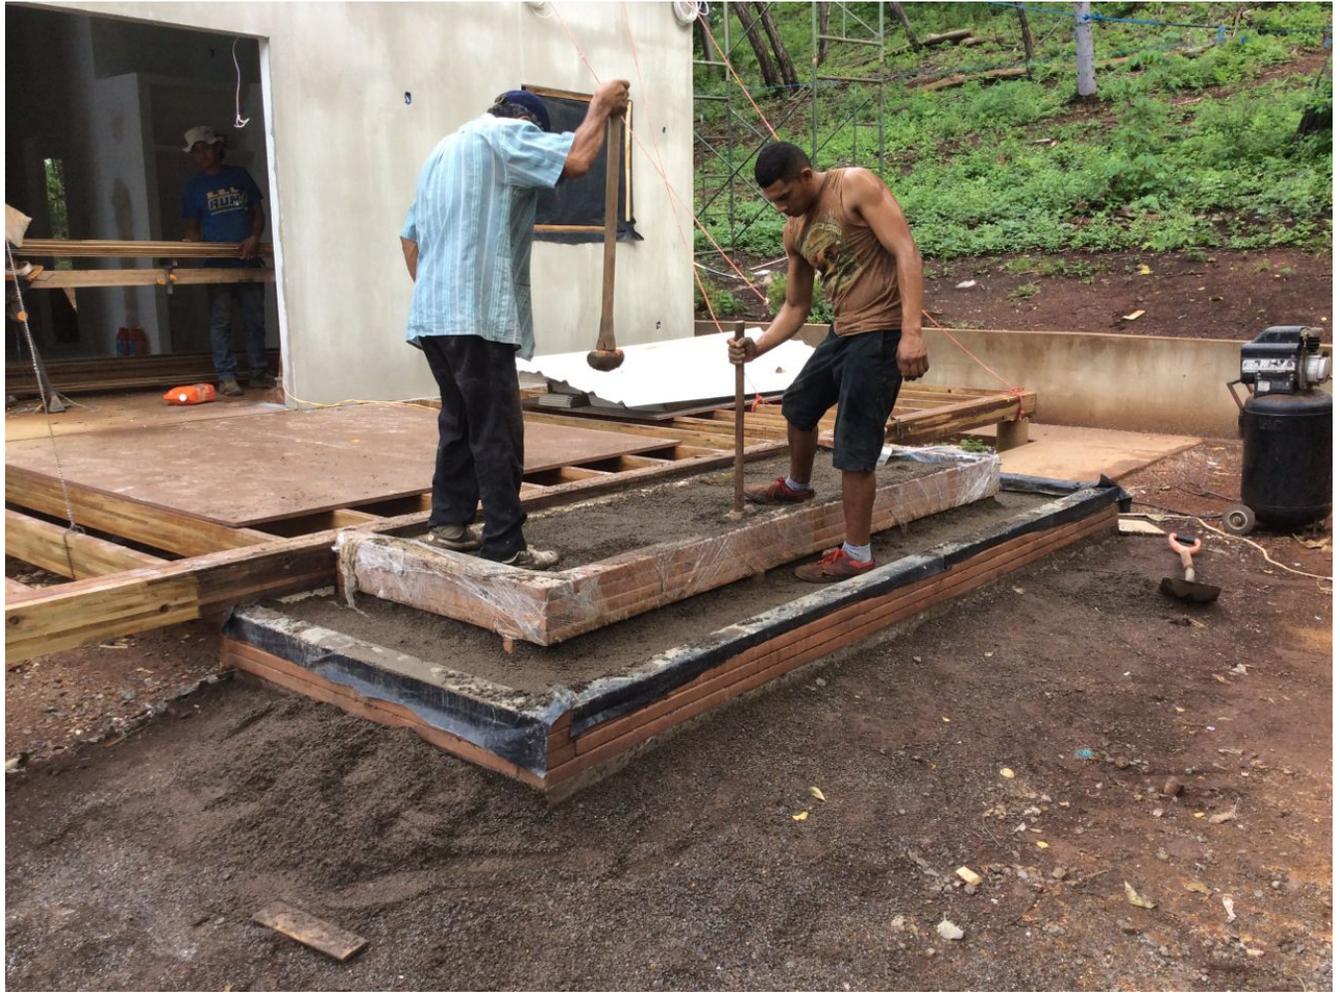
Filling and tamping down the rock base for deck steps to ready for concrete cap.

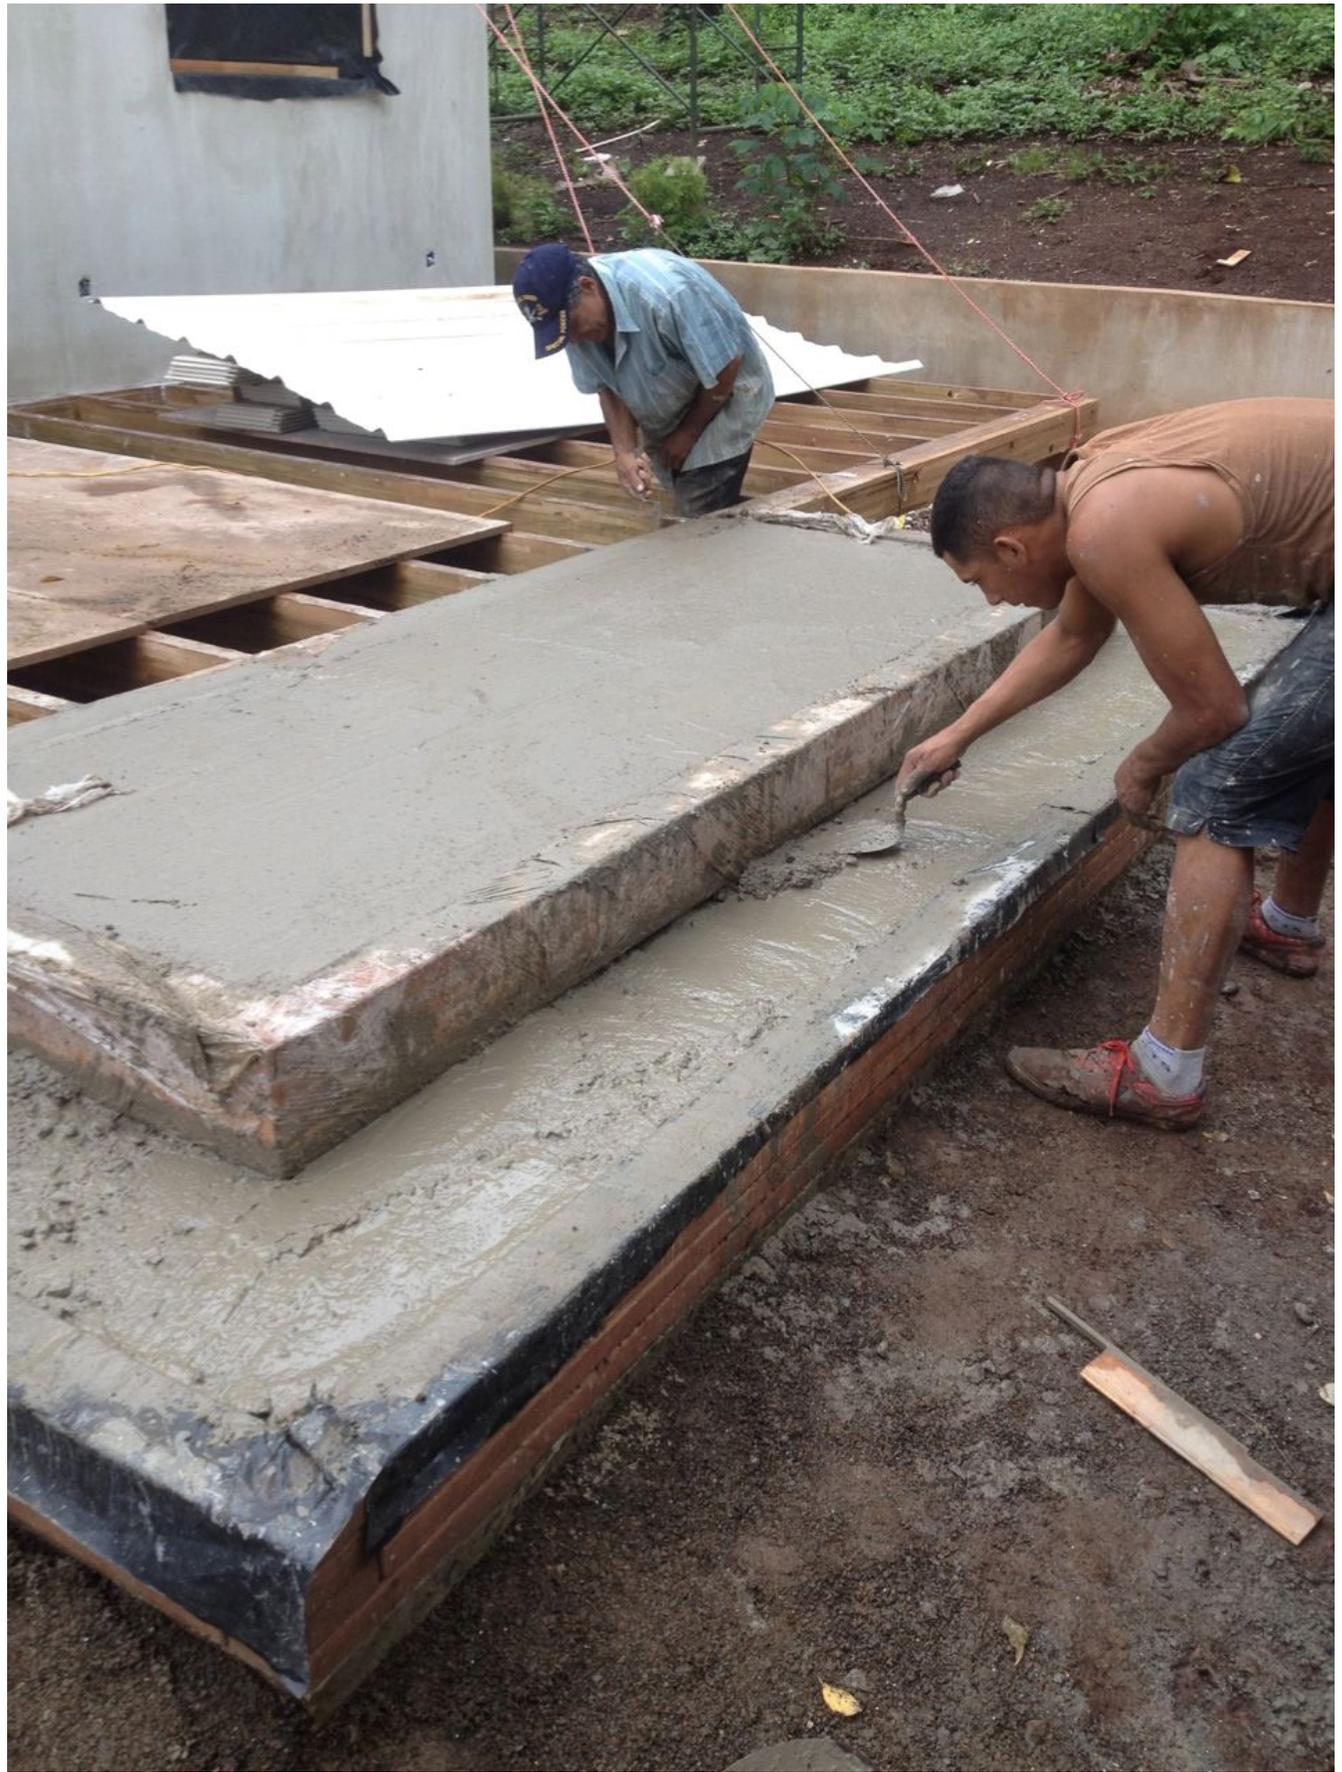
Finishing off the concrete caps that make the base for the exterior tile to be glued down to.
