Techos Siglo XXI – Constructing Your Green Home

Home Diary – Playa Grande

Super Home #3 begins with a BIG MOVE!

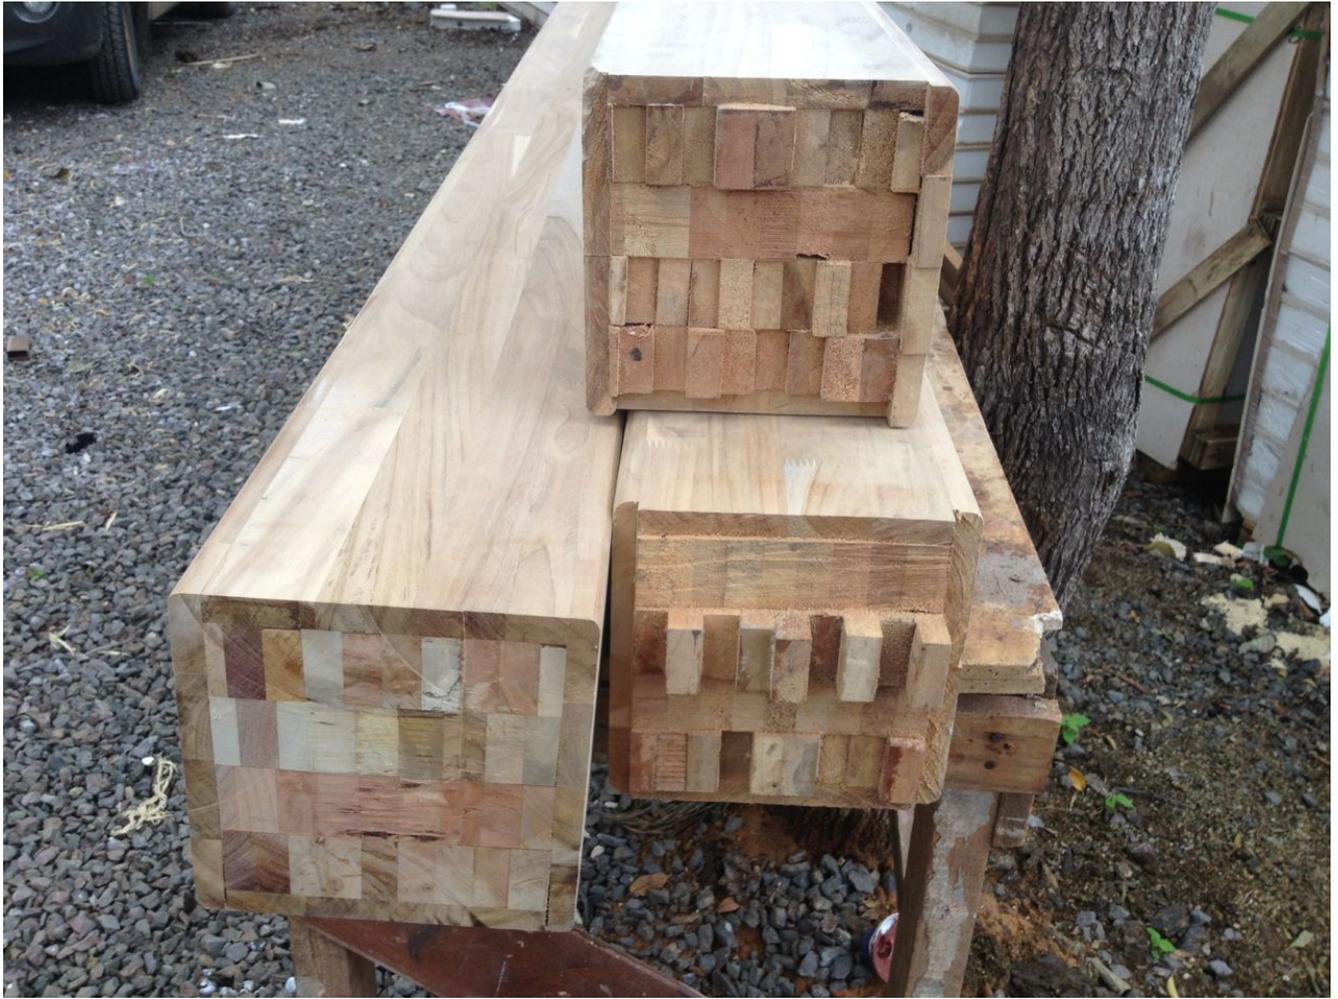
Truck arrived from our mill down south to deliver another load of Teak so we are now in serious Teak phase of this build. Michael designed the deck area to have big hurky posts and beams to give an unusual effect or we could say the old method of post and beam construction however we have used some tricks here that are anything but conventional. These 8" x 8" or 20 x 20 cm posts are not solid Teak but are another glu-lam product. This was done both for economy as well as long term beauty. These posts done with a cheaper core of lower priced wood like Melina or Cedro are then capped with a 1/2" of Teak. All Teak posts would run \$220 each done this way they are \$139 each. Compared with solid Teak of this size would run \$300 to \$400 as you would have to have 35 to 40 year old trees to get a post this size out of. Then when you come back in one to two years it is going to be full of cracks. Not what I call a beauty whereas this process ensures the posts will remain the way they are for generations. Needless to say the least no warping and twisting either.

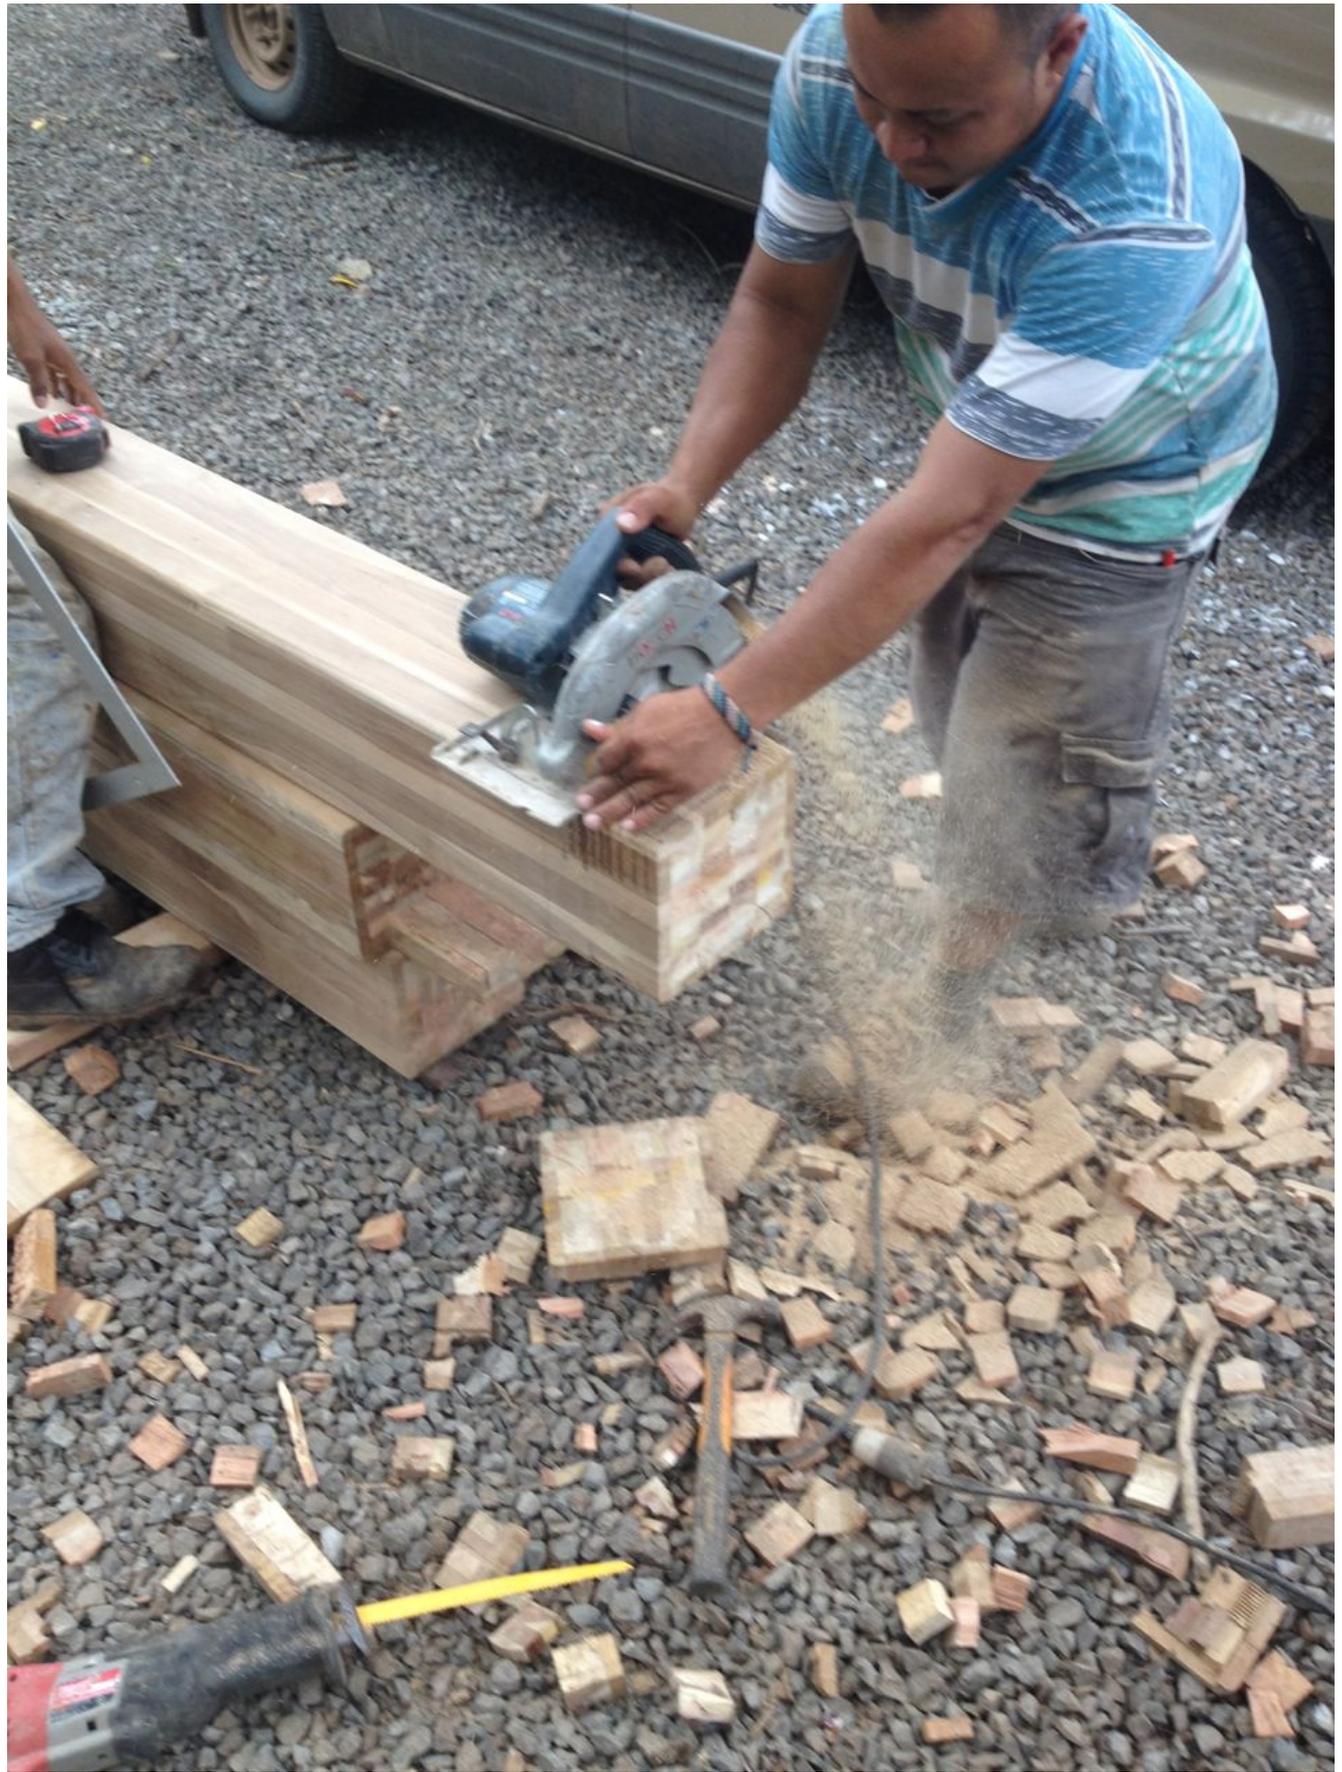
Cutting the posts to length and lapping them to make the floor joints and upper beam joints.

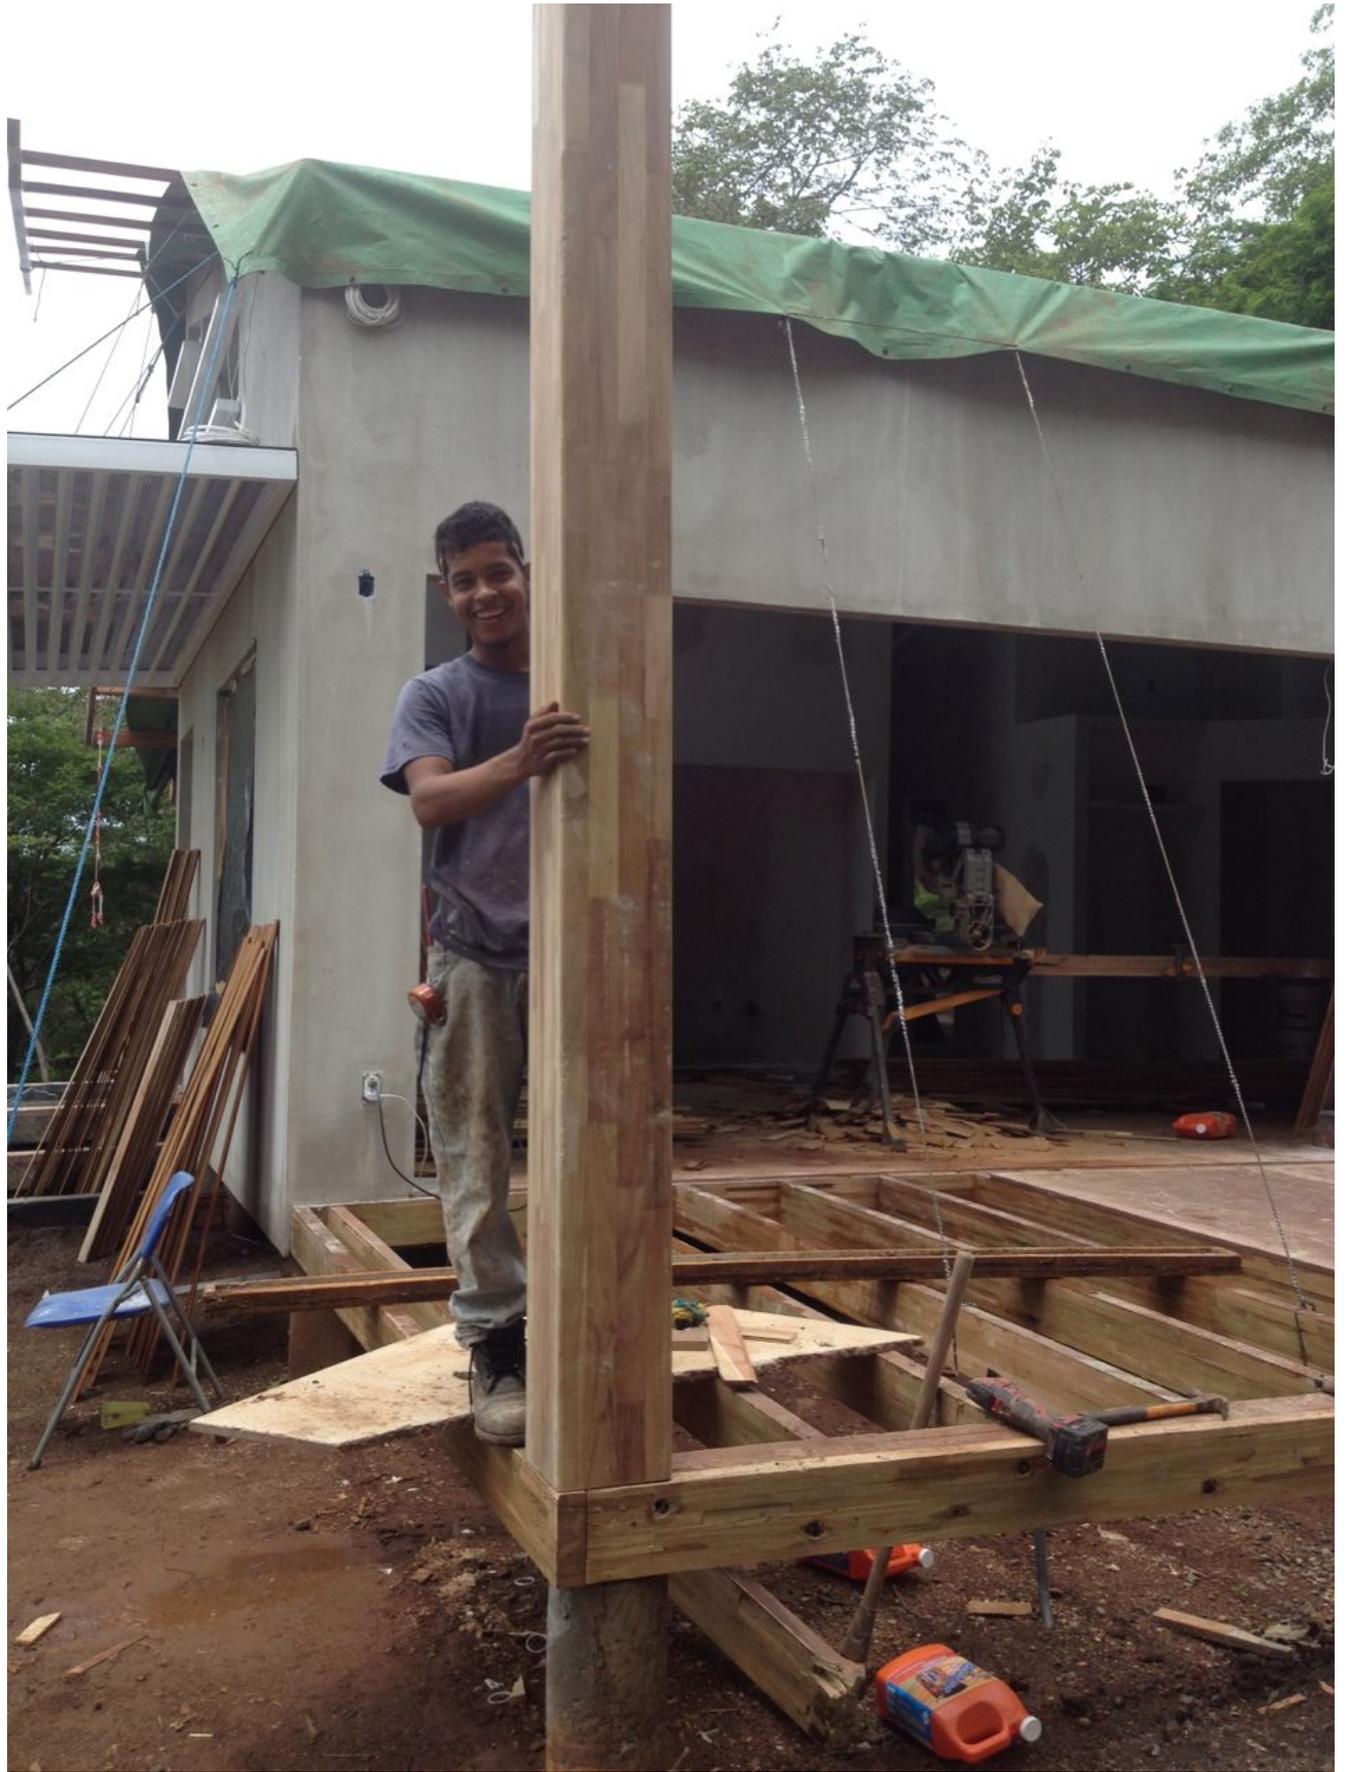
First post in place testing the fit of the lap down into the floor structure.

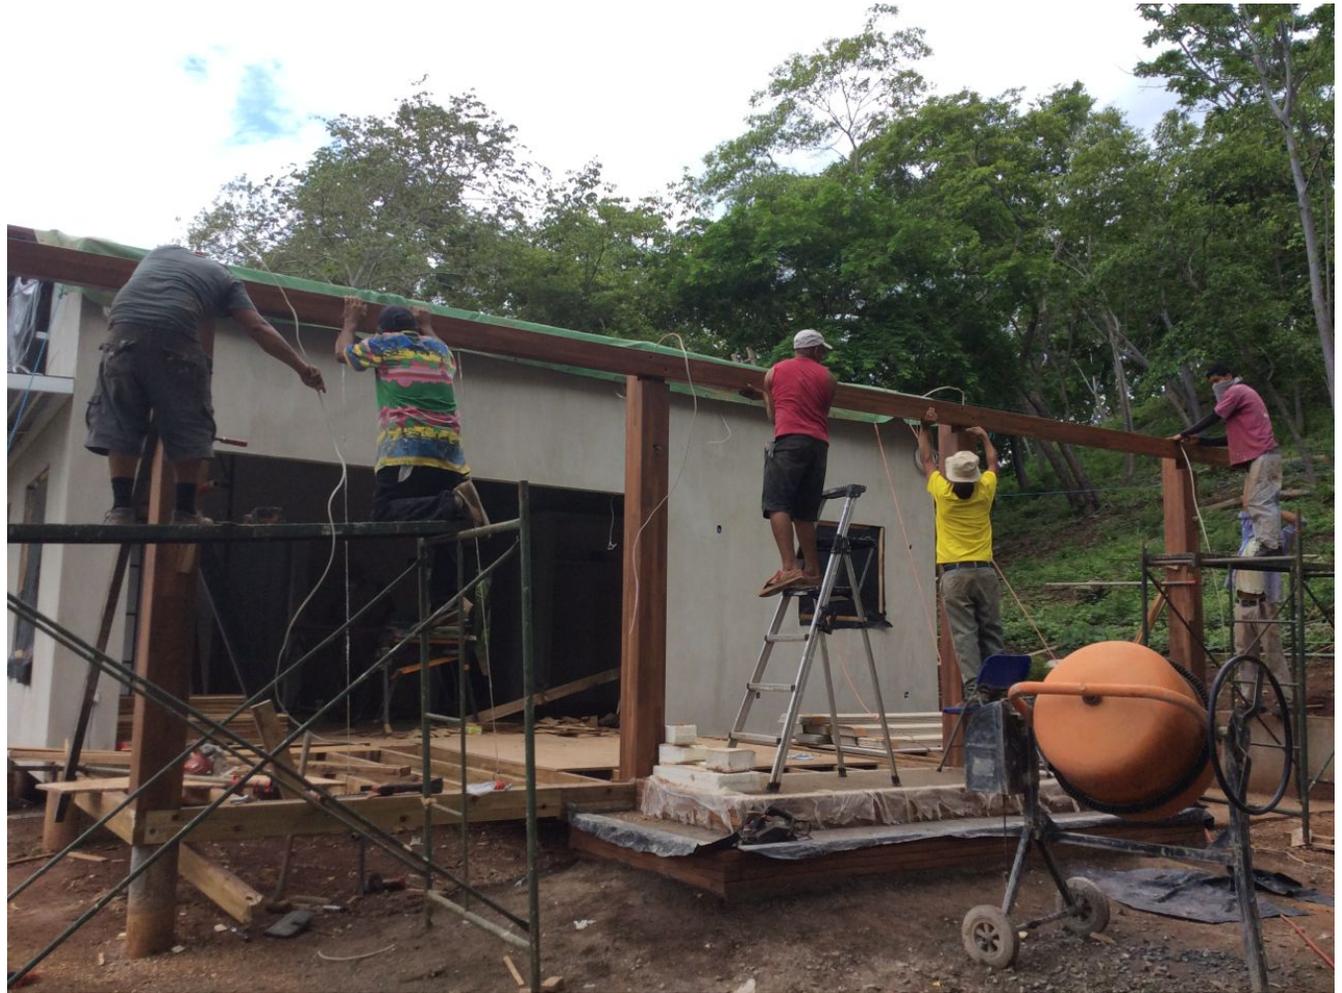
All four posts anchored now putting this very long 10 meter - 33 foot long beam in place over them to support the roof and rafters.

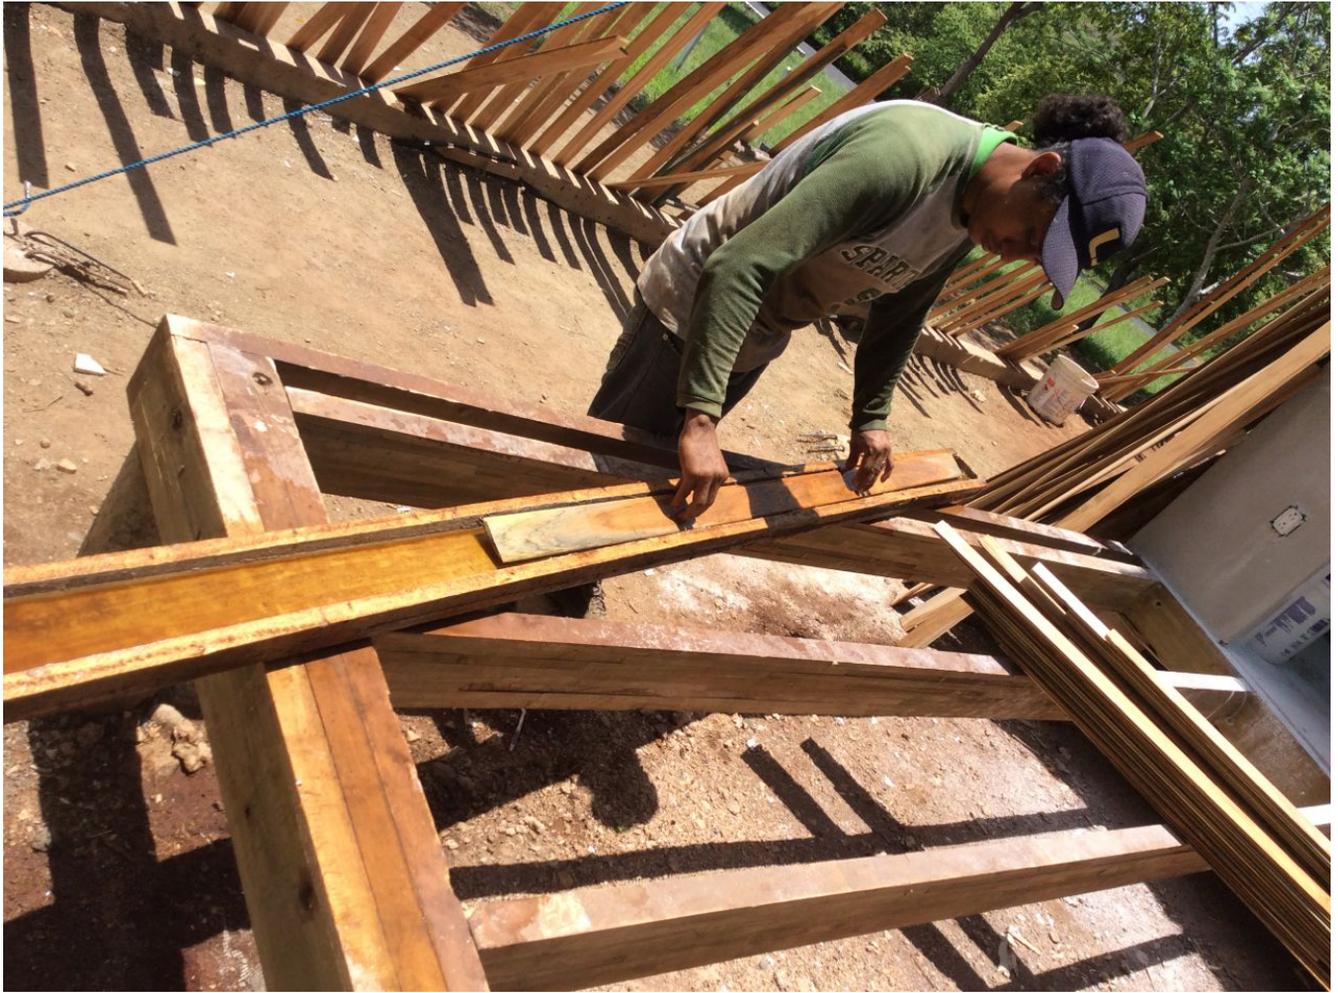
We built a bath tub to dip all of our Teak tablia (tongue and groove) ceiling into. The white younger wood of teak is susceptible to bug attack if not treated. So 16 gallons later we will have all this new order of wood treated.

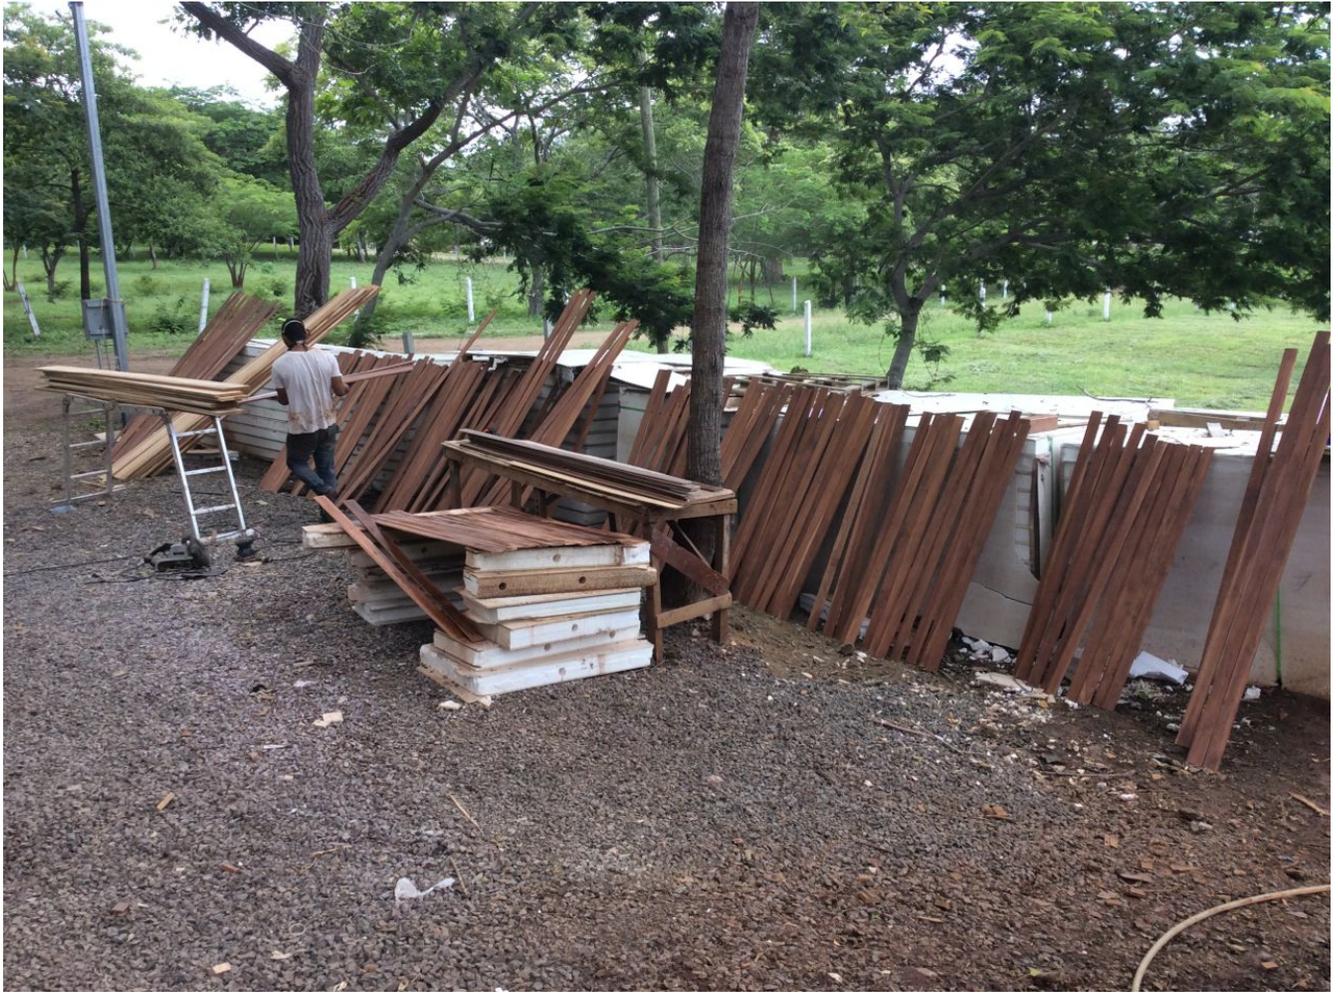
After drying it is all hand sanded then stained with a linseed oil product from Lanco. Here it is drying after being oiled.

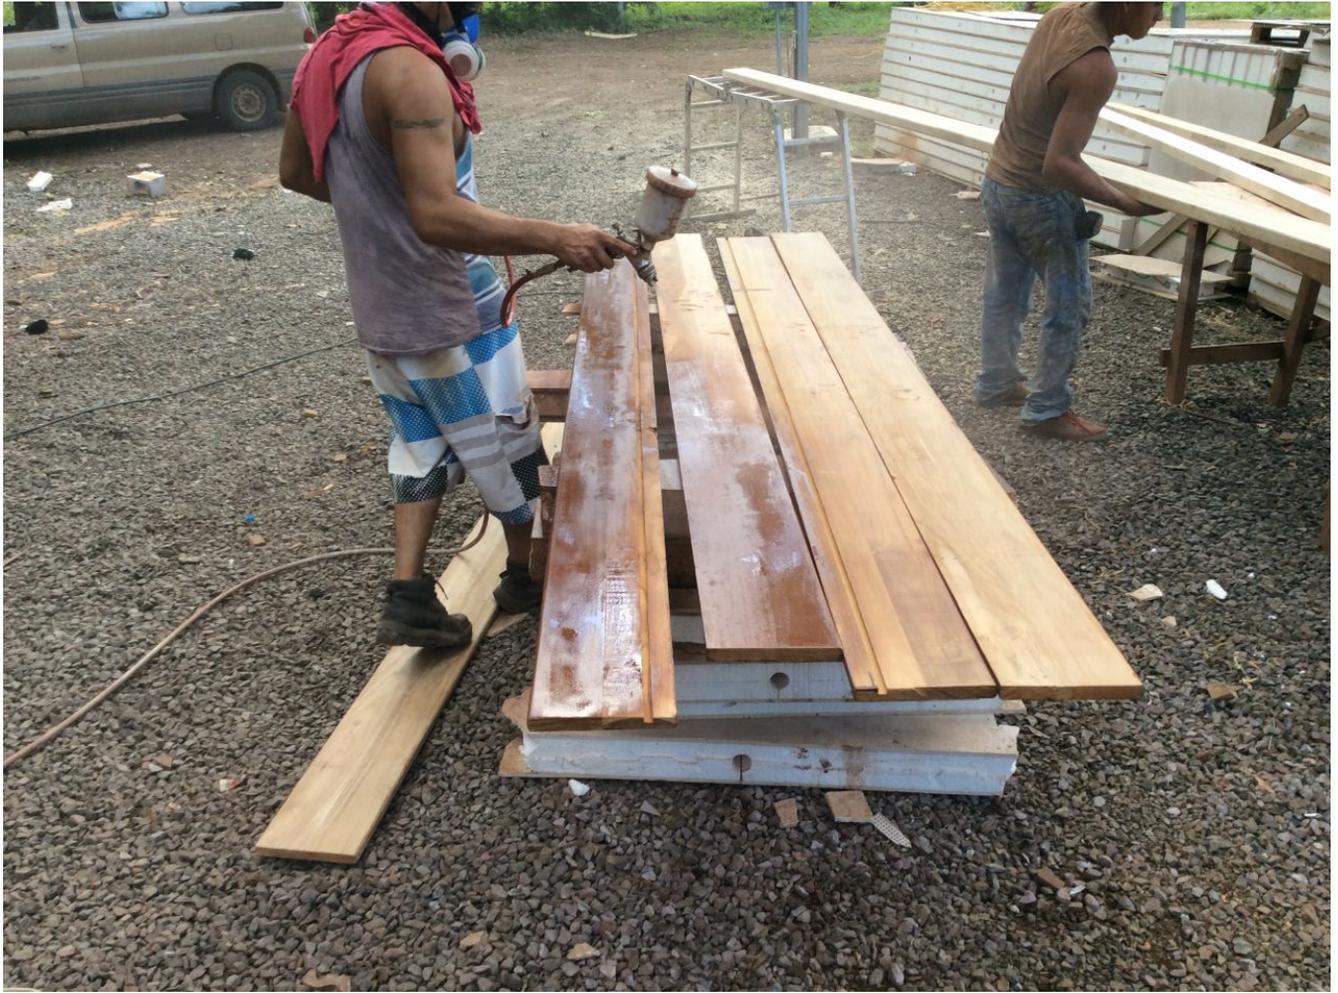
Spraying oil onto fascia boards. Note the groove in the fascia is there to receive the tablia ceiling making a tight joint where the roof deck meets the fascia.

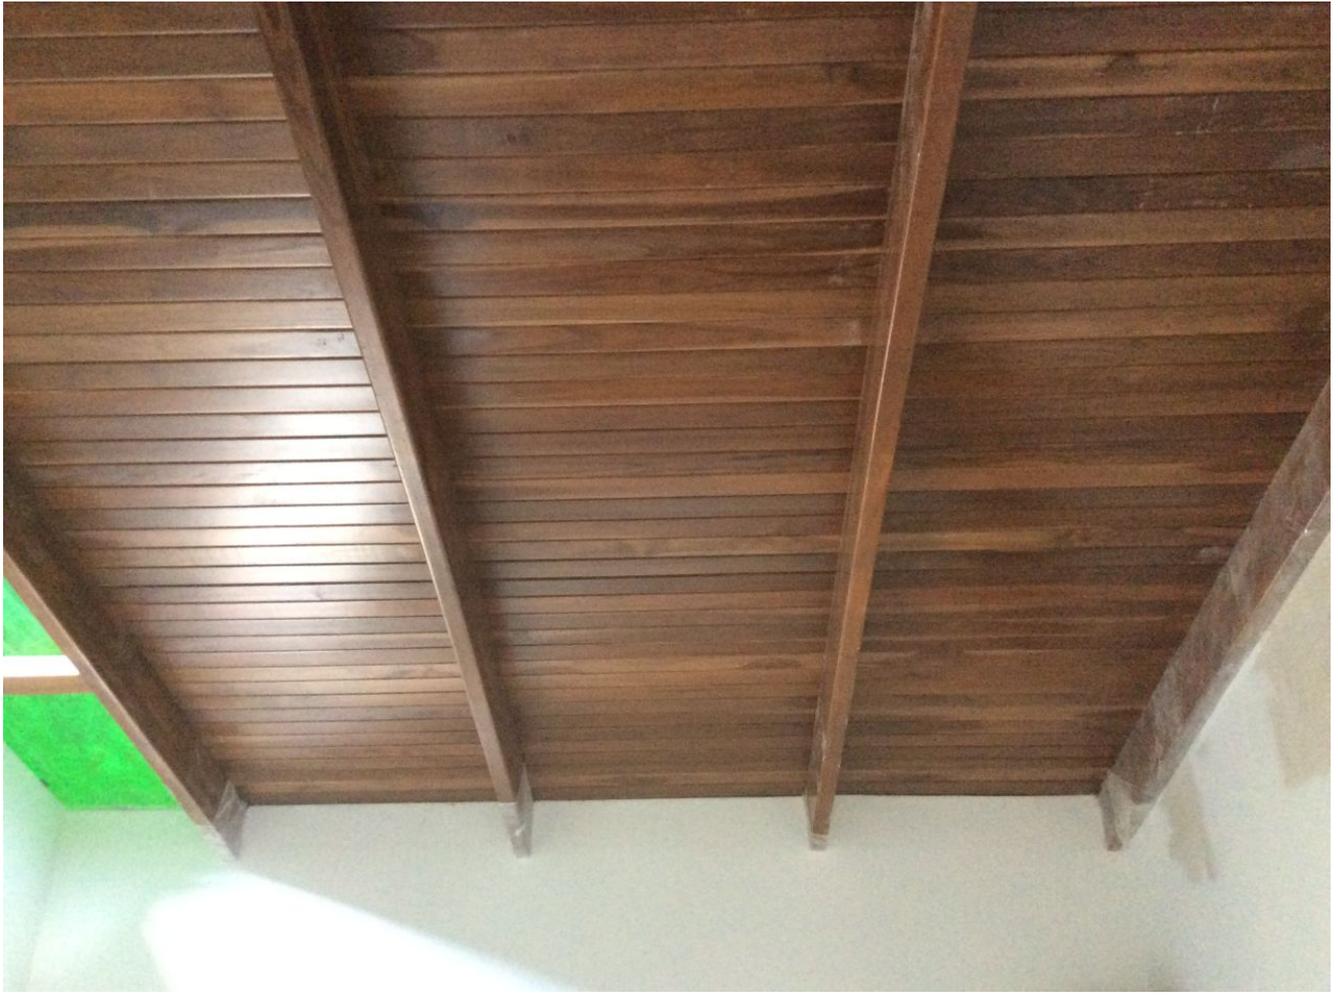
First section of Teak roof completed. This has had two coats of SUR's best catalyzed polyurethane has been sprayed on with a satin finish.

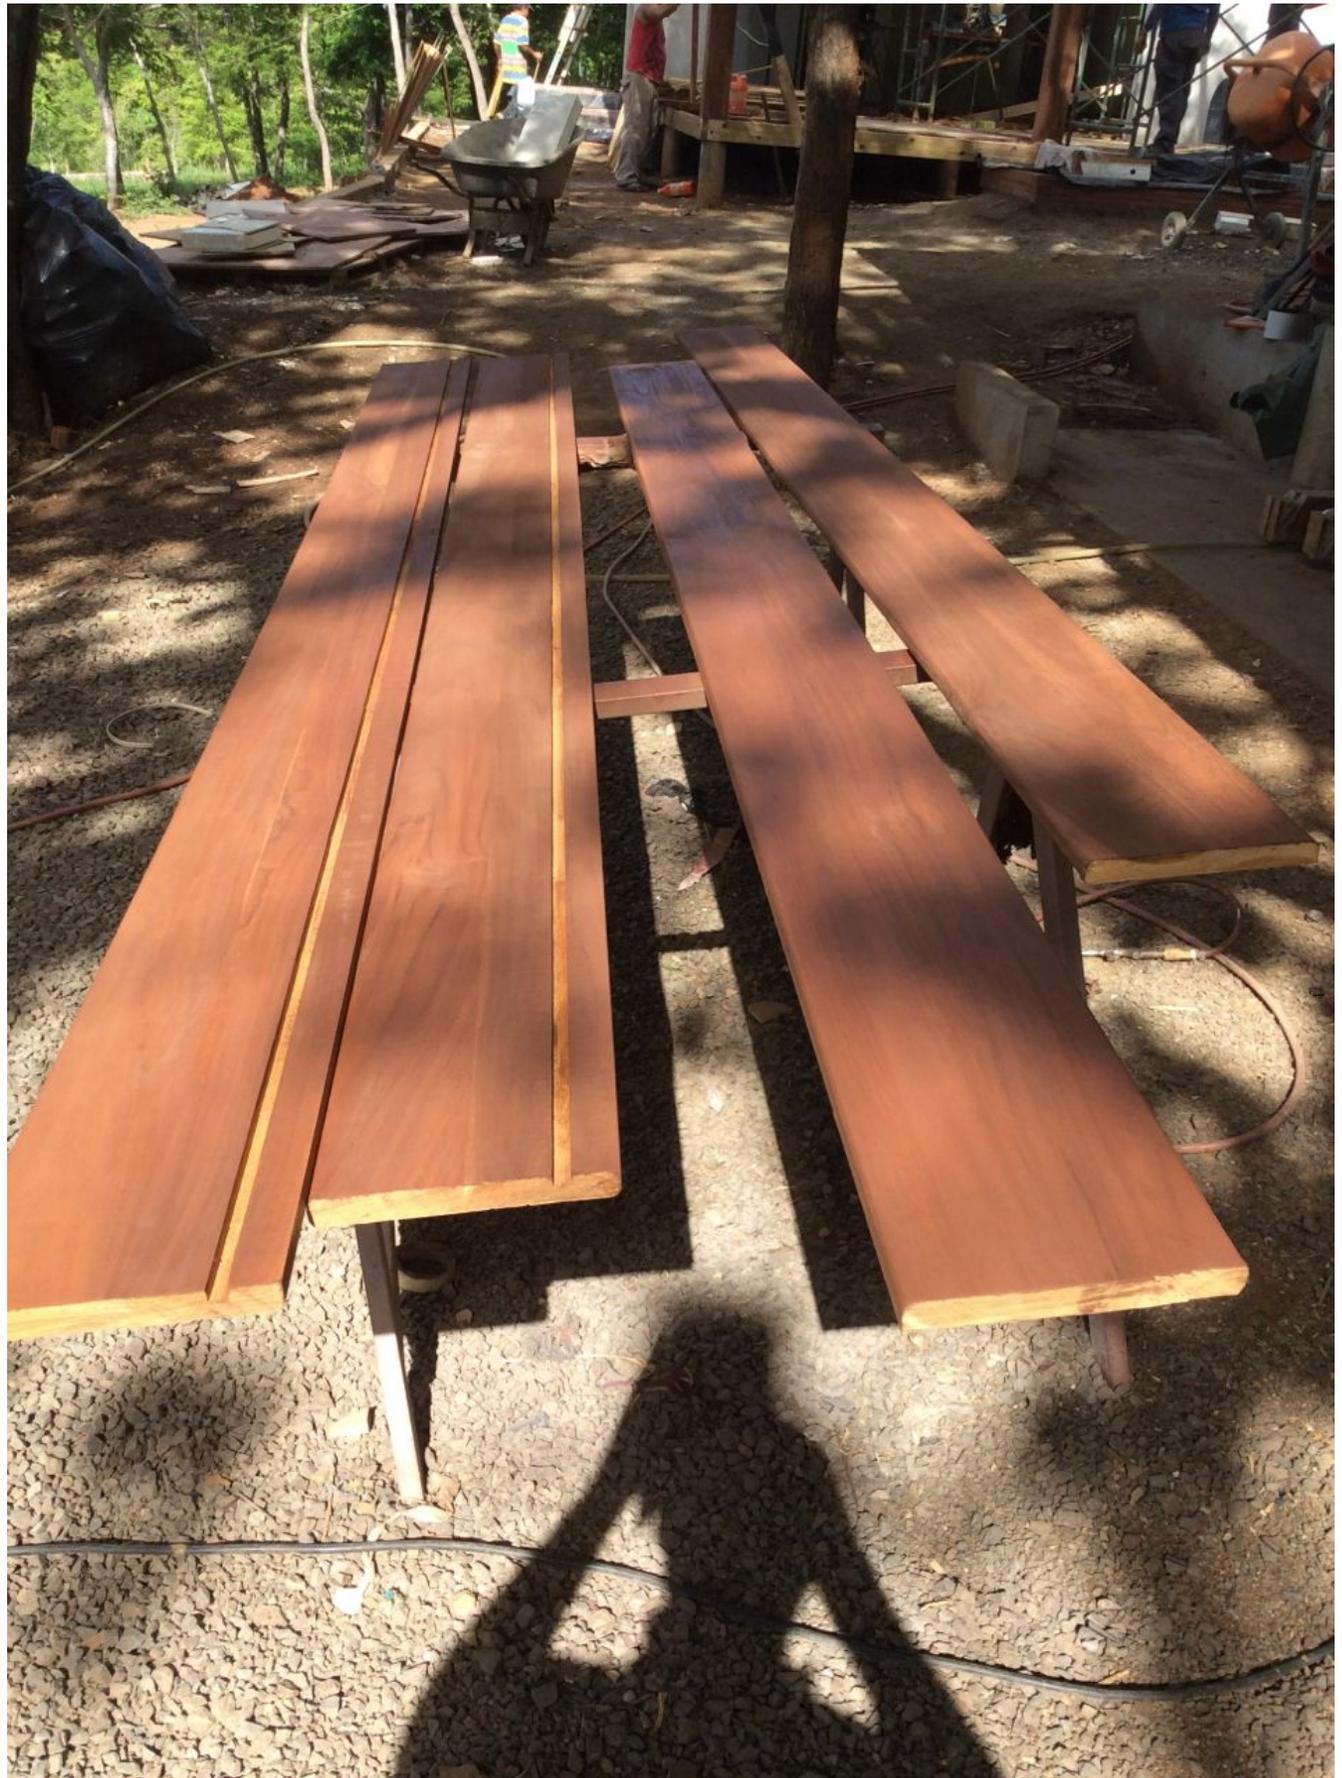
Facia with its oil finish applied, the exterior is left as oil to withstand the climate as polyurethane is destroyed in 5 to 8 months of our climate.

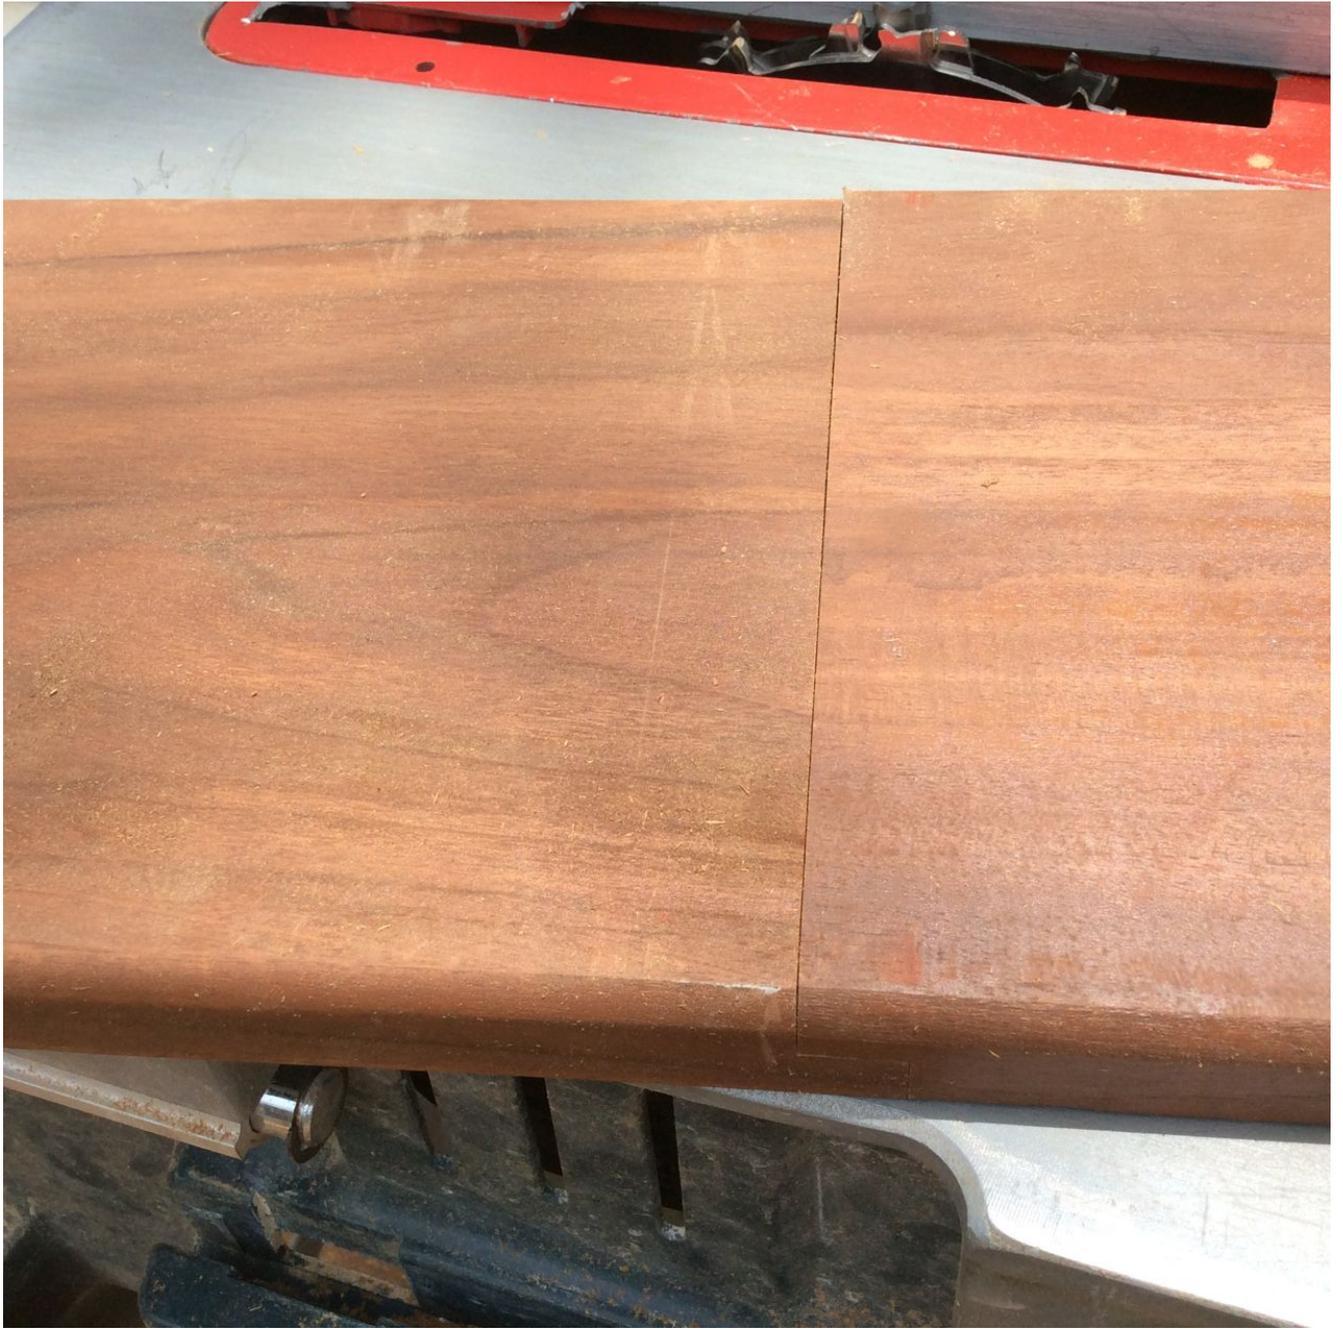
This is the end result.

Here we cut rabbit joints in the end of each fascia board in order to get a tight fit.

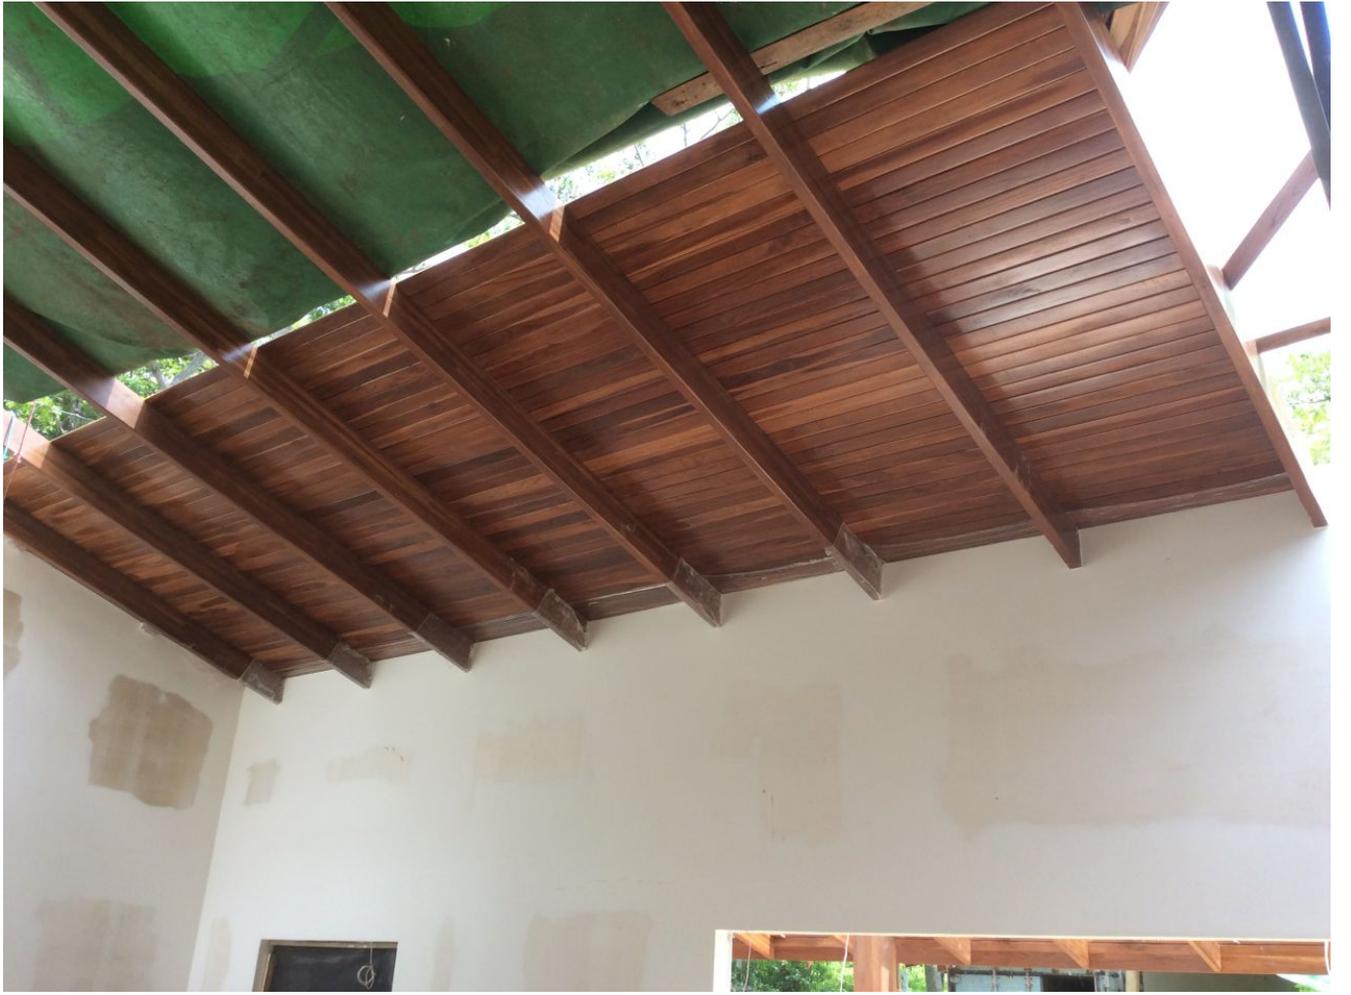
Elsewhere the crew is advancing quickly as the tablia is finished with oil and polyurethane.

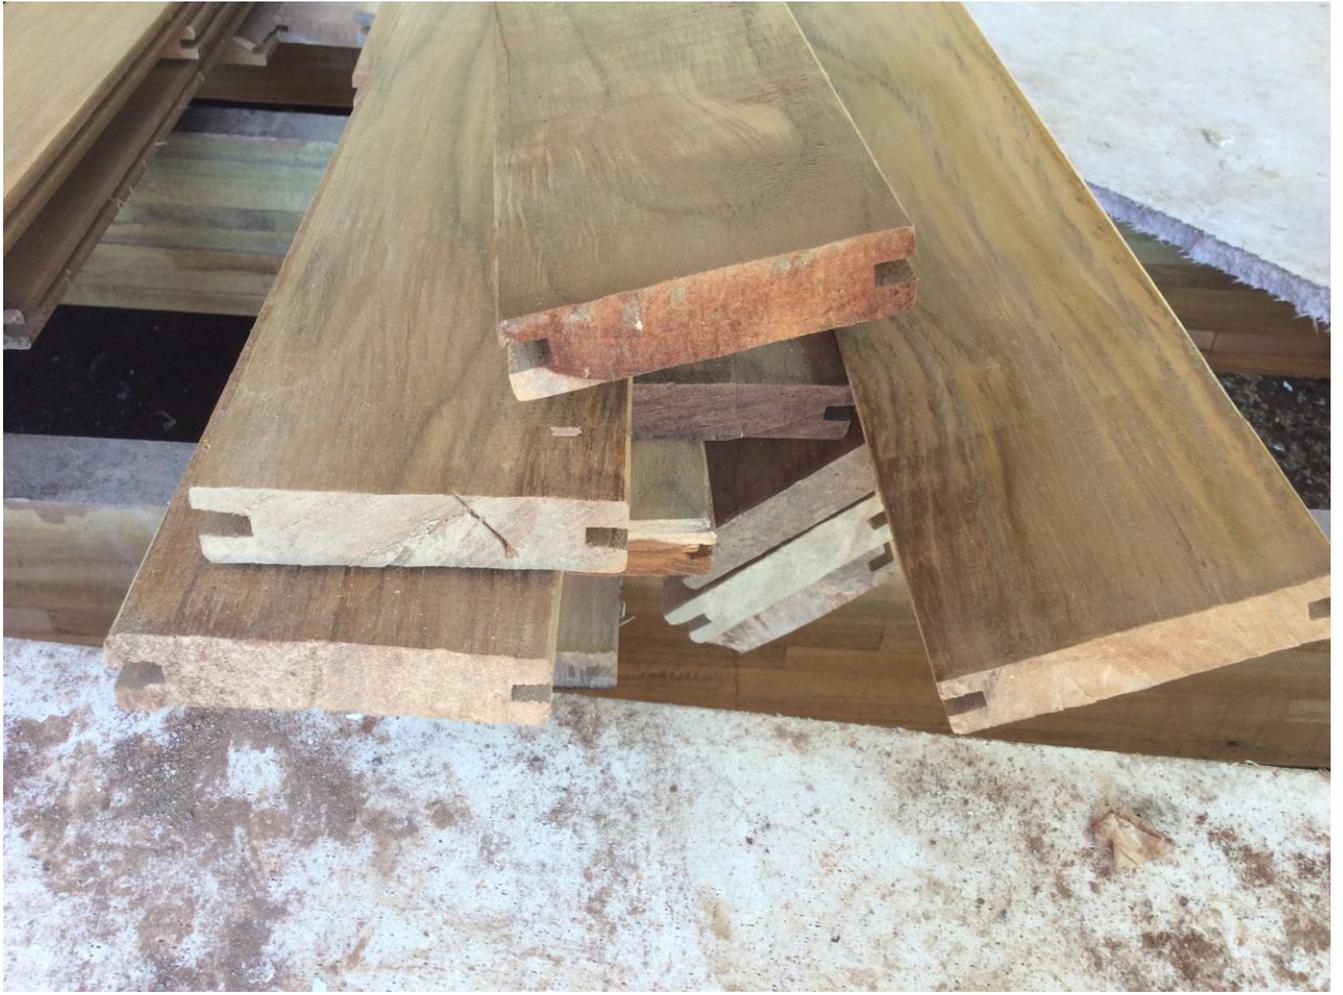
This was specially cut at the mill to work with deck clips so that no fasteners will be visible.

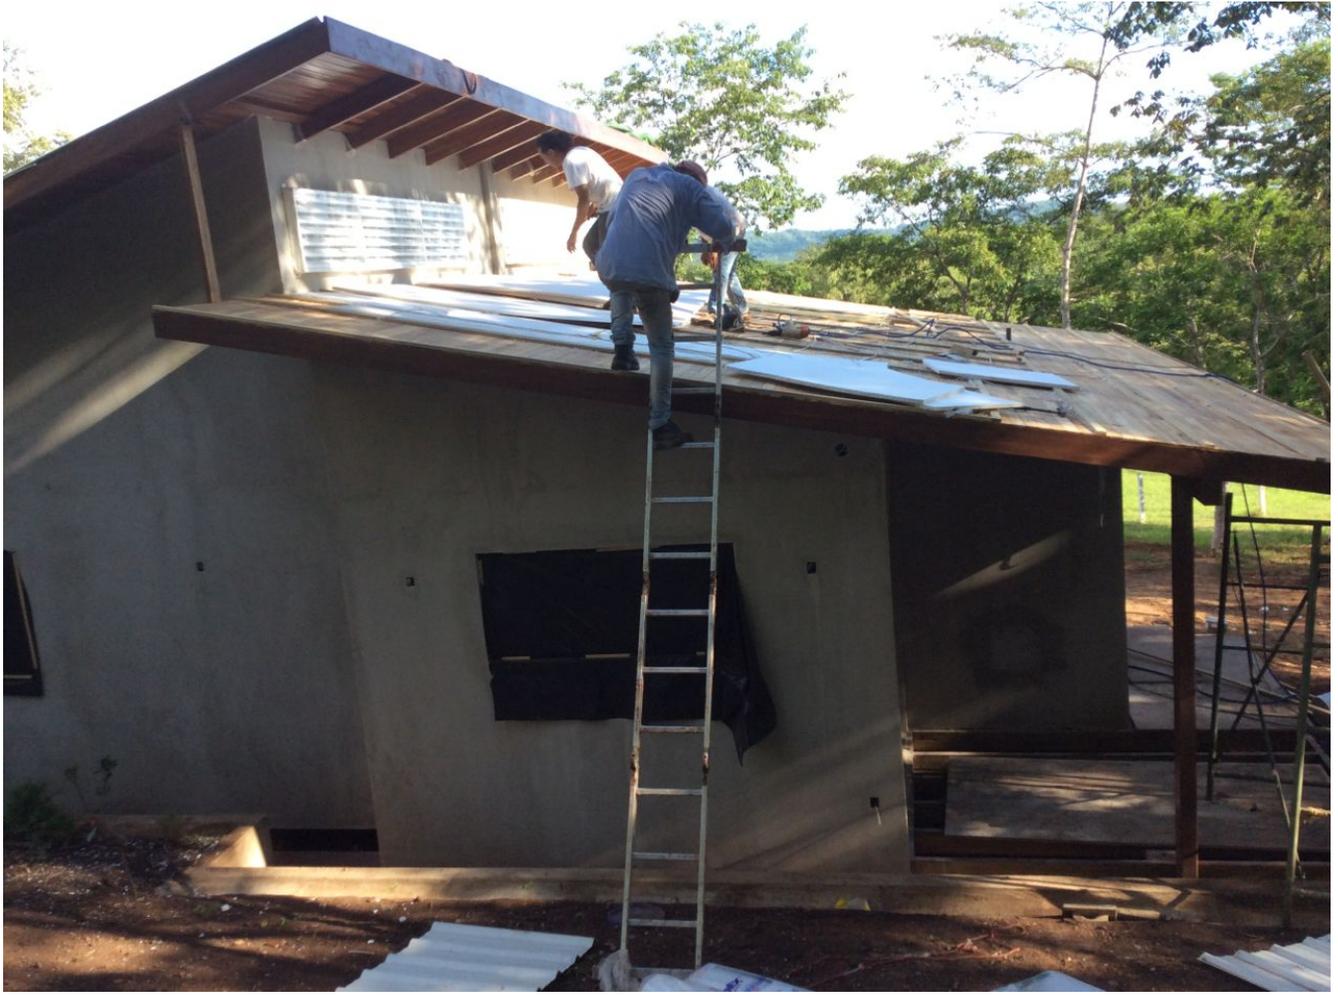
Styrofoam is now being laid over the bedroom ceilings in case A/C is ever added to these rooms.
