Techos Siglo XXI – Constructing Your Green Home

Home Diary – Playa Grande

Super Home #3 begins with a BIG MOVE!

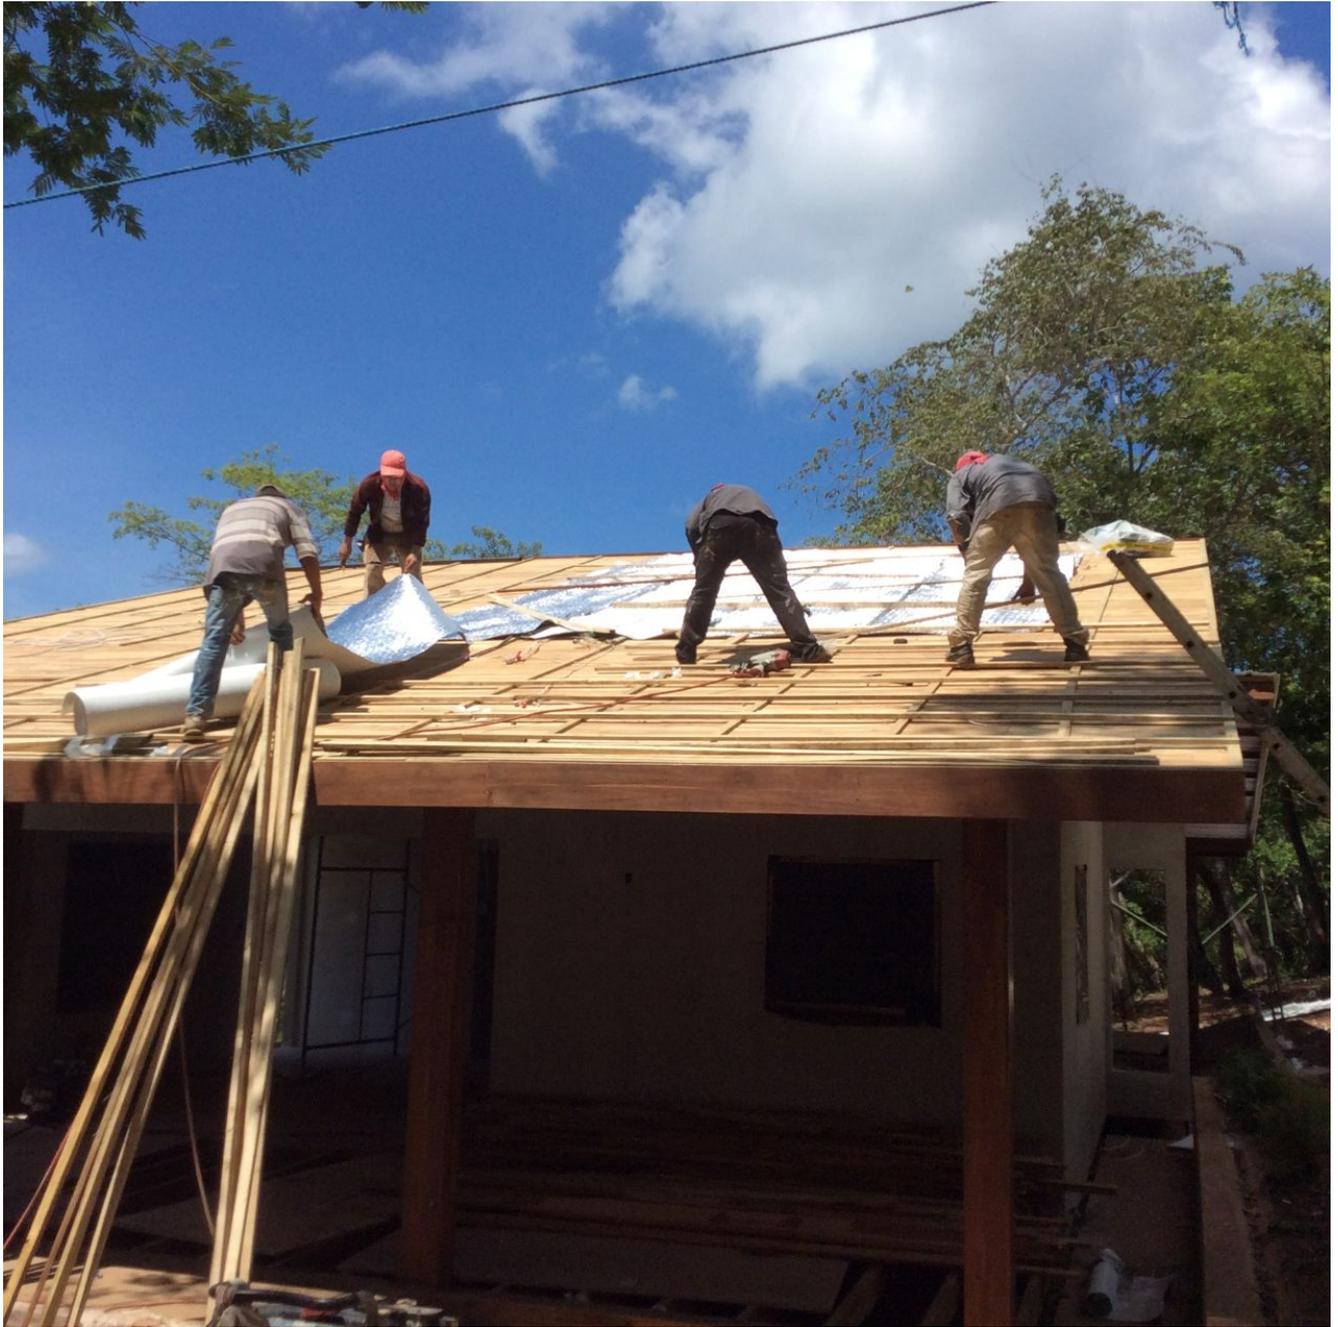
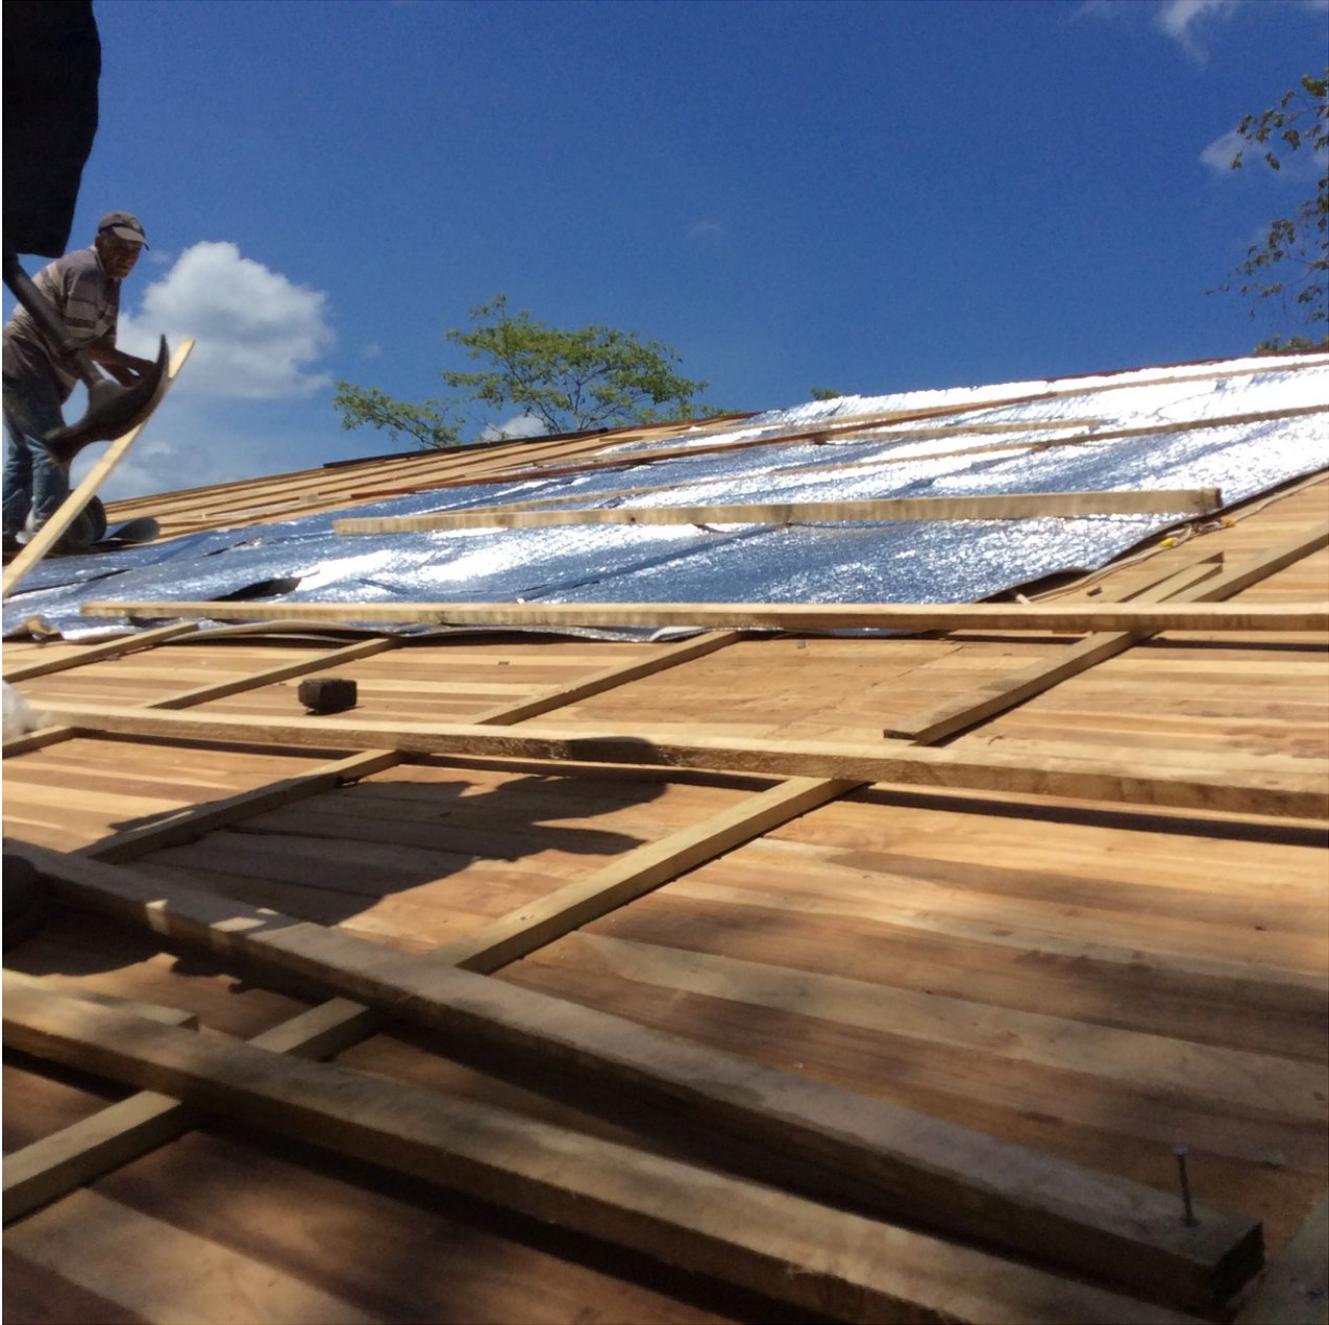
Reflective foil going down prior to the addition of a second layer of strapping goes down over top of it. This is critical point, no foil should touch a roofing surface. In this case the foil is suspended between the two strappings creating a double airspace which insulates both for radiant heat entry as well as roof

noise.
